Draft Wildlife Corridors Action Plan

December 31, 2021

New Mexico Department
of Transportation and
New Mexico Department
of Game & Fish

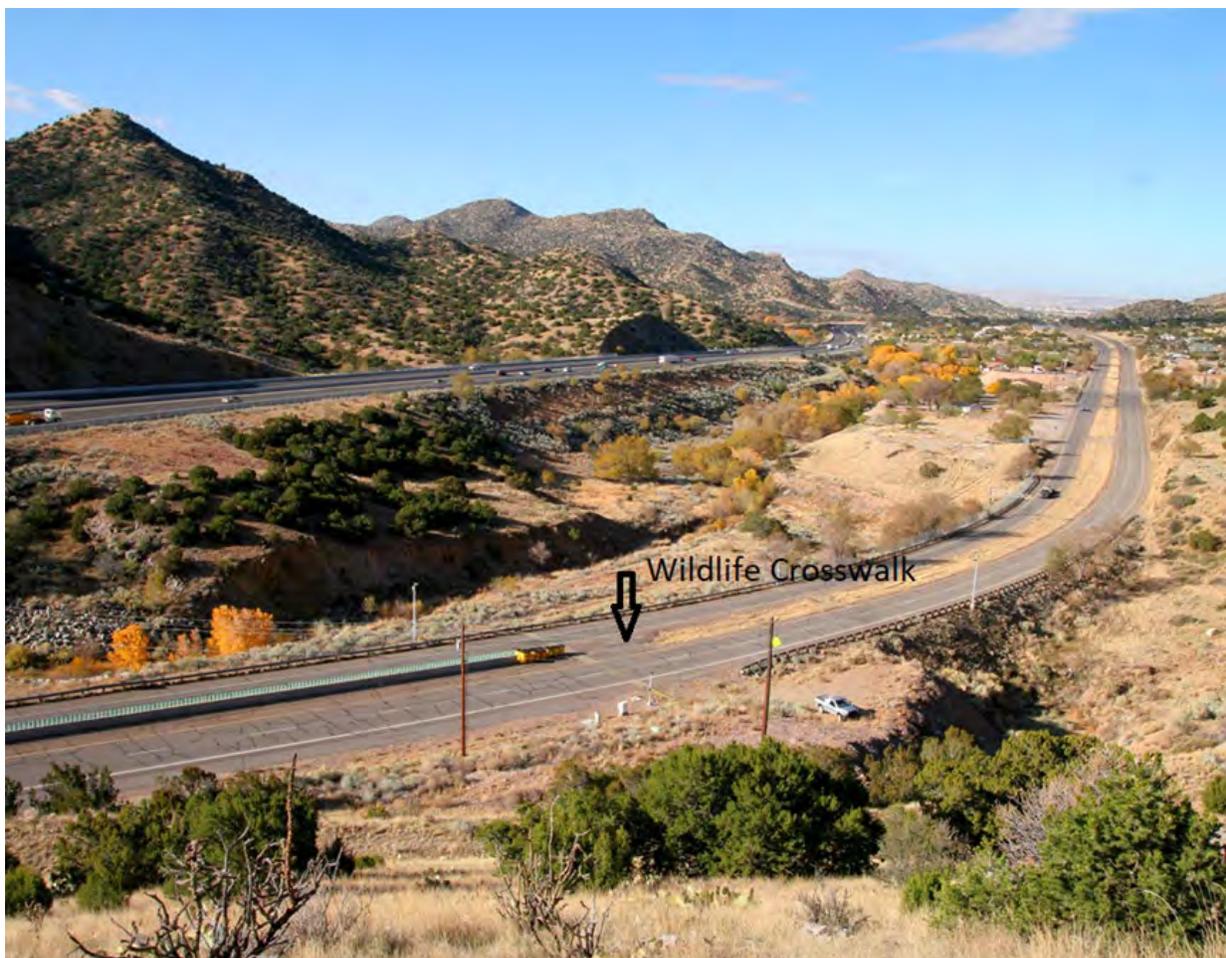
Figure 1-2. Tijeras Canyon Safe Passage Project wildlife crosswalk across NM 333 from the Hawkwatch Property, looking west toward Albuquerque. Tijeras Arroyo in center and I-40 at top (photo credit: Mark Watson).

5 miles of exclusion fencing that is intended to keep wildlife off both highways. Once across NM 333, mule deer and other wildlife can access Tijeras Arroyo for daily water needs, or continue down the arroyo approximately 0.5 mile and move under a large I-40 bridge to access habitat on the south side of I-40, which effectively reconnects the Sandia Mountains to the Manzano Mountains (Watson and Menke, 2010). Mule deer have been documented by game cameras crossing NM 333 at the crosswalk and moving below I-40 at the eastern bridge (Loberger et al., 2021). The Tijeras Canyon Safe Passage Coalition is currently the only citizen advocacy group formed in New Mexico to advocate for a WVC mitigation/habitat connectivity project (Watson and Menke, 2010).

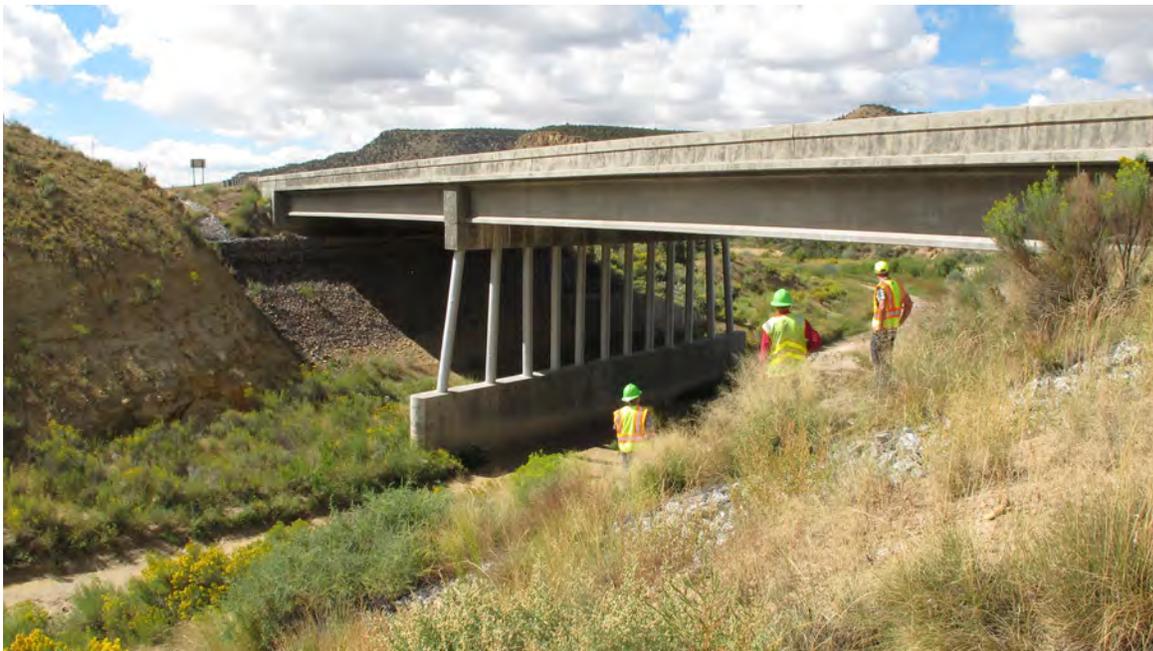
Figure 1-3. Bridge over Rio Puerco, US 550 south of Cuba (photo credit: Mark Watson).

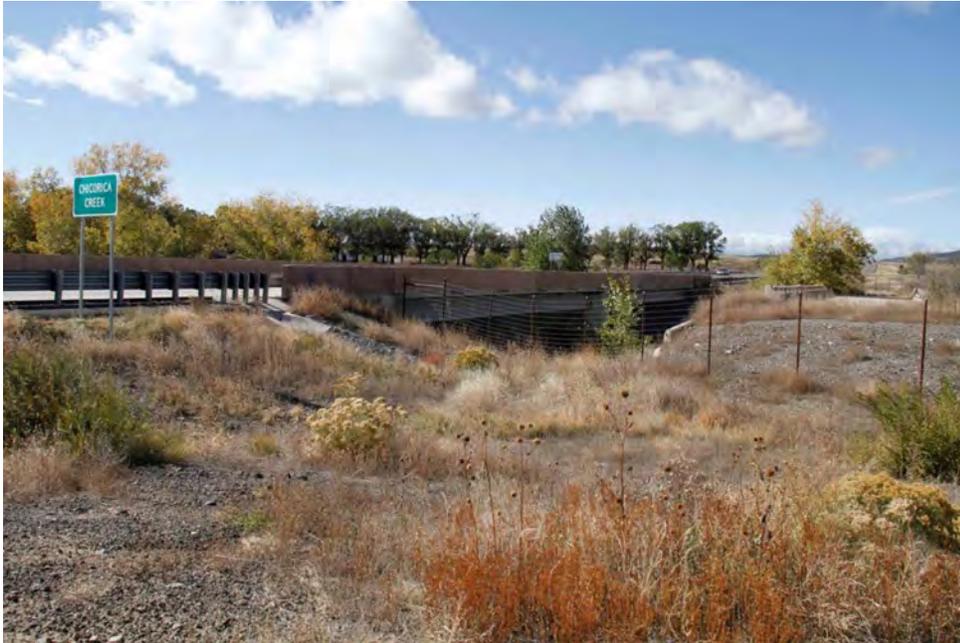
Figure 1-4. A small fencing project implemented in 2004 to mitigate a relatively high deer-vehicle collision hotspot along US 64 in northeastern New Mexico between Raton and Clayton. Chicorica Creek contains riparian vegetation and perennial water in shortgrass prairie habitat. A 0.1-mile game fence was constructed on each end of a bridge that was enlarged during the US 64 highway improvement project (photo credit: Mark Watson).

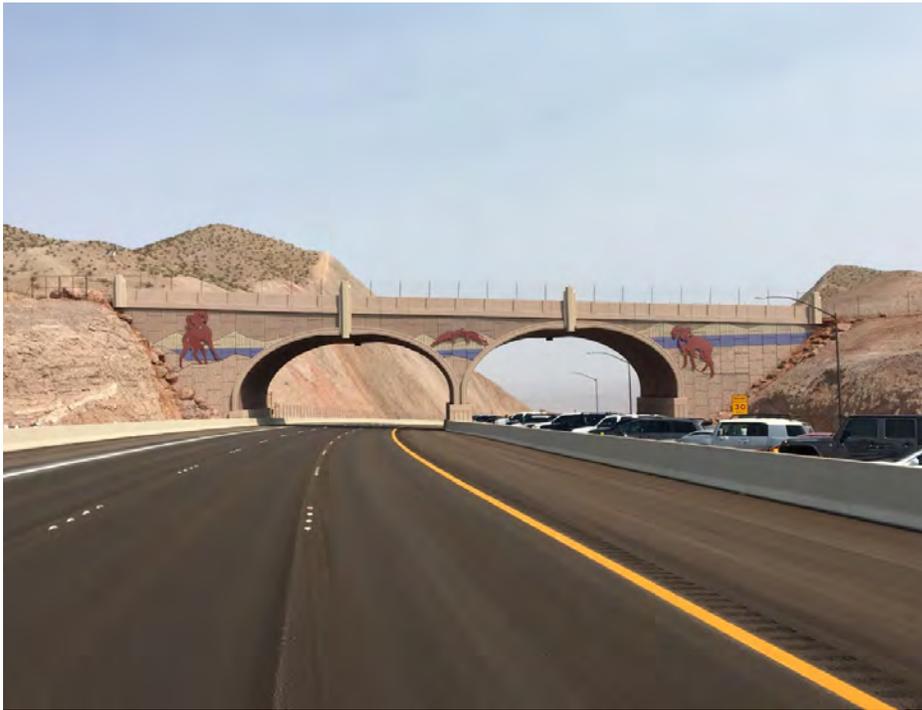
Figure 1-6. Desert bighorn sheep overpass built during Phase II of the I-11 Boulder City Bypass mitigation project in southeastern Nevada (photo credit: Jeff Gagnon).

Nevada partnered with Arizona in a unique example of interstate collaboration during the design and construction of Boulder City Bypass Phase II, a section of the new I-11 in southeastern Nevada. As planning was underway for this new stretch of road through previously undisturbed habitat, Nevada reached out to Arizona for information on the best options for mitigation of desert bighorn sheep collision and habitat fragmentation. The Arizona Game and Fish Department (AZGFD) had recently completed a long-term evaluation of US 93 directly across the Colorado River and gained insights on successful mitigation measures. NDOT and Nevada Department of Wildlife (NDOW) ultimately brought AZGFD on board to help oversee the design, implementation, and monitoring of the mitigation. Construction was completed in 2018, including one overpass (Figure 1-6) and several large underpasses. To date, AZGFD has documented more than 10,000 successful desert bighorn sheep crossings at the new wildlife crossing structures, zero collisions with sheep, and global positioning system (GPS) collared sheep roaming freely across the original range now bisected by the highway. Monitoring will continue through 2024.

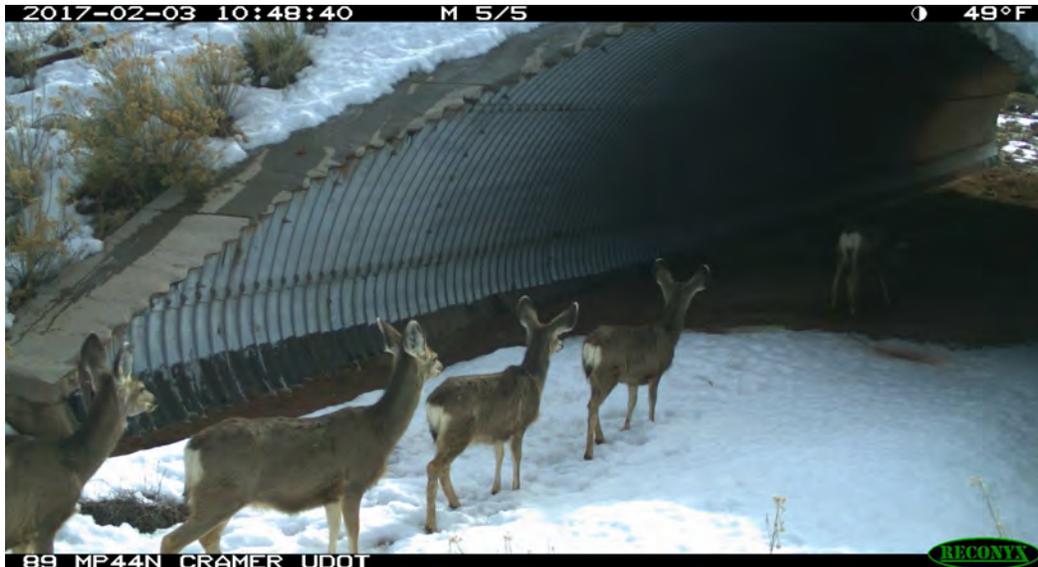
Figure 1-7. Mule deer migrating through a dedicated wildlife crossing structure along the US 89 Kanab-Paunsaugunt Wildlife Mitigation Project (photo credit: Patricia Cramer, UDOT, Utah Division of Wildlife Resources, and AZGFD).

Utah researchers, nearly 80,000 successful mule deer crossings were documented (Figure 1-7) (Cramer and Hamlin, 2019).

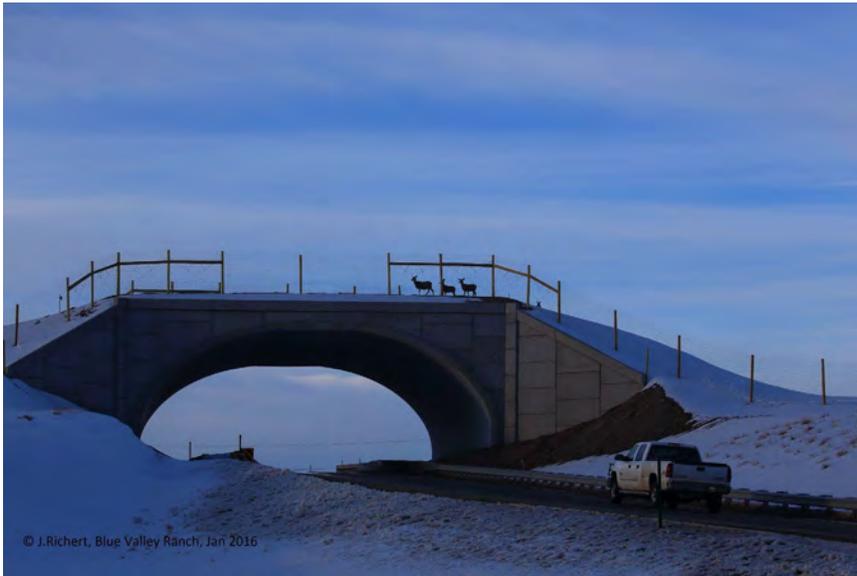
Figure 1-8. Mule deer moving over one of the SH 9 wildlife overpasses in Colorado (photo credit: Josh Richert, Blue Valley Ranch).

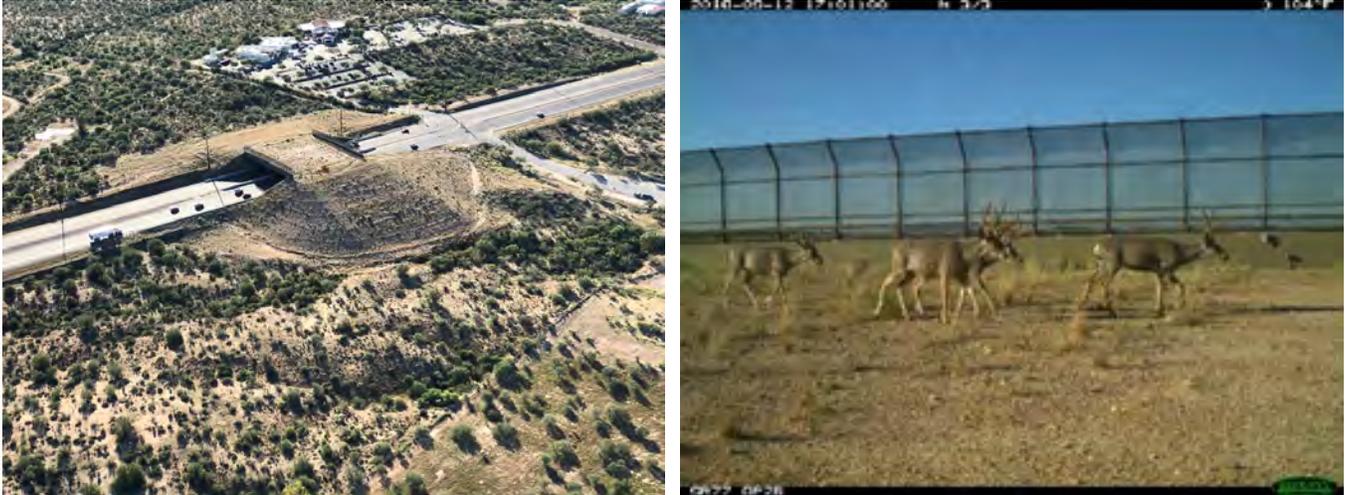
Figure 1-9. First wildlife overpass in the Sonoran Desert along State Route 77 in southern Arizona (photo credit: AZGFD).

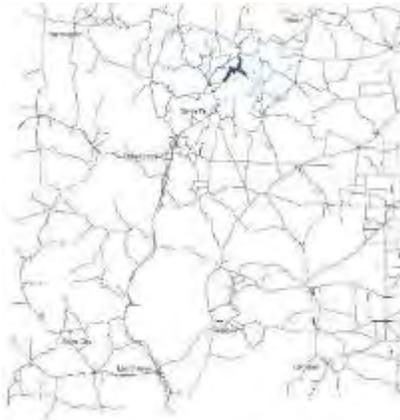
a. Black bear

This modeling effort produced three different types of maps: (1) pixel-level patterns of connectivity values for linkages intersected with roads for each individual species and all species combined, (2) the 25 polygons representing the linkages with the highest connectivity intersecting roads for each and all species together, and (3) high-resolution images of the top 10 intersected roads and connectivity models for each species and all species jointly. Presented below are the pixel-level connectivity value maps for each species (Figure 5-7), all species jointly (Figure 5-8), and each species with the top three segments of road where the connectivity

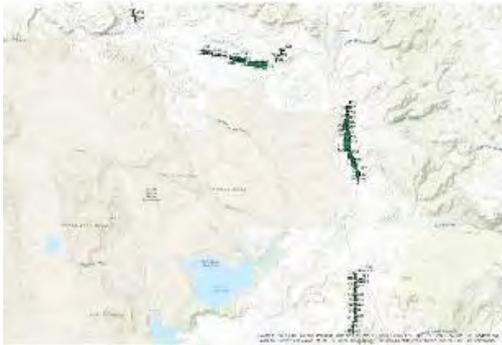
a (Elk)

This corridor/linkage was supported by this Action Plan’s mule deer and elk models, NMDGF unpublished GPS radio collar data for mule deer, and other GPS collar movement data for mule deer and elk. This area is also supported by the S.O. Action Plan high priority Northcentral Landscape. Mule deer occupy winter range near and around Heron and El Vado Reservoirs, and cross US 64/84 south of Chama to higher elevation fawning habitat in the Tusas/South San Juan Mountains. Wildlife-transportation conflict mitigation efforts offer partner opportunities with NMDGF, which owns the Rio Chama Wildlife Management Area just east of El Vado Reservoir, the Carson National Forest, which manages some of the calving and fawning habitat in the Tusas/South San Juan Mountains, and the Jicarilla Apache Tribe, which owns Tribal land on both sides of US 64/84 south of Chama. See Figure 5-25 for greater modeling details on where these species were expected to cross US 64 and US 84.

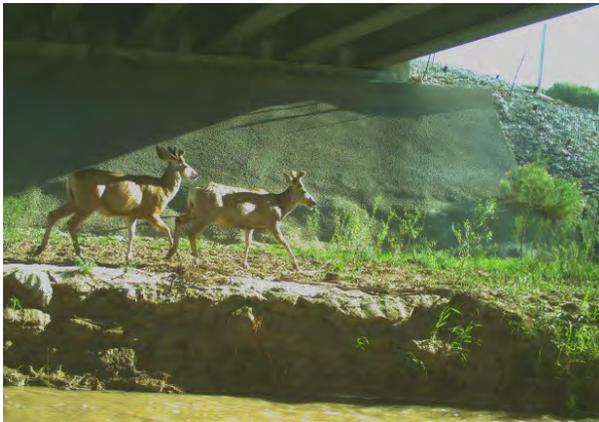
Figure 6-2. Mule deer move beneath the US 550 Rio Puerco Bridge south of Cuba (photo credit: NMDOT).

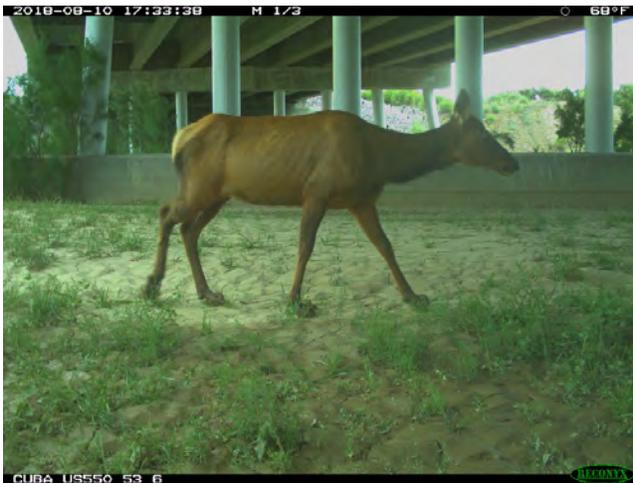
Figure 6-7. Elk photographed using US 550 Bridge at MP 52.6 south of Cuba (photo credit: AZGFD and NMDOT).

Intermediate solutions would consist of installing new underpasses for wildlife. Because elk herds are not typically willing to use underpasses unless they are large bridges, underpasses may not represent a complete solution. Underpass culverts could be complete solutions at specific locations where mule deer are the only species that cross the road. Underpass choices for elk in this area are limited to only span bridges, which elk have used readily in Arizona (Dodd et al., 2007; Gagnon et al., 2011) and in an ongoing New Mexico study (Gagnon and Loberger, 2021) (Figure 6-7).

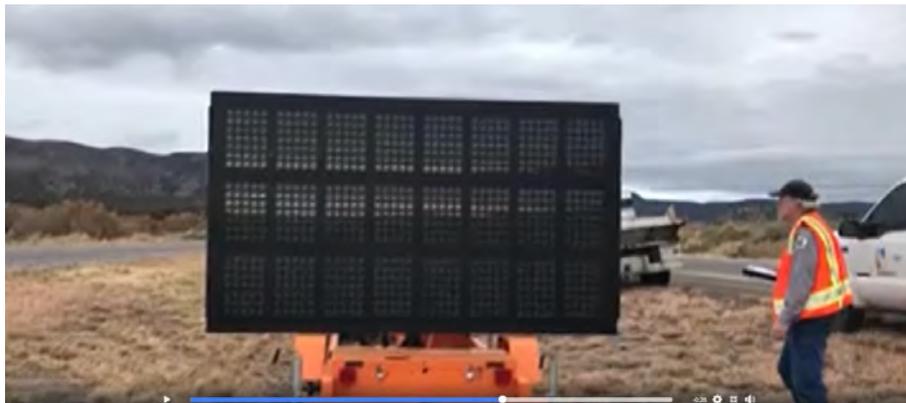
Figure 6-24. M. Watson of NMDGF together with NMDOT maintenance personnel, installed a driver-warning variable message board on US 70 in the wildlife-vehicle hotspot (photo credit: NMDGF).

NMDGF and NMDOT are aware of the high number of elk-vehicle crashes in this WVC hotspot from November through March. NMDGF purchased variable message boards and placed these with NMDOT assistance to warn drivers about elk crossings at MP 237.5 on the west end and MP 241 on the east end (Figure 6-24) during the winters of 2019–2021. The stretch of road between MP 239 and MP 240 is especially dangerous, with 9 of the 13 injury crashes reported in this WVC hotspot occurring between these mileposts. The Mescalero Apache Conservation Officers shared wildlife-vehicle crash data with the Action Plan development team, showing that wildlife-vehicle crashes also occurred east of MP 242.

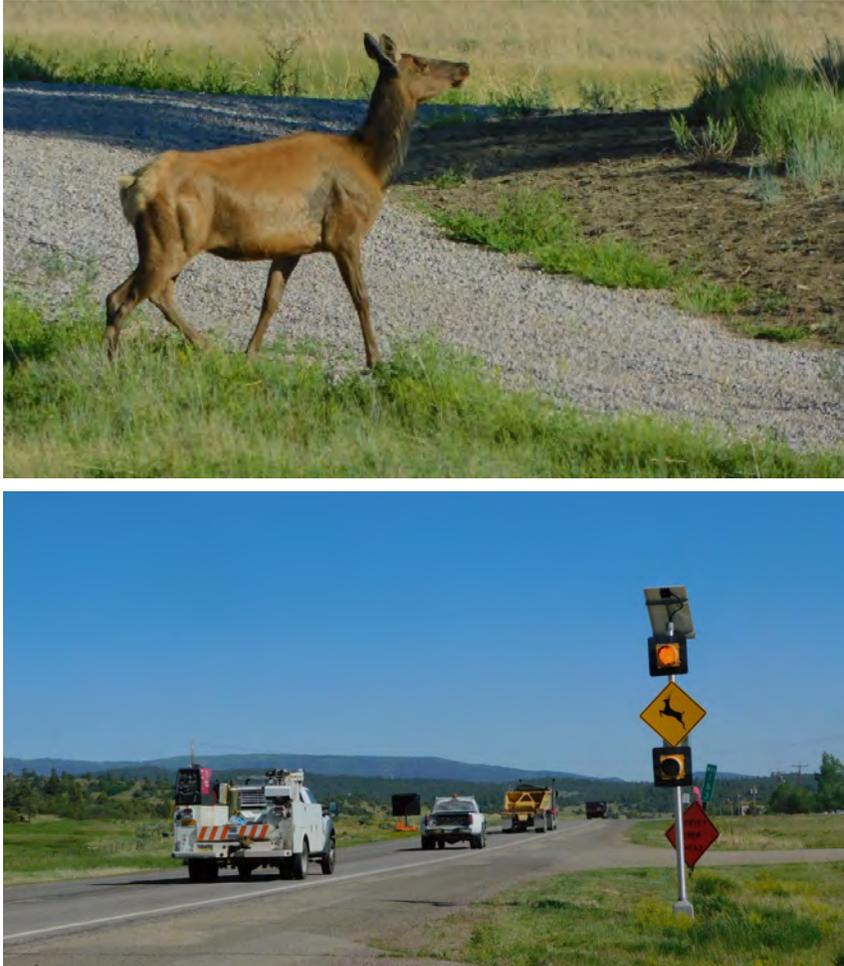
Figure 6-34. Elk cow along US 64 and US 84 west of Chama, June 2020 (top) and US 84/64 looking south of Chama with motorist deer warning sign (bottom).

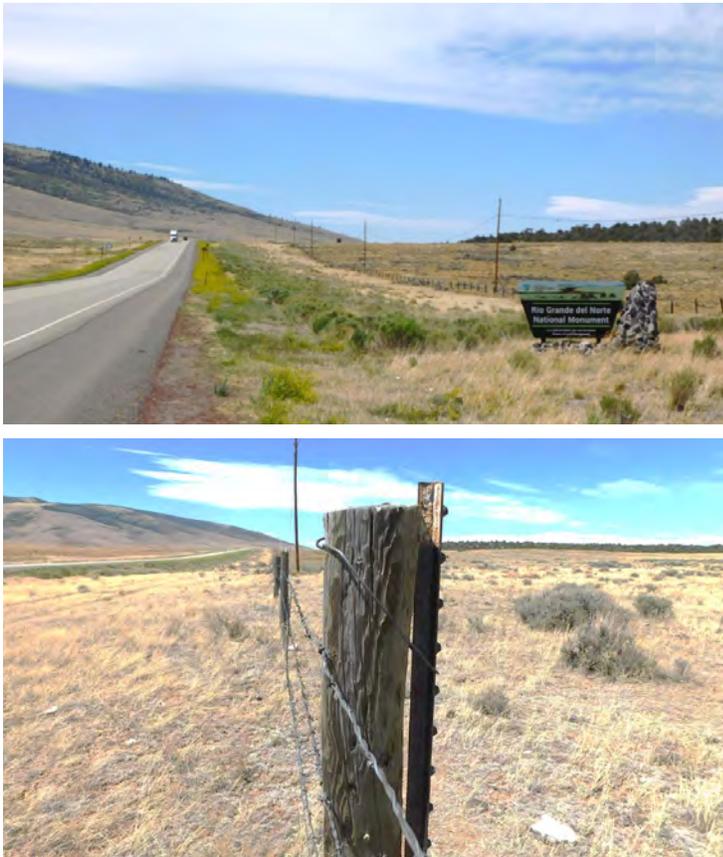
Figure 6-36. Rio Grande Del Norte National Monument and US 285 looking north (top) and Del Norte laydown fence in upright position (bottom) (photo credit: P. Cramer).

Multiple miles of right-of-way laydown fence replaced standard NMDOT right-of-way fence along portions of BLM - Rio Grande del Norte National Monument lands east and west of US 285, near San Antonio Mountain (Figure 6-36). During anticipated migration periods,

laydown fence is dropped by NMDOT maintenance personnel. This allows animals to pass across the road more easily without having to jump over or crawl under the right-of-way fence. In addition to the large swath of Rio Grande Del Norte National Monument, private land, SLO land, and USFS (Carson National Forest) land also abut US 285 within the project area. Some commercial and residential development is present near Tres Piedras at the southern end of the project area, but most of the corridor lies in a rural setting.

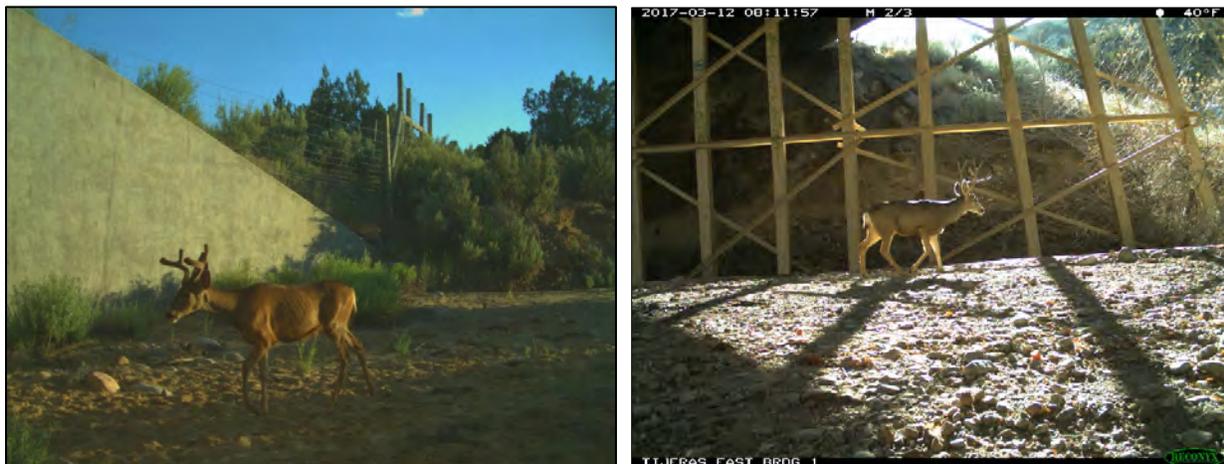
Figure 7-8. Example of adequate monitoring at a small culvert (left) and at a larger road-crossing structure (right) in New Mexico using motion-triggered, remote cameras. The cameras capture both approaches and crossings of deer and other wildlife at the culvert, allowing for the calculation of passage rates, thus contributing to knowledge about the effectiveness of mitigation measures. At the larger structure, most approaches are expected to result in the successful passage of wildlife, at the same time that documenting all approaches is logistically more difficult; the use of cameras is more geared toward documenting the number of passages and the full range of species using the structure (right).

A camera placed at each end of a culvert or on each side of a bridge is typically sufficient to calculate success rates, rates of repellency, and parallel rates. Some structures may be wider than the ability of the cameras to capture animal movement at night, which is typically about 30 feet. If this is the case, additional cameras may be necessary to collect data most accurately.

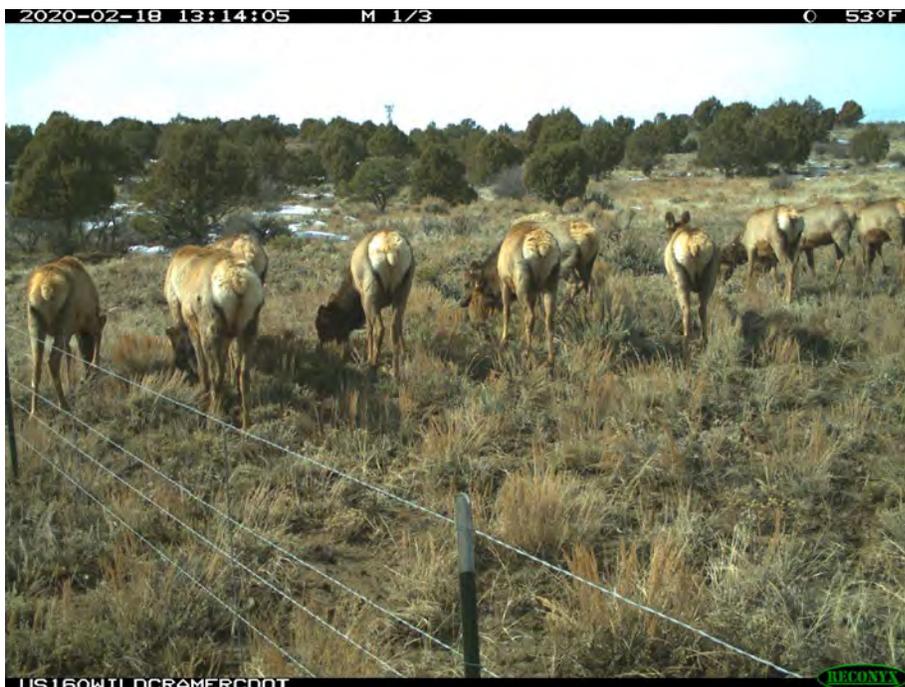
Figure 7-9. Elk outside the fenced right-of-way on US 160 east of Durango, Colorado. Despite 74 elk movements recorded over 2.5 years, none of the animals approached the wildlife crossing structure only 130 feet away (Cramer and Hamlin, 2021). This information greatly helped Colorado DOT better plan for future elk crossing structures.

It is also important to evaluate structure success for all the animals present in the area. For instance, if elk are known to be in the area but they are not using the structure—a common problem—the structure did not function as providing habitat connectivity for elk. One way to assess an area for the species present outside of the structure entrances is to place a camera at the edge of the road right-of-way fence, facing out to the wild area. This camera can then evaluate species of animal and numbers of those animals nearby but not using the structure. This has proven helpful in studies in Utah (Cramer and Hamlin, 2019) and Colorado (Cramer and Hamlin, 2021; Kintsch et al., 2021) (Figure 7-9).

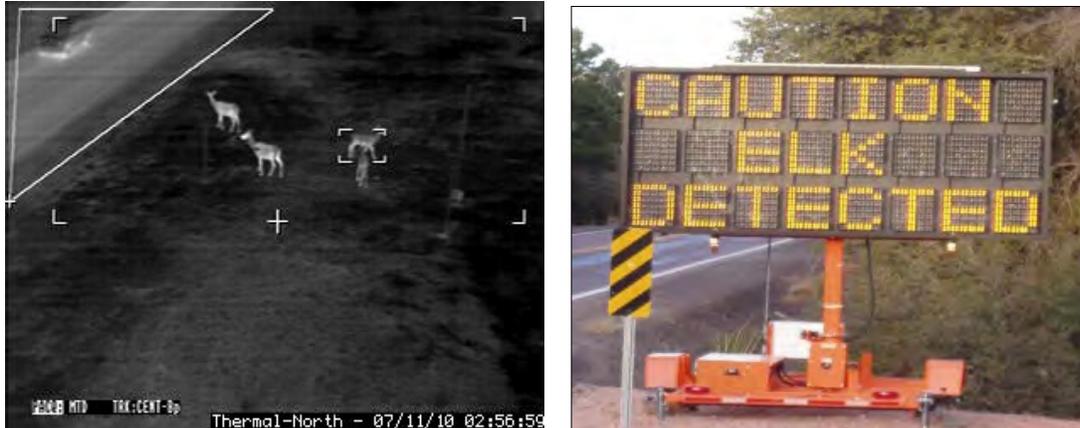
Figure 7-10. Example of thermal target acquisition software used to activate motorist alert signs (left) and sign activated when a target is identified as wildlife large enough to pose a safety concern to motorists.

While most forms of wildlife-vehicle conflict mitigation, such as wildlife crossings and fences, are geared toward altering the behavior of the animals, other methods may provide an opportunity to evaluate motorist behavior. Although changes in WVC rates are one form of motorist response to a mitigation effort, further examination of motorist behavior can help to further determine why a mitigation is effective or ineffective. Mitigation methods such as signage, speed reduction zones, roadside vegetation removal, and animal-activated detection systems (AADSs) are intended to modify driver behavior in a manner that causes motorists to either avoid collisions completely or strike an animal at a slower speed, reducing the potential for injury (Huijser et al., 2008). The “Elk Crosswalk” completed in 2007 along SR 260 in Arizona is an excellent example of measuring motorist behavior in response to the implementation of a WVC mitigation measure. This AADS uses complex software linked to thermal detection to identify animals large enough to potentially pose a safety concern to motorists (set at fox-sized or larger animals). The software also calculates speed, thermal differences, direction of travel, and other identifiers to confirm the target. Once the software identifies the target as a large animal that is moving toward the road, it triggers a series of signs in an attempt to alert the motorist in time to brake or avoid collision (Figure 7-10).

Over nine years of monitoring, motorist speeds were reduced by 13 percent and there was a 5-fold increase in braking response with the signs on versus off, contributing to the 97 percent reduction in elk-vehicle collisions achieved as a result of the mitigation project being implemented (Gagnon et al., 2019). This information could not have been obtained without

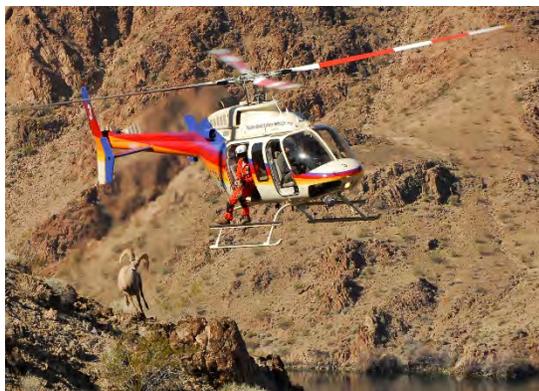
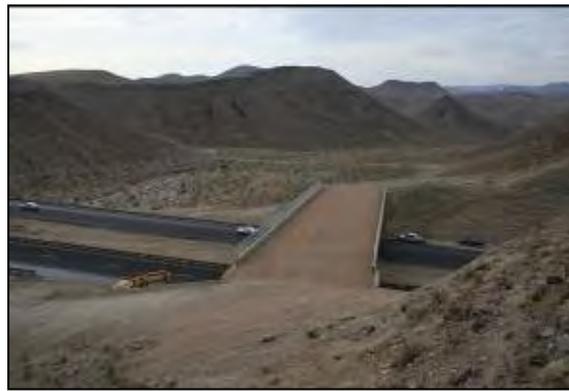
Figure 7-11. Capture of desert bighorn sheep (left) along US 93 to locate suitable wildlife overpasses (right) and provide baseline levels of highway permeability.

In the early 1990s, US 93 in northwestern Arizona was in the planning stages of being upgraded from a 2-lane road to a higher-speed, 4-lane divided highway. To address concern for the safety of both the local desert bighorn sheep (*Ovis canadensis*) and motorists, as well as the potential for additional habitat fragmentation affecting the local sheep herd, the ADOT and federal partners worked closely with the AZGFD throughout the planning and implementation processes, from the early 1990s through completion of the project in 2011 (Cunningham and Hanna, 1992; McKinney and Smith, 2007; Gagnon et al., 2014). Sheep-vehicle collision data were collected over time, and telemetry data from collared sheep were used to locate suitable locations for road-crossing structures and provide baseline levels of highway permeability (Figure 7-11). Using results from a nearby study on the lack of use of wildlife underpasses by desert bighorn sheep, the planning team implemented three wildlife overpasses in the reconstruction of US 93 (Bristow, 2008).

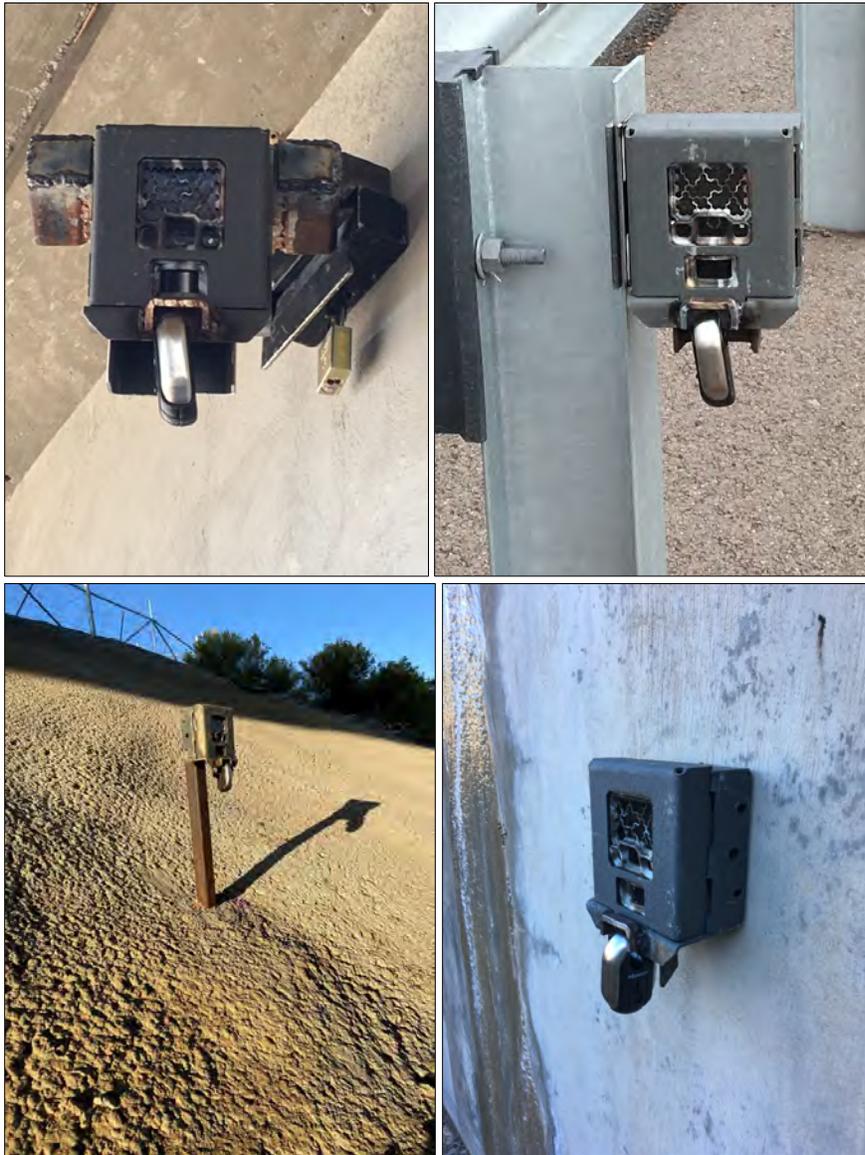
Figure 7-13. Consistent data collection from cameras is important to determine mitigation success, and taking measures to secure cameras is essential. Options like these being used in New Mexico can help reduce theft, and include articulated mounts that deter cutting with power or hand tools (upper left), flush mounts with robust anchors to hinder prying (upper right), cameras welded to poles and set in concrete (lower left), and hiding cameras in discrete locations such as behind a guardrail (lower right).

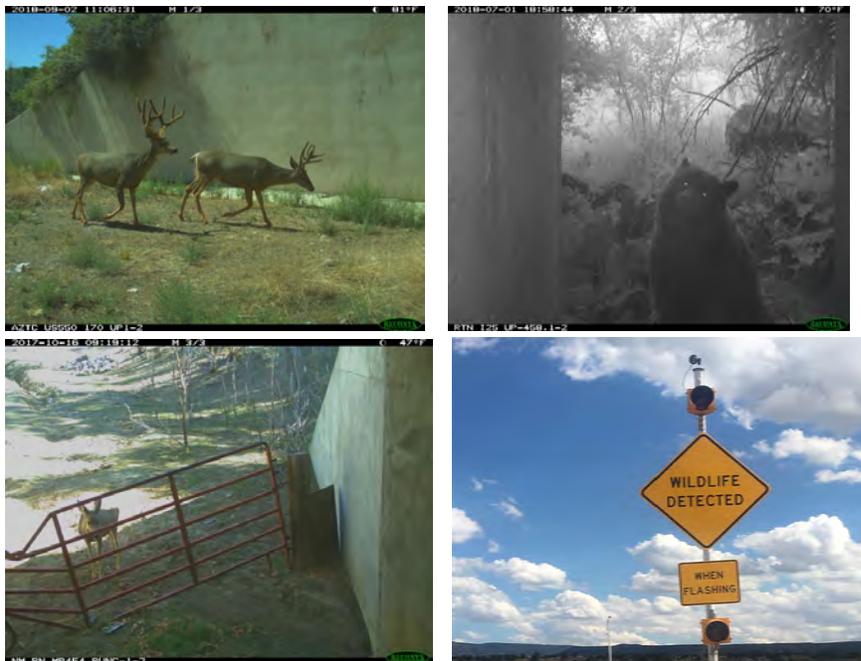
Figure 7-14. Examples of mitigation types and phases being monitored in a collaborative interstate effort by NMDOT Research Bureau and AZGFD, including post-construction deer use of culverts at Aztec (upper left), pre-construction monitoring at Raton Pass (upper right), comparison of use of culverts with and without obstructions at multiple sites (lower left), and an animal detection system at Cuba (lower right).

Since 2004, NMDOT has completed 10 main WVC mitigation projects. In 2016, the NMDOT Research Bureau funded AZGFD in a collaborative interstate effort to evaluate 4 of these sites to determine project effectiveness. Researchers determined that the projects have markedly reduced WVCs, and that crossing structures are being effectively used by wildlife. During the three-year Phase I study, researchers captured more than 1.25 million images that showed 18,034 animals belonging to 21 different species at the structures. A total of 14,242 successful animal movements through road-crossing structures were thus documented: 12,408 by mule deer, 220 by elk, 169 by black bears, and 45 by cougars (*Puma concolor*) (Loberger et al., 2020). Phase II monitoring was funded in 2020 and will continue through 2026. Phase II will include additional sites, areas where pre-mitigation data were collected during Phase I, and an AADS evaluation (Figure 7-14).

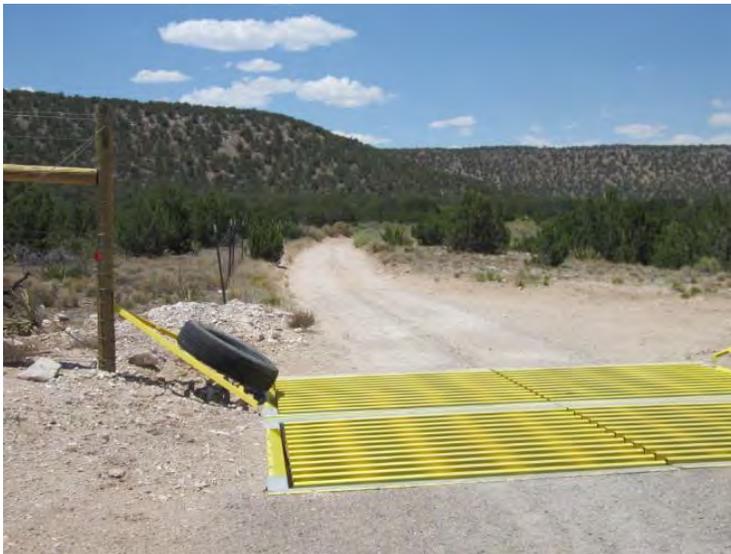
Figure A-2. US 54 double cattle guard with wing and tire to prevent wildlife from walking across the guard (photo credit: Mark Watson).

In 2013, 3 miles of game fence were constructed along US 54 just north of Corona in central New Mexico in association with a highway reconstruction project. The area was a known deer-vehicle collision hotspot. One issue during project construction was the installation of double cattle guards without removing the wing braces. This created a gap that deer can easily jump over or crawl under to access the roadway. NMDOT Environmental Bureau and NMDGF personnel visited with the local patrol yard regarding this issue. The patrol yard modified the cattle guard wings and added short run a game fence (Figure A-2).

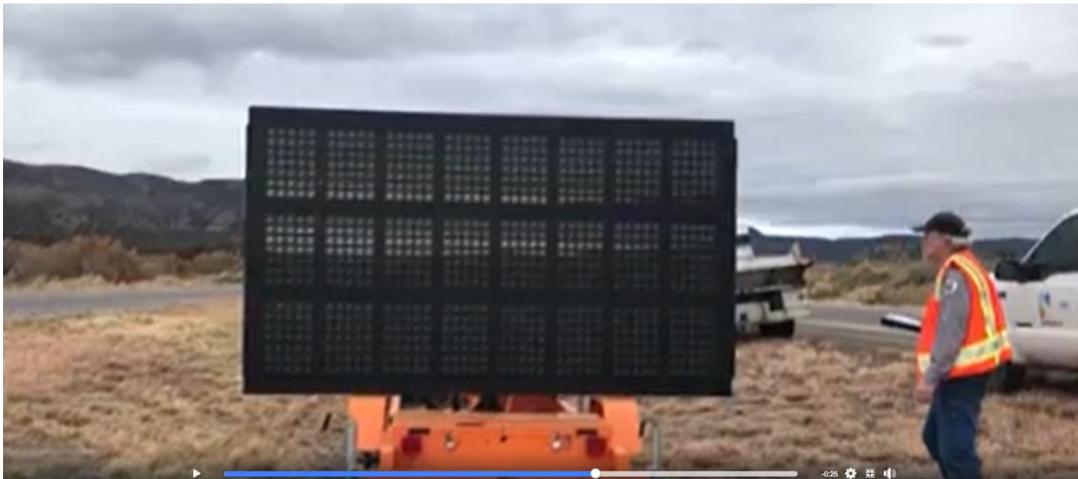
Figure A-3. Installation of driver warning variable message board along US 70.

NMDGF purchased and placed two portable variable message boards along US 70 in the winters of 2019/2020 and 2020/2021 to warn drivers of elk in a narrow 3-mile corridor between Tularosa and Ruidoso at Bent. As mentioned in a video (social media – Facebook page for NMDGF, published movie on the project: <https://www.facebook.com/nmdgf/videos/554675078649398/>), a local landowner notified NMDGF about the high elk collision risk in the area. NMDGF deployed the message boards with NMDOT Tularosa patrol yard staff assistance (Figure A-3).

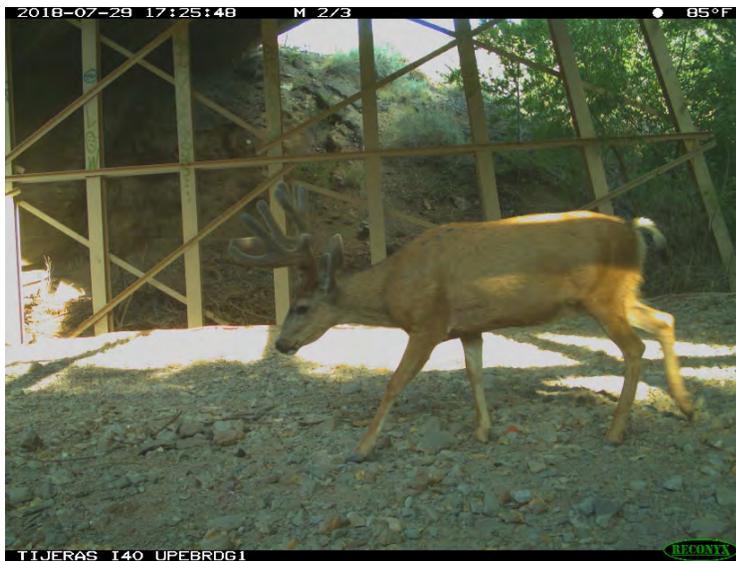
Figure A-5. A mule deer buck moves beneath I-40 at the East Bridge, Tijeras Canyon Mitigation Site (photo credit: AZGFD, NMDOT).

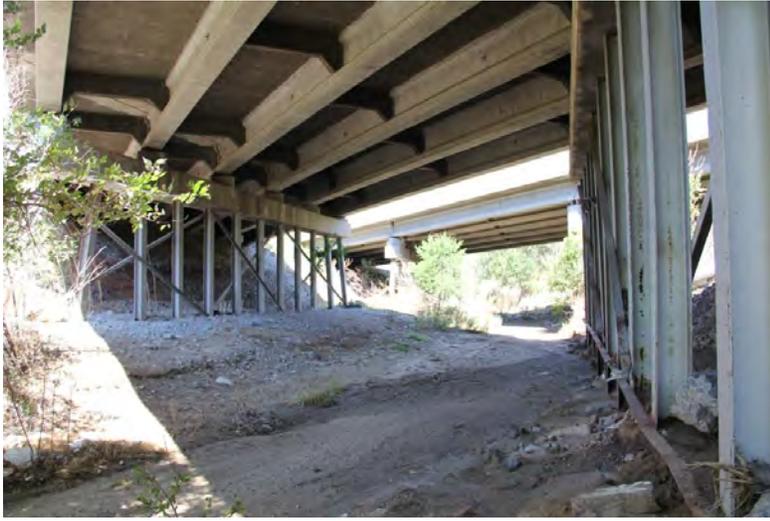
Figure A-6. I-40 Middle Bridge over Tijeras Arroyo where wildlife moves beneath the highway (photo credit: M. Watson).

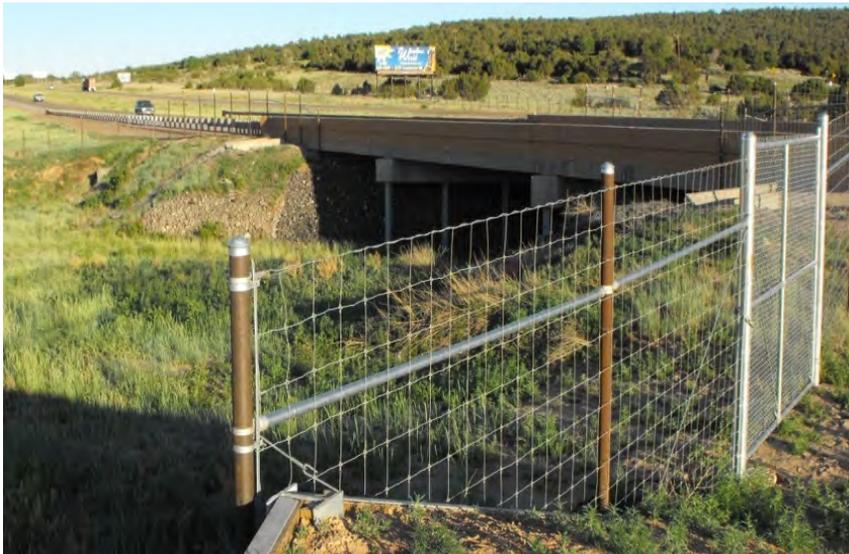
Figure A-7. Bridge under I-40 used by wildlife near Edgewood (photo credit: M. Watson).

Phases 2 and 3 included additional fence projects along I-40 to force deer and other wildlife under existing underpasses and concrete box culverts. The fence was extended 3 miles east from Tijeras to Zuzax in Phase 2. In Phase 3, the fence was extended 4 miles from Edgewood west to NM 217 (Figure A-7). These two areas were identified as having high deer-vehicle collision rates in the I-40 feasibility study.

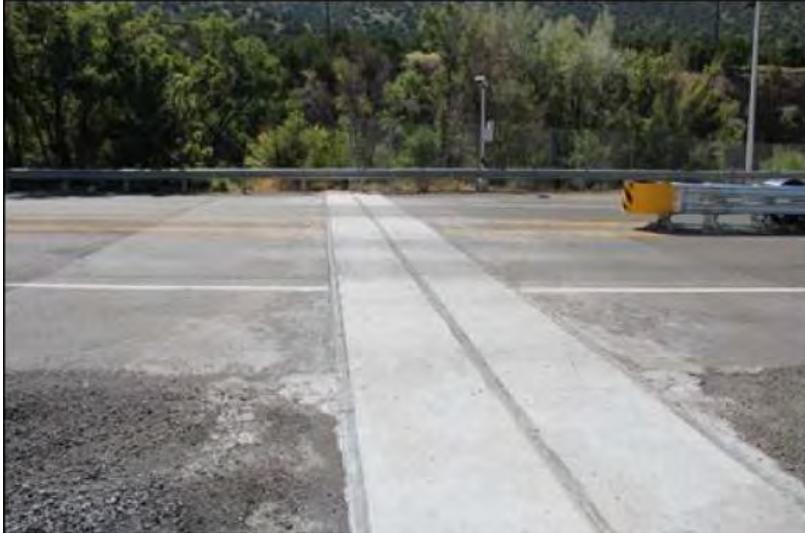
Figure A-8. Tijeras Canyon Safe Passage Project electrified concrete barriers at NM 333 wildlife crosswalk (photo credit: AZGFD).

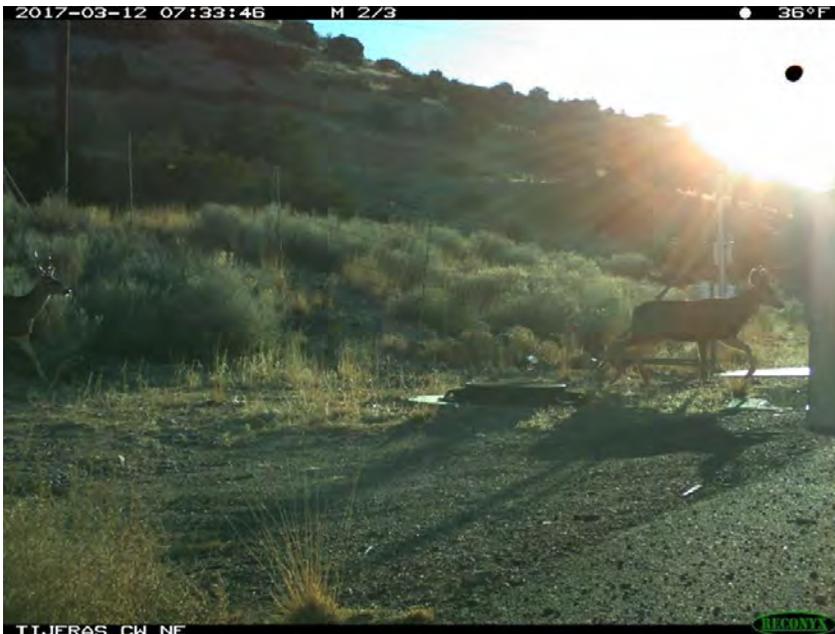
Figure A-9. Two mule deer bucks entering and exiting the NM 333 crosswalk (photo credit: AZGFD and NMDOT).

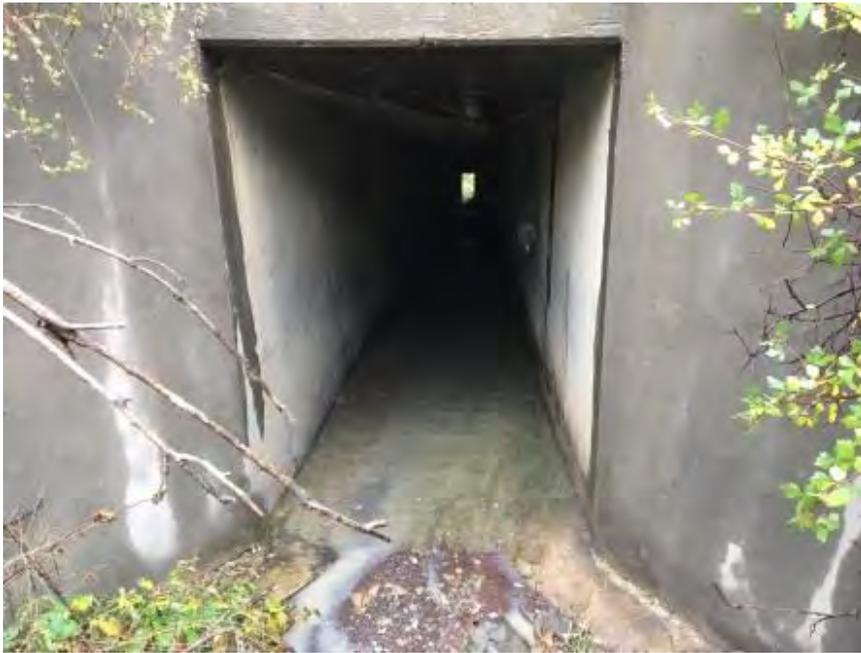
Figure A-11. I-25 Raton Pass MP 458.1 box culvert (photo credit: AZGFD).

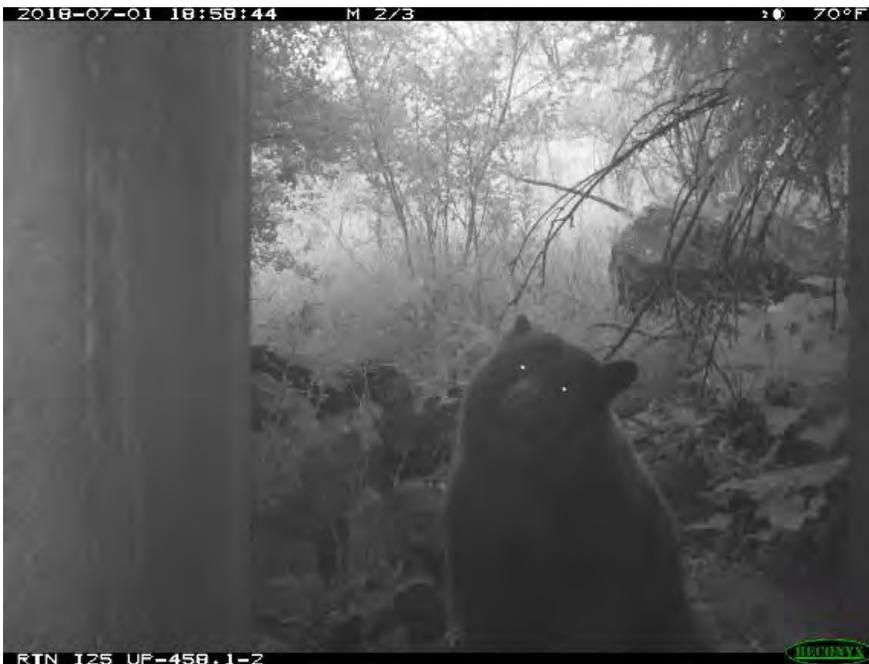
Figure A-12. Black Bear ponders before eventually using an existing box culvert under I-25 at Raton Pass MP 458.1 (photo credit: AZGFD, NMDOT).

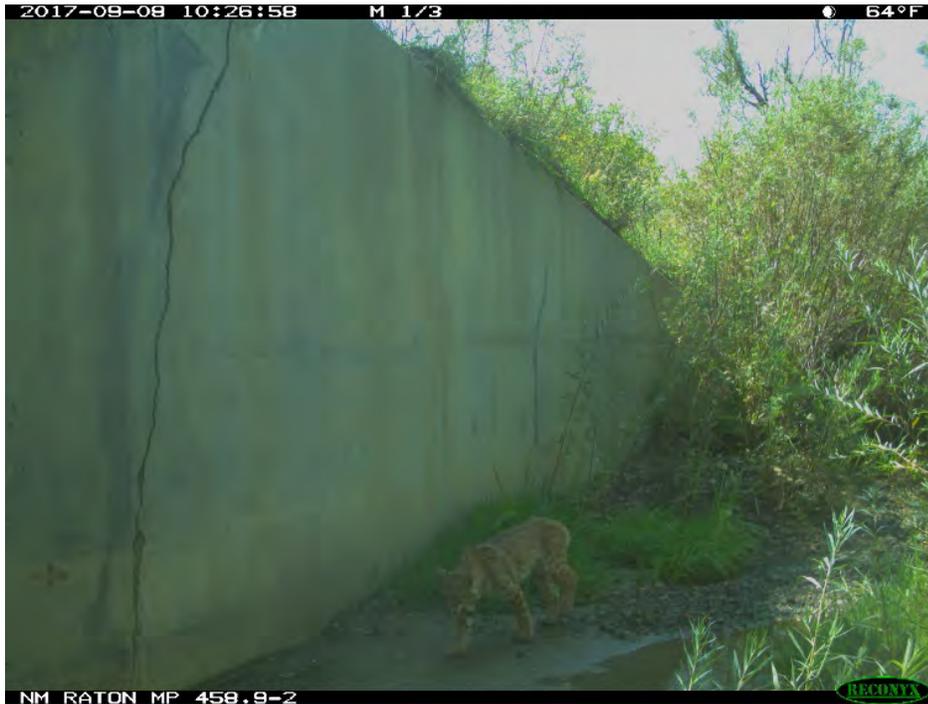
**Figure A-13. A bobcat using an existing box culvert at MP 458.9
(photo credit: AZGFD, NMDOT).**

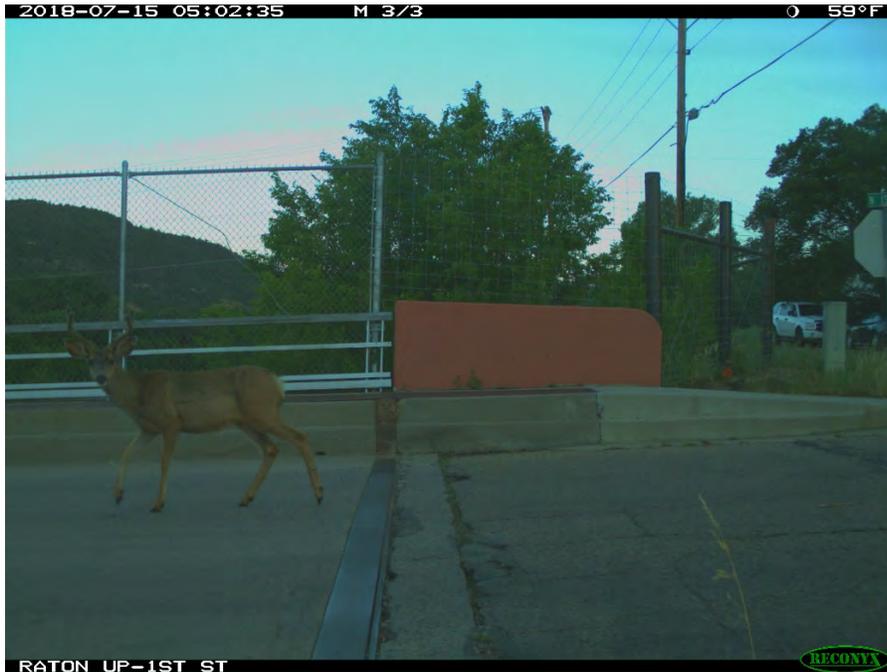
Figure A-15. Mule deer crossing First Street vehicle bridge spanning I-25 at Raton (photo credit: AZGFD, NMDOT).

I-25 from MP 450 to MP 455 located in Raton was identified as having the highest number of wildlife-vehicle collisions on this interstate in New Mexico. The I-25 Raton Wildlife Mitigation project placed wildlife exclusion fence (8 feet), electrified concrete mats, and double cattle guards to exclude mule deer, elk, cougars, and black bears from the highway and guide them to four existing road-crossing structures. The project was completed in 2017, and AZGFD is monitoring wildlife use of existing structures including a roadway bridge (overpass) that spans the interstate. NMDOT and AZGFD documented mule deer use of the roadway bridge that spans I-25 (Figure A-15). Past studies in Arizona have not documented large ungulate use of similar structures. Large ungulate use of the roadway bridge is likely because the study area is within an urban environment where deer, bear, and other wildlife are habituated to humans and transportation infrastructure.

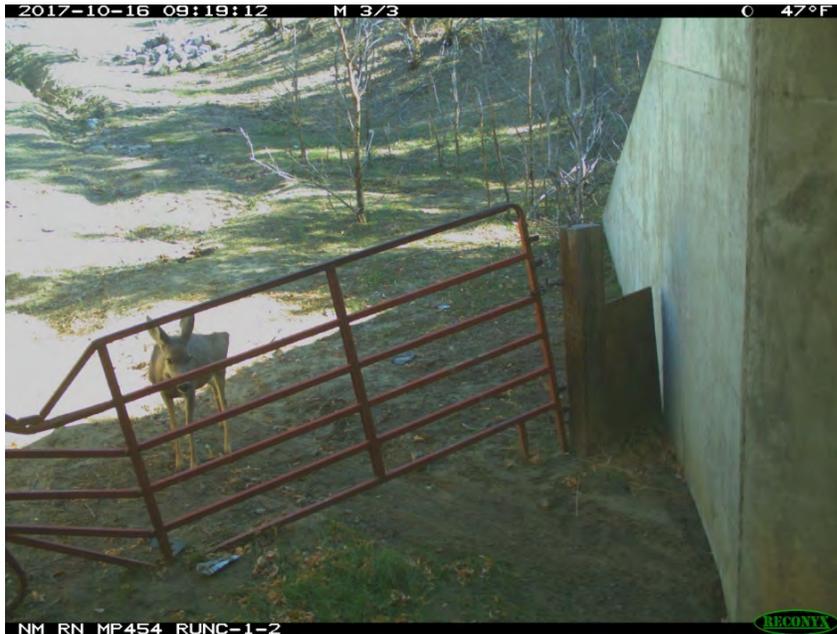
Figure A-16. Gate placed by landowner on box culvert to keep livestock from using culvert (photo credit: AZGFD, NMDOT).
