Draft Wildlife Corridors Action Plan

December 31, 2021

New Mexico Department
of Transportation and
New Mexico Department
of Game & Fish

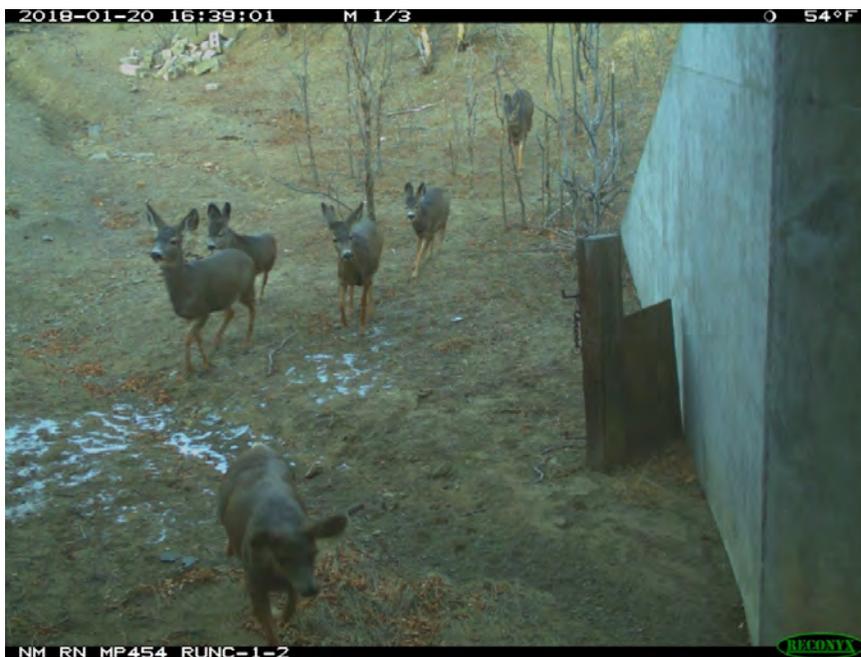
Figure A-17. Mule deer using the culvert after removal of the gate (photo credit: AZGFD, NMDOT).

NMDOT and AZGFD found that the MP 454 box culvert had a gate placed at the entrance by a landowner to keep horses from moving through, which heavily impacted mule deer passage rates. NMDOT maintenance personnel worked with the landowner to remove the gate and build a wildlife-friendly right-of-way fence 40 feet from the opening; this greatly enhanced deer passage rates in a matter of days (Figures A-16 and A-17).

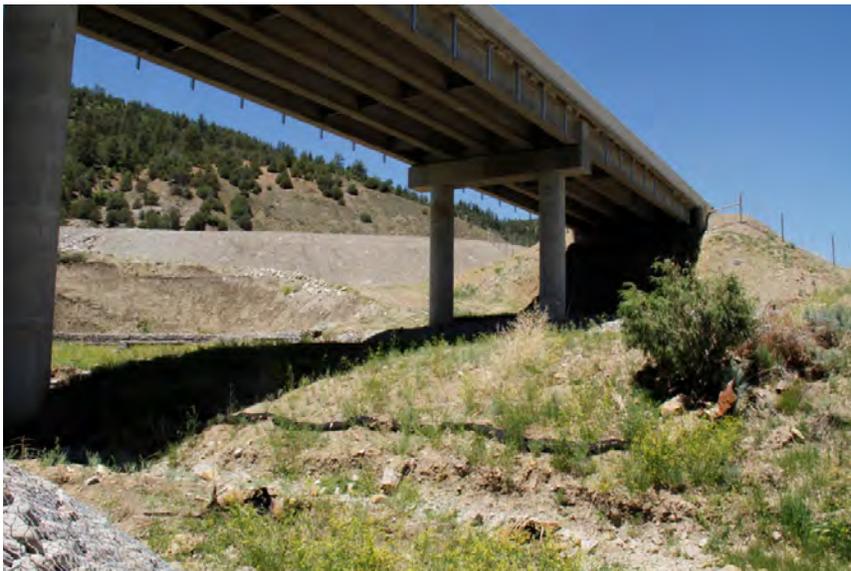
Figure A-19. US 64 near Lumberton Bridge over Amargo Creek at MP 144.8.

In 2012, the US 64 project near Lumberton in the northwest corner of the state was completed. The project constructed about 3 miles of wildlife exclusion fence to force elk and mule deer to use a new enlarged bridge constructed over Amargo Creek at the south end of the project area (Figure A-19). The large bridge over Amargo Creek was constructed to address vertical and horizontal geometry issues, while at the same time facilitating deer and elk passage. On the west end of the project area, the fence ties into a reconstructed small openness factor bridge that has some deer and elk movement underneath. However, at the western fence end, the roadway emerges from a canyon and enters sagebrush flats with greater sight distance for motorists. No detection system was installed.

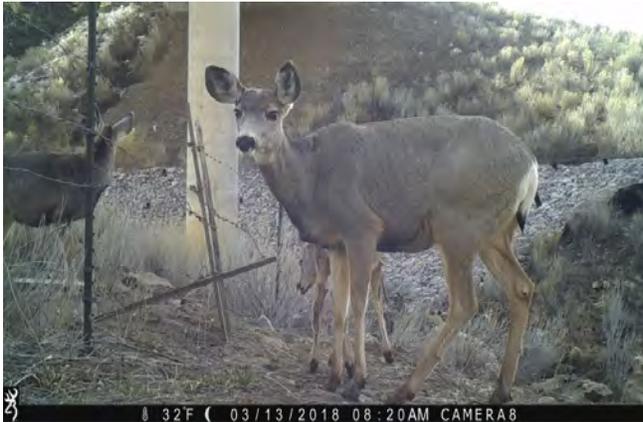
Figure A-20. Mule deer hesitate at a rancher-placed barbed wire fence at NMDOT Bridge (photo credit: NMDGF).

Trail cameras have documented deer, elk, and other wildlife safely passing under these bridges (Figures A-20 and A-21), but a local rancher has installed a poorly constructed barbed-wire fence under these bridges that hinders some wildlife movement. Generally, adult deer and elk can jump the fence and fawns and calves can crawl through or underneath it.

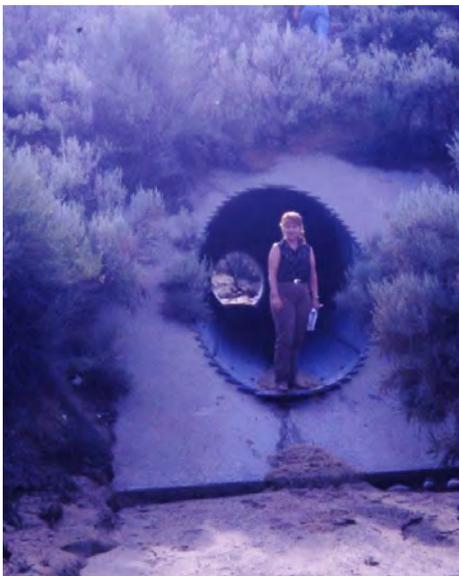
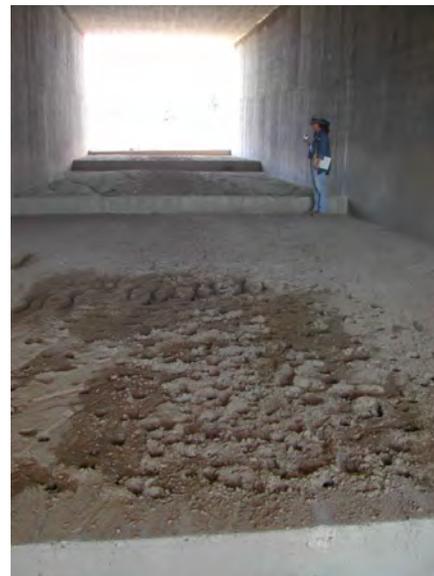
Figure A-22. US 550 original corrugated metal culvert (left) replaced with a wildlife crossing concrete box culvert (right) in Aztec Project (photo credit: M. Watson).

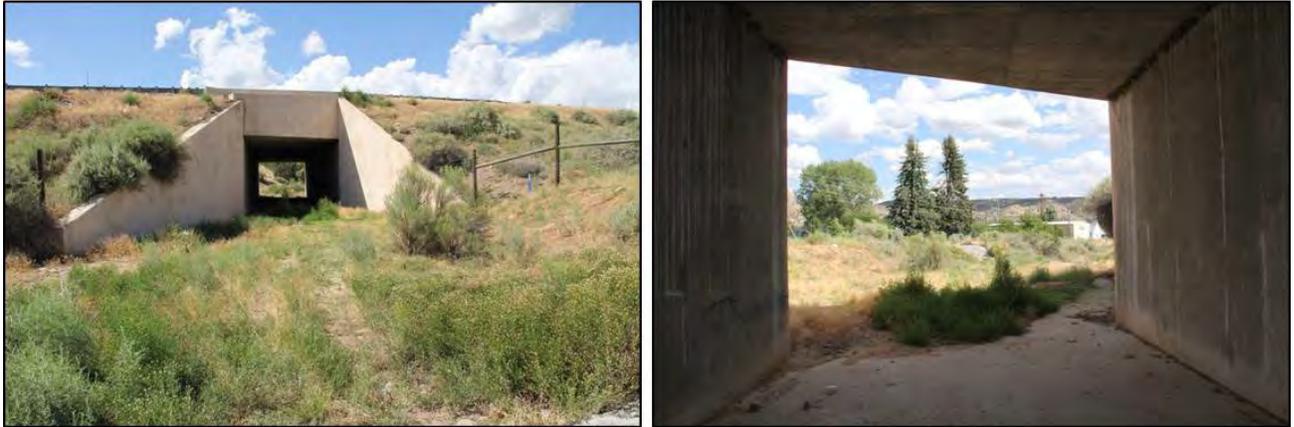
Figure A-23. US 550 wildlife crossing concrete box culverts (photo credit: AZGFD).

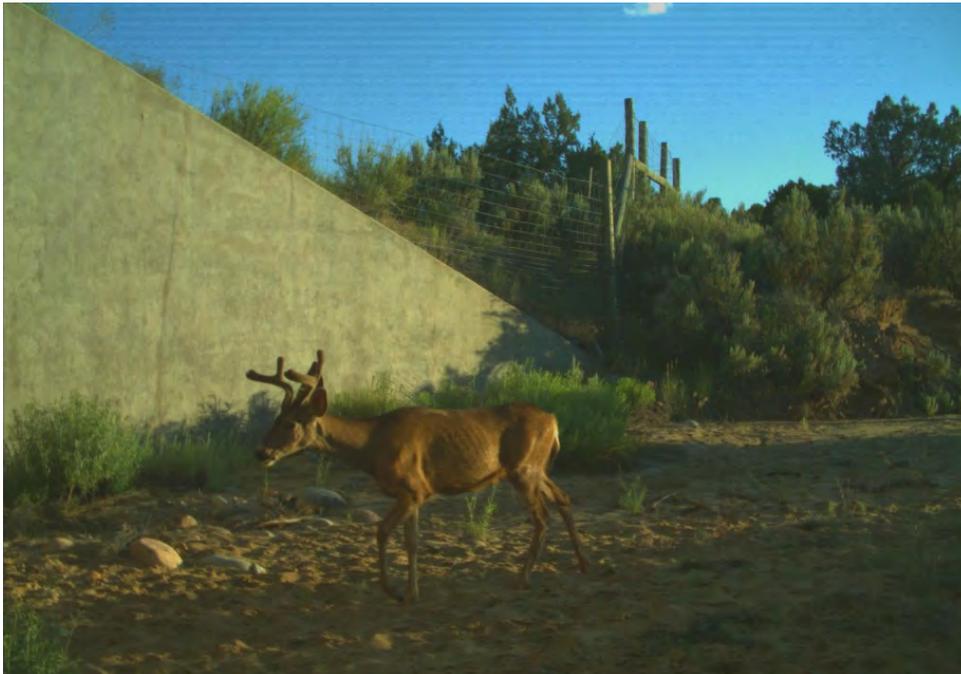
Figure A-24. Mule deer buck using concrete box culvert to move beneath US 550 (photo credit: AZGFD, NMDOT).

Openness factor averages 2.86 for the three structures. AZGFD was monitoring these culverts as of 2020 and found that mule deer routinely use all three culverts, with 6,133 mule deer successful movements through the three structures over the monitoring study up to the first quarter of 2020. Both the number of successful movements and the 83 to 91 percent success rate, or passage rate, make these the most successful wildlife crossing structures in New Mexico, far exceeding the numbers and success rates at the structures studied in Tijeras, Raton, and Cuba.

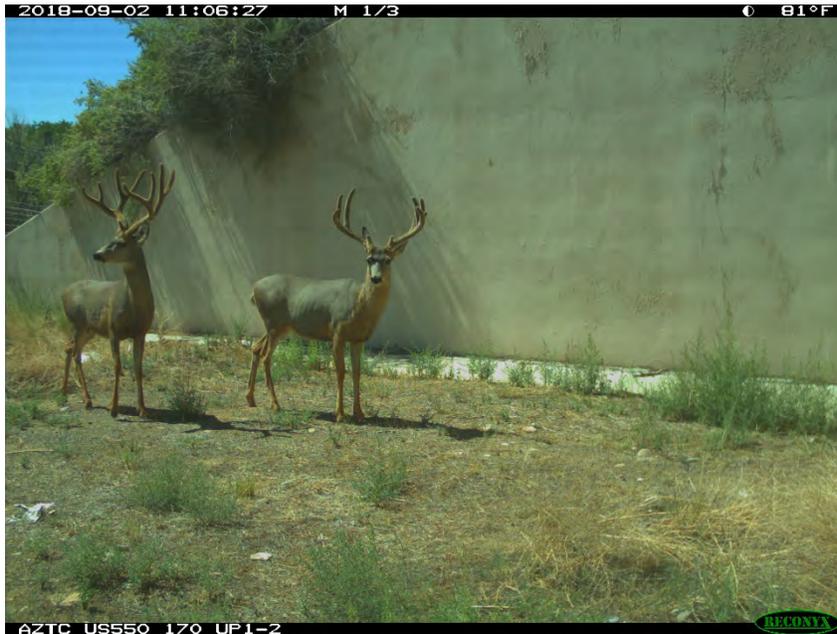
Figure A-25. Mule deer bucks using the wildlife crossing box culvert to move beneath US 550 (photo credit: AZGFD, NMDOT).

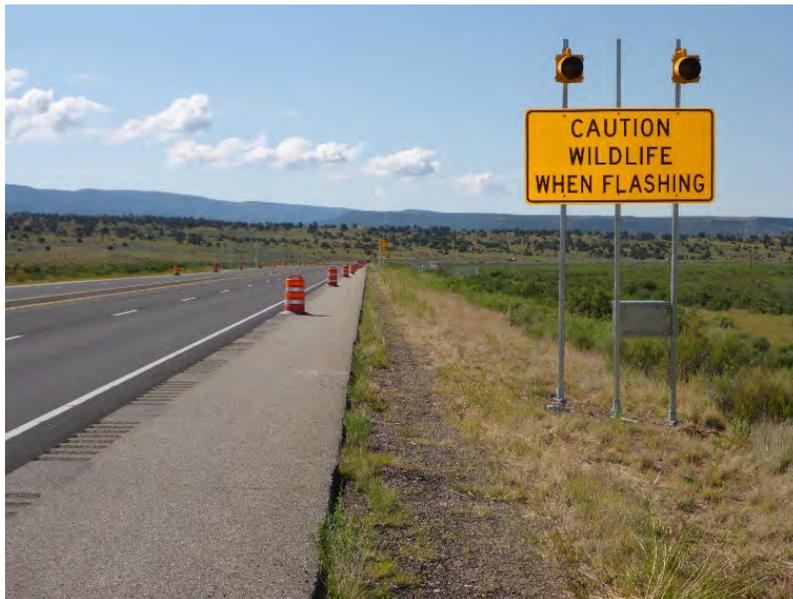
Figure A-26. Wildlife-activated driver warning system on US 550 (photo credit: NMDGF, NMDOT).

Wildlife-vehicle collisions were fairly high in this 6-mile stretch from MP 50 to MP 56. From 2002 to 2013, there were 22 reported crashes involving wildlife. A motorist was killed in one of these crashes. The project was designed to use 4 miles of 8-foot-high, woven wire fence to direct deer, elk, and other wildlife to cross safely under two existing bridges. The project also included electrified concrete mats and double cattle guards. NMDOT has also placed a thermal-based camera system with a motorist warning system that is activated by any wildlife as it approaches the road at the fence ends. The project was completed in 2019. AZGFD began monitoring the bridges at MP 52.7 and MP 53.6 in 2017 for both pre- and post-fence wildlife use of the structures, and will continue to monitor beyond 2020. Photographs from this project are provided as Figures A-26 and A-27. An example of thermal detection imagery is shown in Figure A-28. Photographs obtained as part of the monitoring effort are provided as Figures A-29 and A-30.

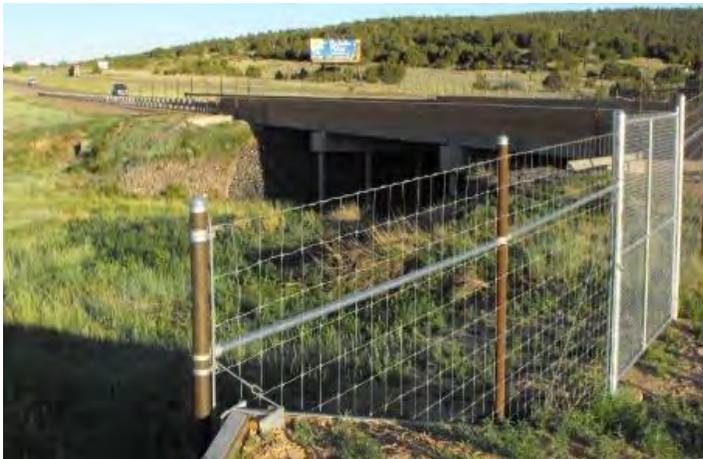
Figure D-1. Bridge under I-40 that wildlife use near Edgewood, New Mexico. Mule deer and other wildlife are directed to the area under the bridge for movement beneath I-40 (photo credit: M. Watson and J. Hirsch).

New Mexico has implemented multiple projects involving the retrofitting of existing bridges, culverts, and fences, deterring wildlife movements over roads and instead directing animals to use structures below the road (e.g., Figure D-1).

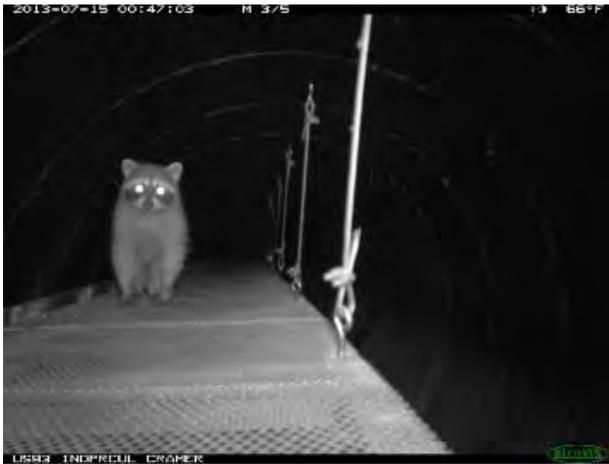
Figure D-3. Small mammal shelf placed in a Montana culvert facilitated movement of raccoons and other wildlife (photo credit: P. Cramer and Montana DOT).

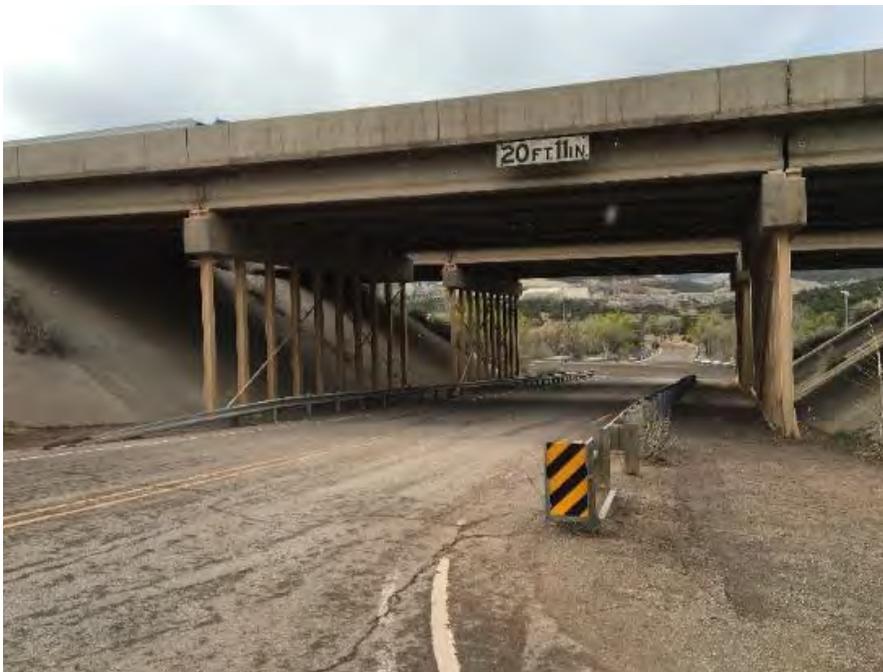
Figure D-4. Tijeras Canyon retrofit of public school interchange under I-40; no known wildlife use (photo credit: J. Gagnon, AZGFD).

If culverts and areas under bridges are more like nearby natural conditions, wildlife will have more of a tendency to use them. The most common methods to make culverts and areas under bridges more suitable for wildlife use are as follow (e.g., Figures D-3 through D-6):

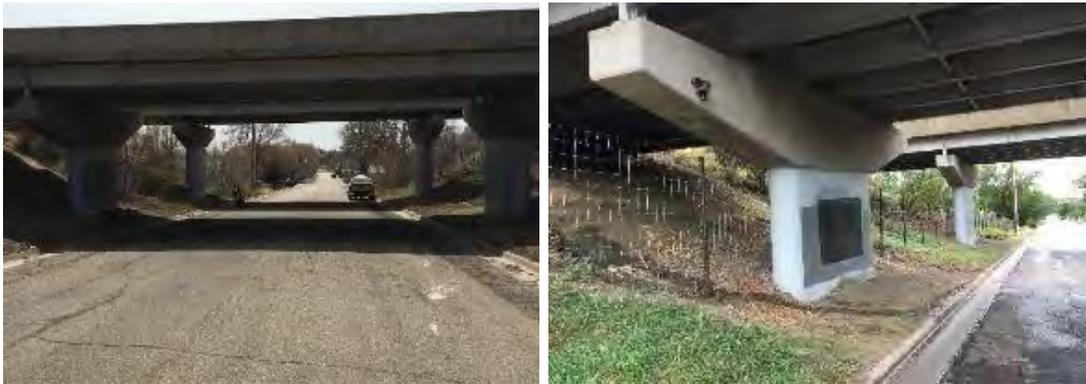
Figure D-5. New Mexico I-25 Raton Interchange where retrofit fence was added and existing pathways were available and used by wildlife (photo credit: J. Gagnon, AZGFD).

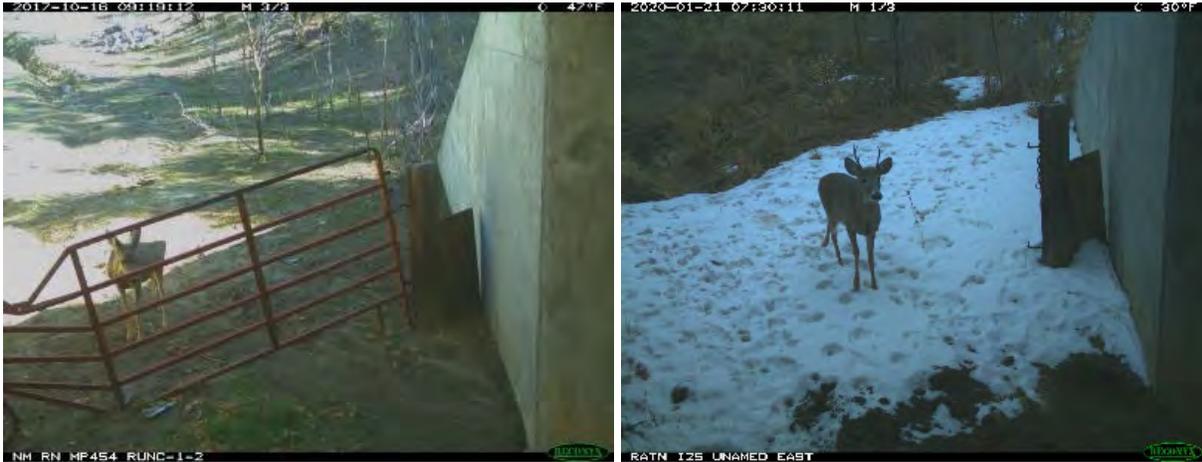
Figure D-7. Gate located at concrete box culvert contained livestock within a pasture (left), but it also prevented mule deer passage (0 deer successful crossings). When the gate was removed and a right-of-way fence installed 40 feet from the culvert entrance, it greatly facilitated deer movement through the culvert (887 deer successful crossings, right) (photo credit: AZGFD and NMDOT).

It is important to remove or modify fences and gates that are located at the entrances of culverts and bridges. Fences and gates near the entrances of these structures can impede wildlife movement (e.g., Figures D-7 through D-9).

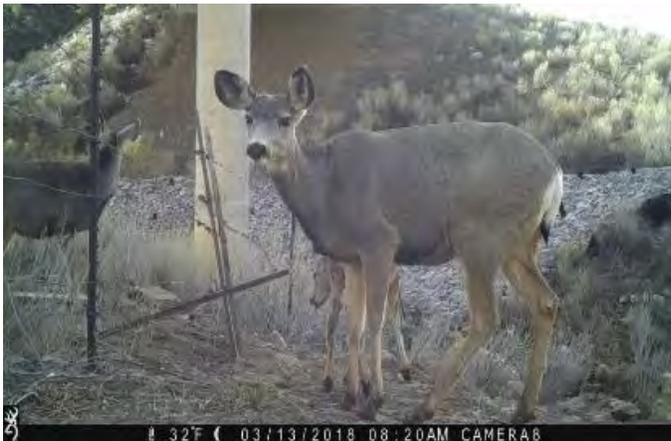
Figure D-8. Mule deer hesitate at a rancher-placed barbed wire fence at NMDOT bridge. NMDOT maintenance pulled this fence away from pathway to allow wildlife movement (photo credit: NMDGF).

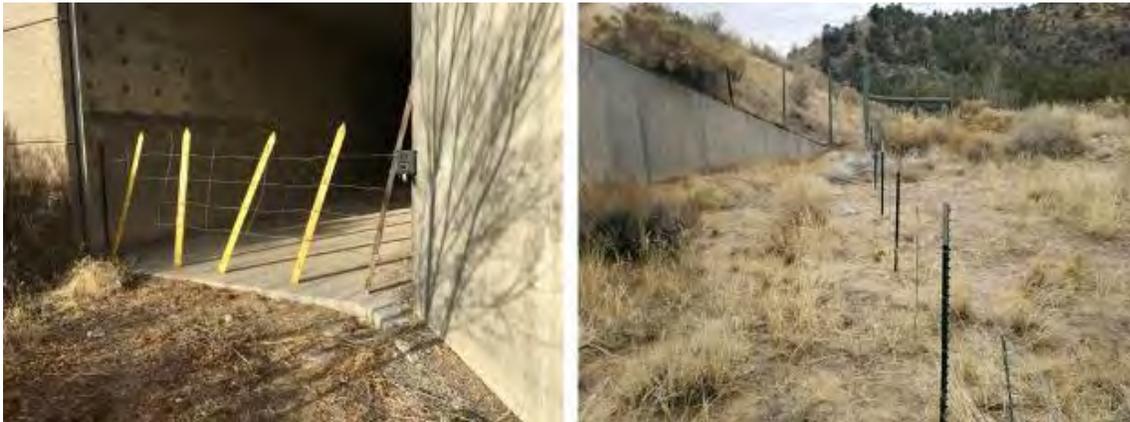
Figure D-9. Fence placed at entrance of concrete box culvert under US 550 near Aztec, New Mexico (left) (only four mule deer successfully crossed), and NMDOT adapted fence placed away from concrete box culvert entrance to enhance mule deer movement while containing cattle (right) (741 successful mule deer crossings) (photo credits: J. Gagnon, AZGFD).

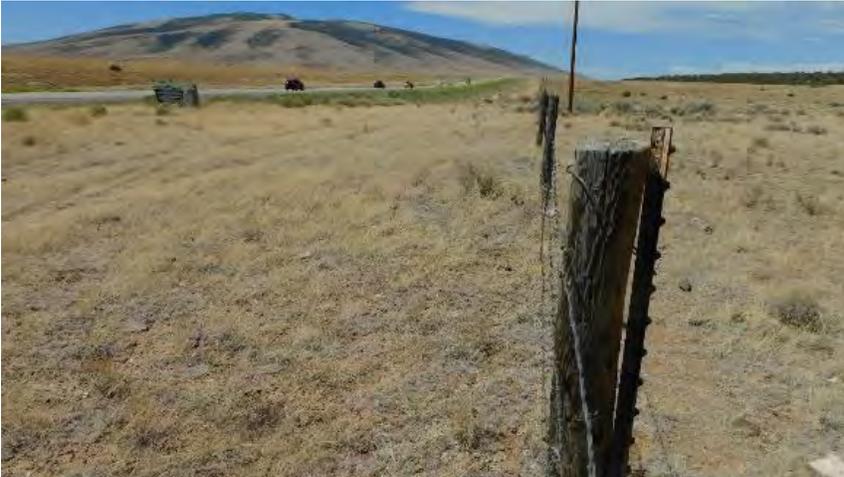
Figure D-10. Lay-down fence in erect setting on the Rio Grande Del Norte National Monument, Tres Piedras, New Mexico (photo credit: P. Cramer).

Fences are laid down in New Mexico on USFS lands along SR 17 north of Chama, and BLM lands on the Rio Grande Del Norte National Monument along US 285 (Figure D-10). The fences are then placed back to upright positions during periods when cattle are in the area.

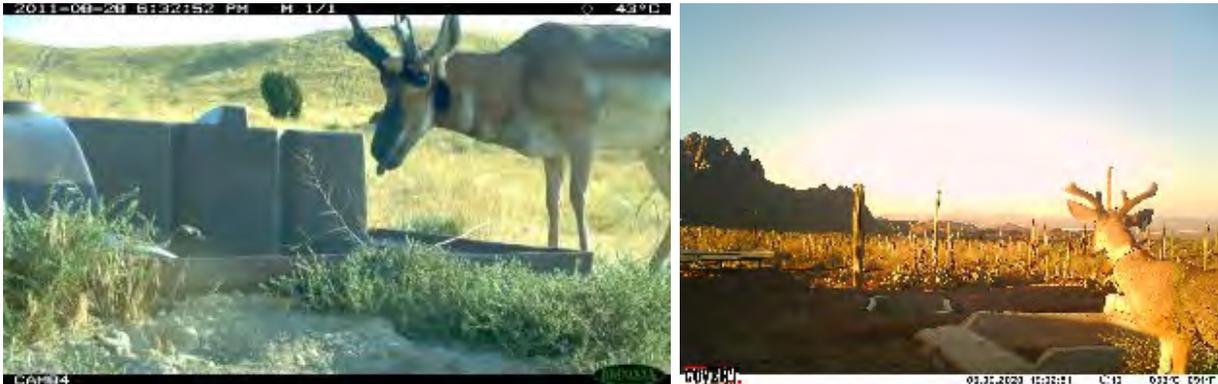
Figure D-11. Pronghorn at a Water Guzzler in Utah (left) (photo credit: R. Larson, Brigham Young University) and mule deer at water guzzler in Arizona (right) (photo credit: AZGFD).

- Remove roadkill carcasses promptly to avoid attracting eagles and other scavengers (Grubb and Lopez, 2018).
- Place water resources such as water guzzlers or water catchments away from the road to attract thirsty animals there and to keep them on one side of the road.

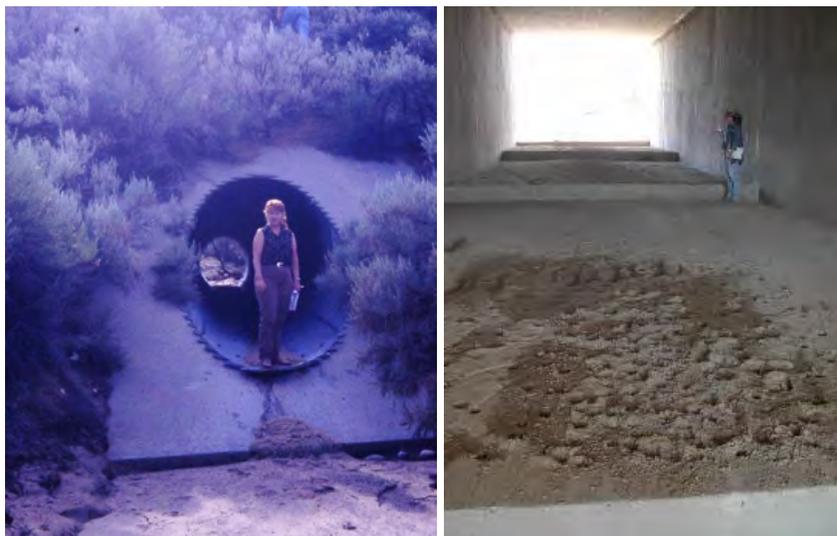
Figure D-12. US 550 original corrugated metal culvert (left), replaced with a wildlife crossing concrete box culvert (right) in the Aztec Project (photo credit: NMDGF).

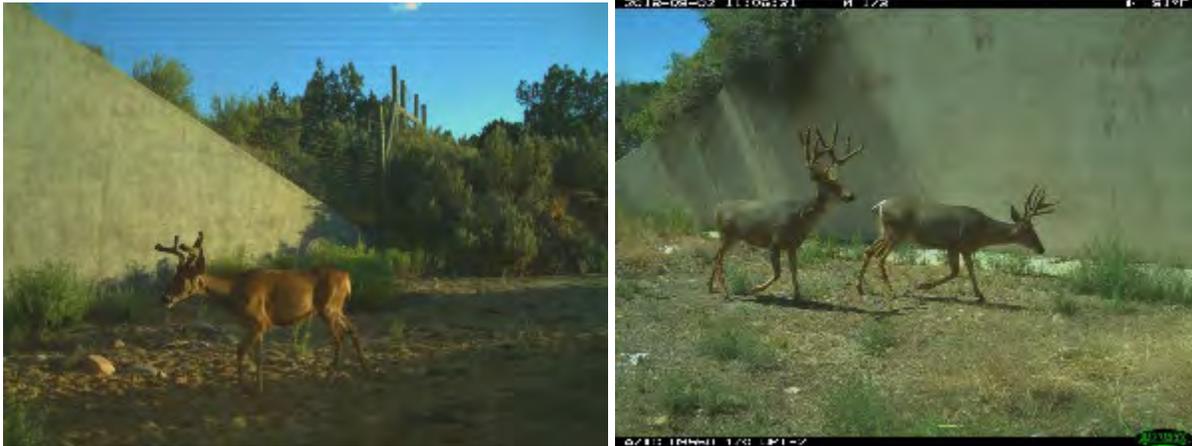
Figure D-13. Mule deer successfully moved through the US 550 wildlife crossing culverts (photo credit: AZGFD and NMDOT).

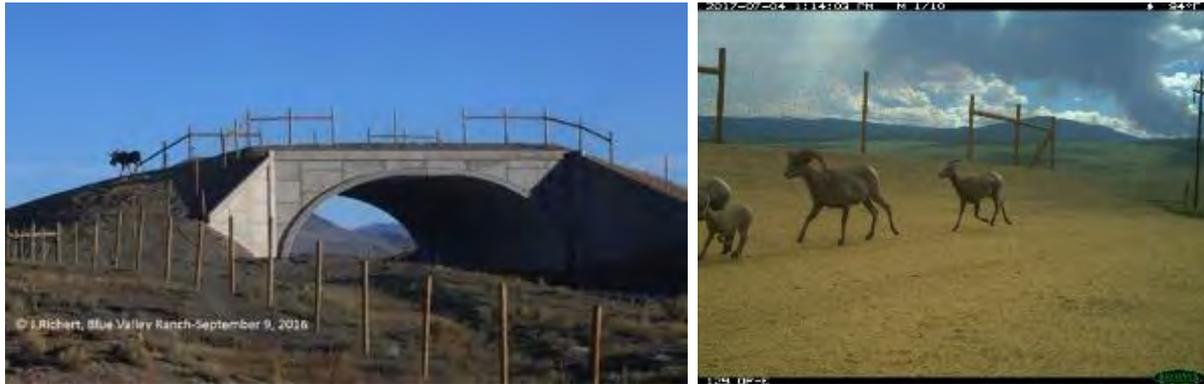
Figure D-14. Moose used the Colorado SH 9 overpass the first fall after completion (left). The overpass was created with pre-fabricated arches (photo credit: J. Richert, Blue Valley Ranch). Bighorn sheep use a Colorado SR 9 overpass (right) (photo credit: Eco-Resolutions, CDOT, and CPW).

Overpasses are typically the most expensive option of all wildlife crossing structures, but can be the best option for certain landscapes, types of roads, and specific ungulate species (Figures D-14 through D-19). In particular, bighorn sheep species and pronghorn have proven that overpasses are the most viable option for facilitating movement of entire herds of mixed genders and ages (Gagnon et al., 2017; Kintsch et al., 2021).

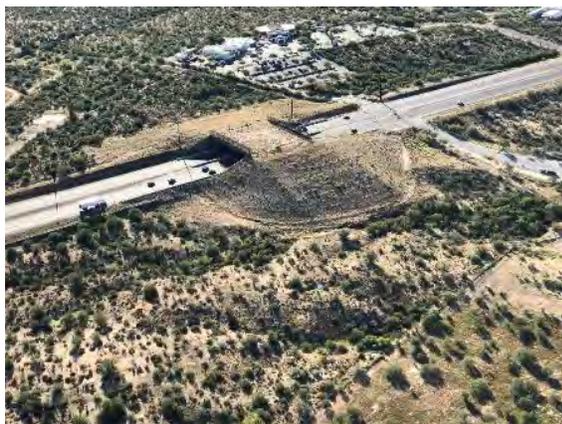
Figure D-16. Arizona SR 77 wildlife overpass, 150 feet wide (photo credit: AZGFD).

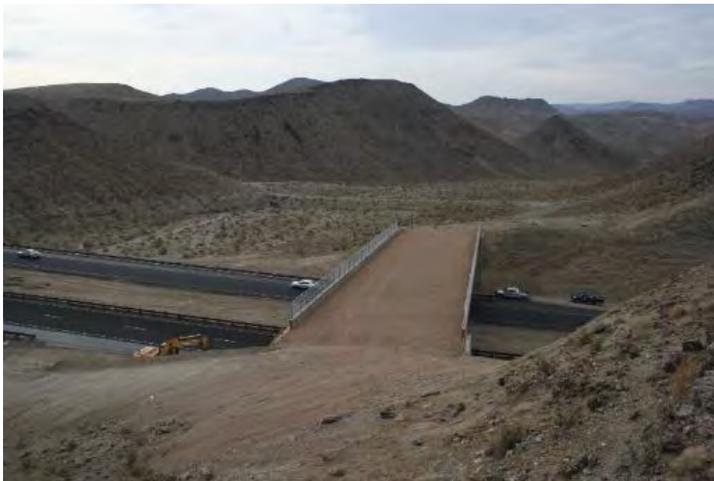
Figure D-18. Arizona US 93 desert bighorn overpass (photo credit: AZGFD).

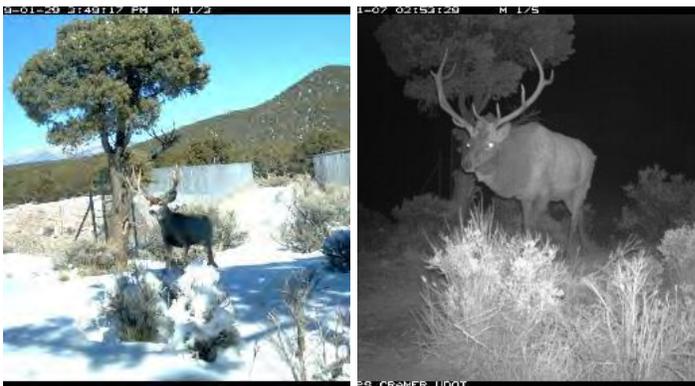
Figure D-19. Mule deer and elk use the first overpass built in North America over I-15 in Utah (photo credit: P. Cramer, UDOT and UDWR).

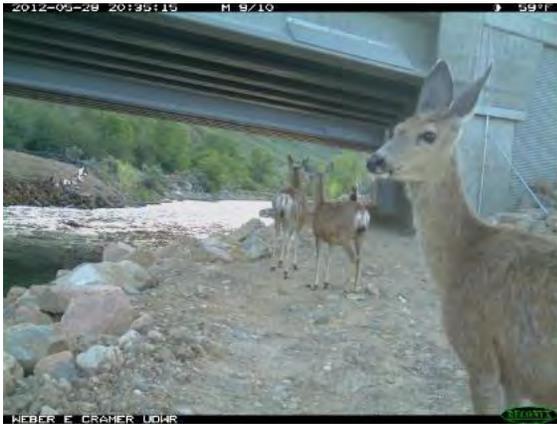
Figure D-20. In Utah, mule deer use wildlife crossing bridge at the Weber River, under I-80 (photo credit: P. Cramer, UDOT, UDWR).

Bridges are commonly used as wildlife underpasses, in part because studies have shown that mule deer, elk, and other ungulates have higher success rates moving through these types of structures than most culverts (Cramer, 2012, 2014a, 2014b, and 2015; Dodd et al., 2007; Gagnon et al., 2011; Simpson et al., 2016). When a river or wetland is involved, bridges can be the most logical choice, helping to avoid wetland building permits, providing human movement below the road, and allowing for natural terrestrial and aquatic wildlife movement (Figures D-20 through D-23).

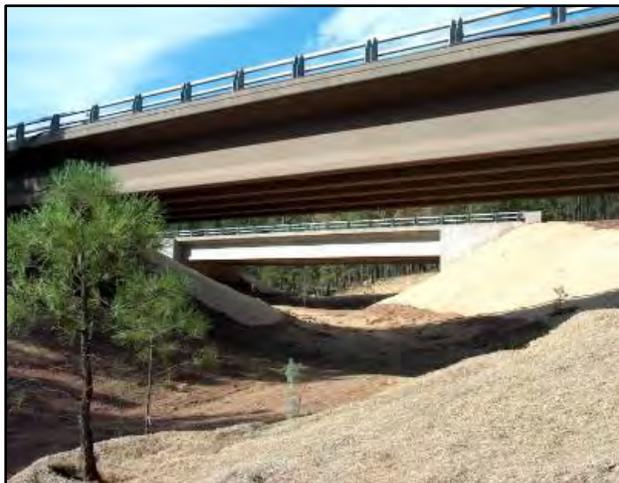
Figure D-21. In Arizona, SR 260 wildlife crossing bridges were found to facilitate over 6,000 successful elk crossing movements (Gagnon et al., 2011) (photo credit: AZGFD).

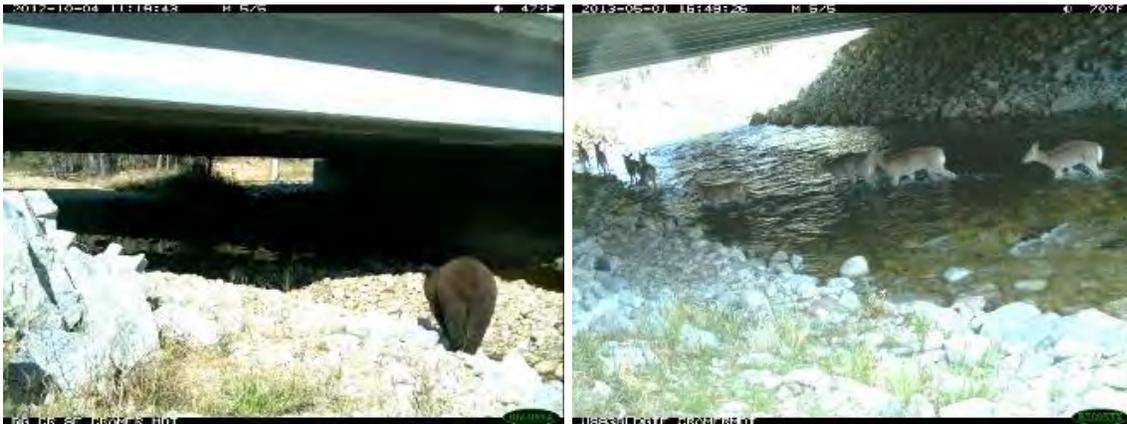
Figure D-22. In Montana, black bear and white-tailed deer used bridged wildlife crossing structures with and without water features (photo credit: P. Cramer and Montana DOT).

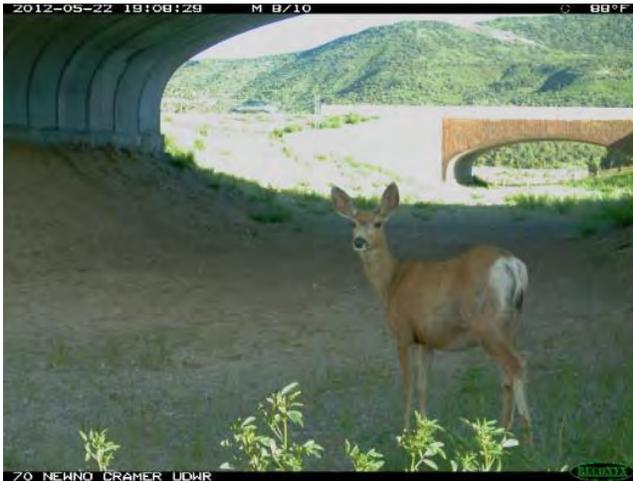
Figure D-24. Mule deer used the arch underpass under I-70 in Utah (photo credit: P. Cramer, UDOT, and UDWR).

These structures are created with pre-fabricated concrete arches that are typically about 6 feet wide, with the arches placed on a concrete foundation. The prefabrication of underpasses with these arches, and with overpasses created in the same way, help reduce the traffic detours and congestion associated with large infrastructure placement in the road. They allow for a high amount of vertical and horizontal space to accommodate wildlife. Mule deer success rates at these structures have been over 90 percent in Utah (Cramer, 2014a and 2014b) (Figure D-24), Colorado (Kintsch et al., 2021), and other states. However, they are still a limited option for elk movements. While elk have been present at the locations monitored at the Utah and Colorado

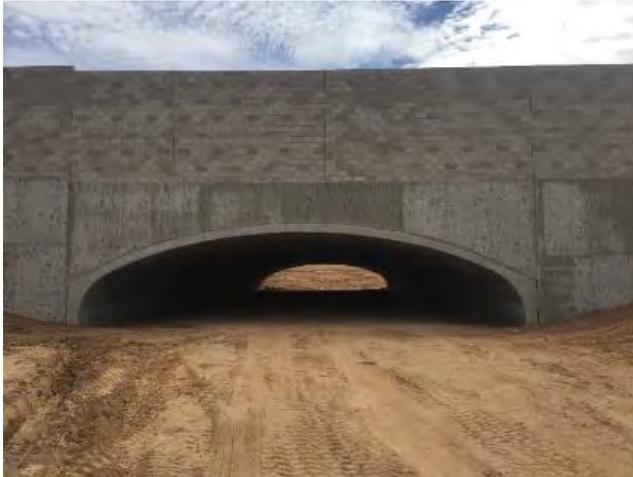
Figure D-25. Arch wildlife underpass on Arizona's six-lane SR 77. Wildlife have used it over 5,000 times to pass beneath the highway (photo credit: J. Gagnon).

The diversity of wildlife species in New Mexico will have different preferences for types of structures. For example, in Arizona along SR 77, both an overpass and an underpass wildlife crossing structure were installed within close proximity to each other (Figures D-25 and D-26). More than 10,000 times mule deer and other wildlife used these structures in nearly equal numbers. When given the choice, mule deer primarily selected the overpass, while a large variety of other species, including coyote, bobcat, javelina, and multiple other species preferred the arch underpass (Gagnon et al., 2020b).

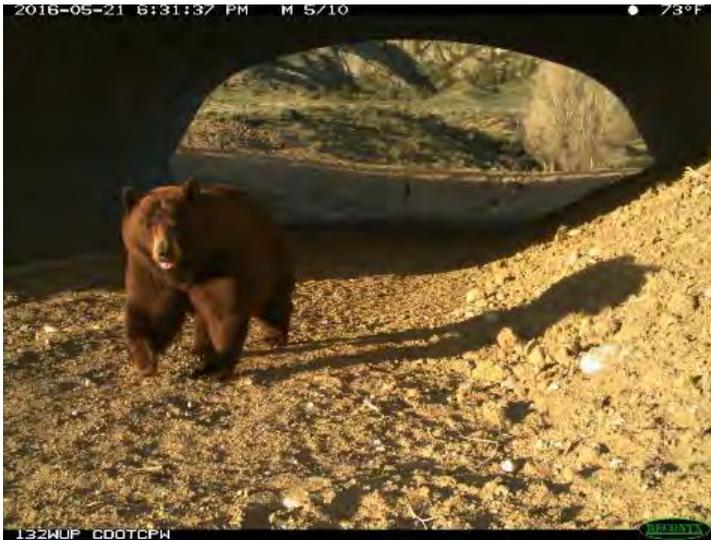
Figure D-27. Black bear used an arch underpass under Colorado's SR 9 (photo credit: Eco-Resolutions, CDOT, and CPW).

In Colorado, the full diversity of ungulate and carnivore species present in the area were documented using the five arch underpass structures on SR 9, including mule deer, limited numbers of elk, moose, single bighorn sheep, single pronghorn, black bear, coyote, bobcat, and medium sized mammals (Kintsch et al., 2021) (Figure D-27).

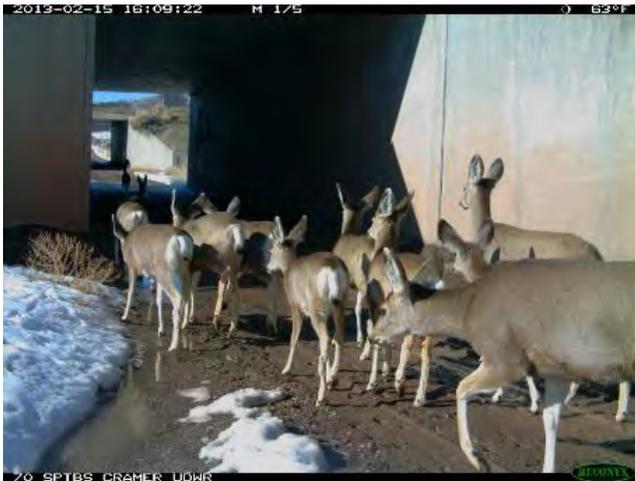
Figure D-28. In Utah, once wildlife exclusion fence was placed along this USFS road that encompassed a pair of concrete box culverts, mule deer began using these to pass beneath I-70, with hundreds of successful mule deer movements through the pair of culverts each year (Cramer, 2012 and 2014) (photo credit: P. Cramer, UDOT, and UDWR).

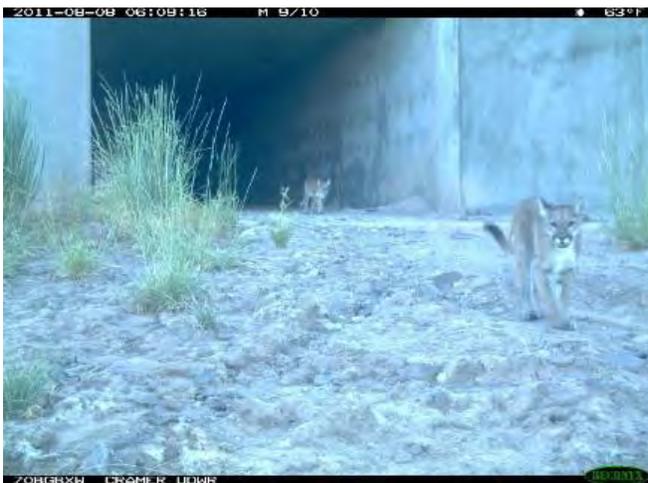
Figure D-29. Cougars use ranch operations concrete box culvert under I-70 in Utah (photo credit: P. Cramer, UDOT, and UDWR).

Concrete box culverts have been used to accommodate wildlife of all sizes and movement capabilities (Sparks and Gates, 2012) (Figures D-28 through D-30). As long as the culverts are less than 200 feet long and are at least 13 feet high and wide, mule deer may use them over time as they adapt to them. For example, from 2017 to 2019, researchers with AZGFD documented more than 6,000 mule deer successful movement through box culvert wildlife underpasses installed along US 550 near Aztec, New Mexico (Gagnon and Loberger, 2020). Concrete box culverts are not recommended for elk, bighorn sheep, and pronghorn; these species have rarely used this type of structure in numbers greater than singular or several animals. Carnivores, such as mountain lion and black bear, have used these structures regularly in Montana (Cramer and Hamlin, 2018), Utah (Cramer, 2012 and 2014), and Colorado (Kintsch et al., 2021). In New Mexico, Gagnon et al. (2020c) documented black bear use of existing concrete box culverts.

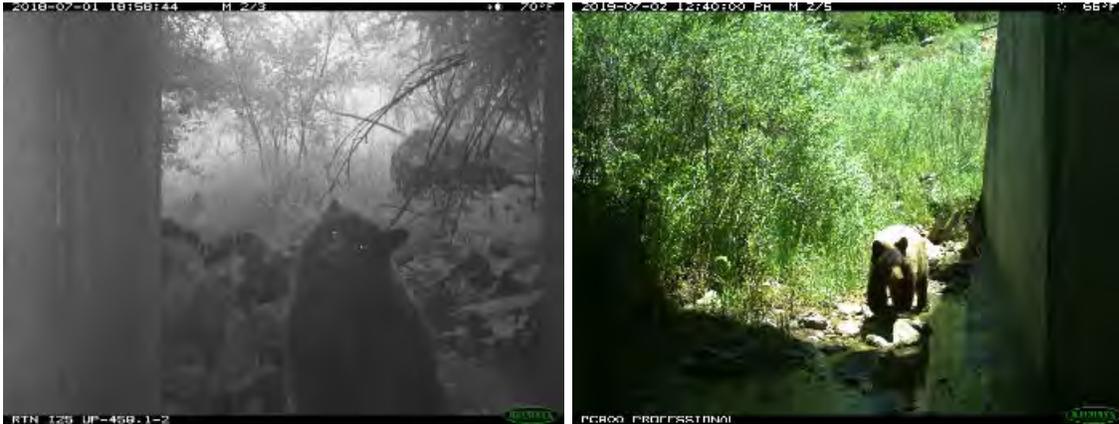
Figure D-30. In New Mexico, black bear have regularly used existing box culverts to cross under I-25 near Raton (photo credit: AZGFD, NMDOT).

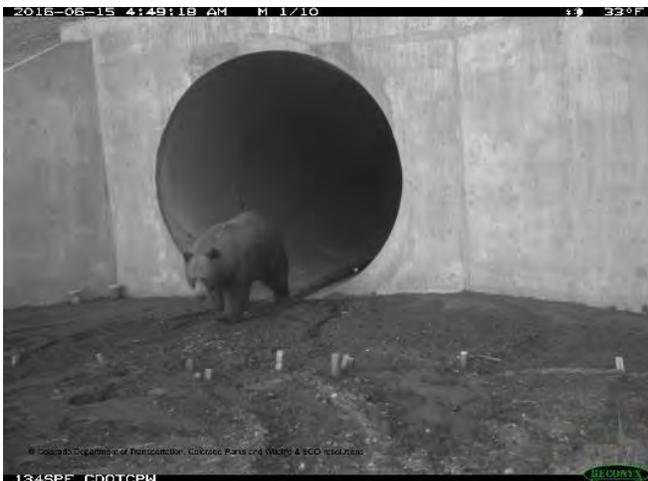
Figure D-31. In Colorado on SR 9, a black bear exits an existing corrugated steel 6-foot by 6-foot culvert (photo credit: ECO-Resolutions, CDOT, and CPW).

Corrugated steel culverts, also known as squash pipes, or corrugated metal pipes (CMPs) are used by departments of transportation to accommodate wildlife across the western U.S. As long as they are high, wide, and short enough, mule deer will use them (Cramer, 2012 and 2014; Cramer and Hamlin, 2019a, 2019b, and 2019c), as will multiple wildlife species (Clevenger, 2001b; Cramer and Hamlin, 2019a) (Figures D-31 and D-32). However, elk, bighorn sheep, and pronghorn will typically not use them. Smaller wildlife and carnivores have been proven to use these culverts as well.

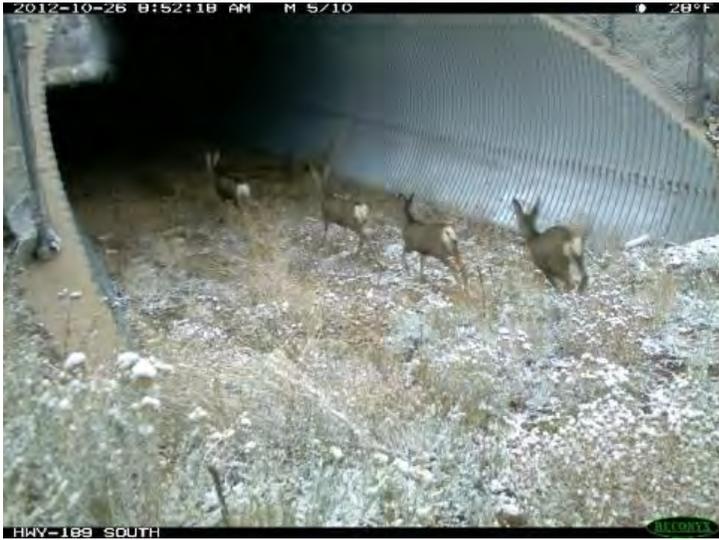
Figure D-32. In Utah, mule deer use a large corrugated steel culvert underpass in Deer Creek State Park under US 189 (photo credit: P. Cramer, UDOT).

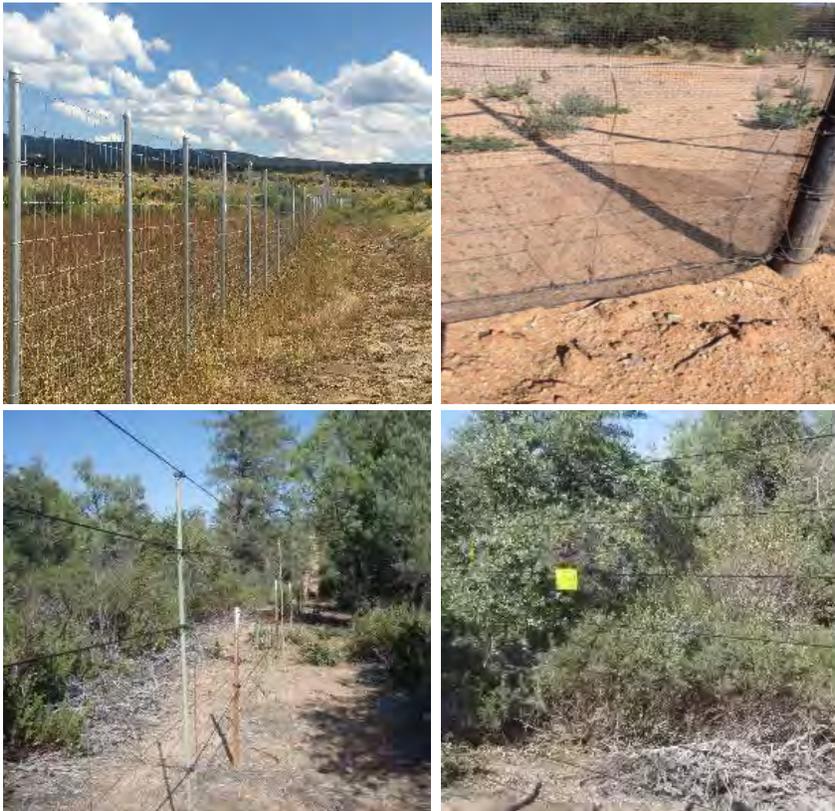
Figure D-33. Traditional field fence 8 feet high (top left), woven wire mesh fence for smaller wildlife (top right), standalone electrified braid fence (bottom left), and combination of electrified braid and standard right of way fence to limit elk access to Arizona’s SR 260 (bottom right) (photo credit: AZGFD).

Wild ungulate exclusion fence is used to prevent wildlife in general, access to the road area. It is described in better detail in the previous section on deterring wildlife from entering the road. There are field fences with welded wire to deter ungulates, mesh fence to deter smaller animals, and Electrobraid fence, or a combination of these types of fences to deter large mammals (Figure D-33).

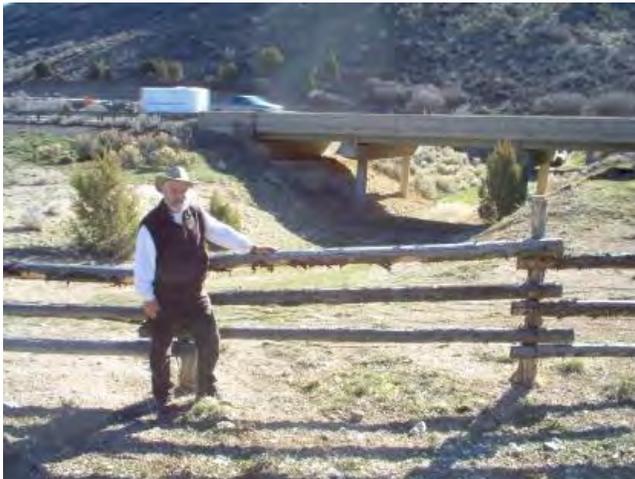
Figure D-34. Utah wildlife rail fence at a wildlife crossing structure under I-15 (photo credit: P. Cramer).

Wildlife also needs to access wildlife crossing structures and existing culverts and bridges. If there is a need to keep domestic livestock out of the structures, it is important to place rail fence 18 inches above the ground (Figure D-34) and back at the right-of-way line of fence to accommodate wildlife trying to use the structure while deterring livestock from entering the crossing. Wildlife friendly fence options are detailed in two manuals from Montana and Wyoming (Paige, 2008; Paige, 2012).

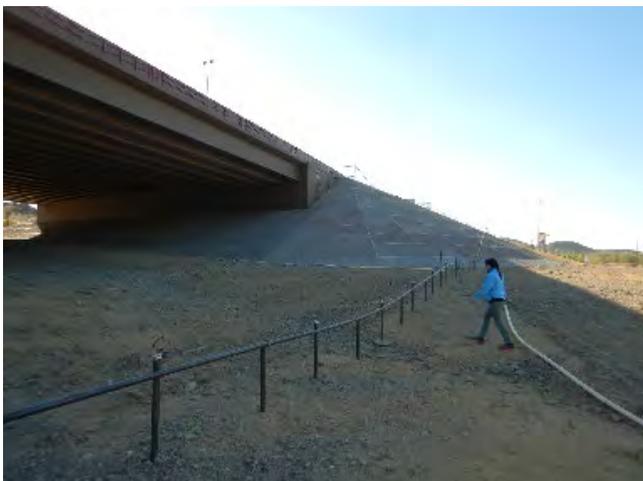
Figure D-35. Arizona placed a steel rail fence at a wildlife underpass structure to deter motorized vehicle use (photo credit: AZGFD).

Fence may also need to be placed to deter motorized vehicles, particularly off-highway vehicles (OHVs), while still allowing wildlife access to the area. See Arizona’s approach to this challenge in Figure D-35.

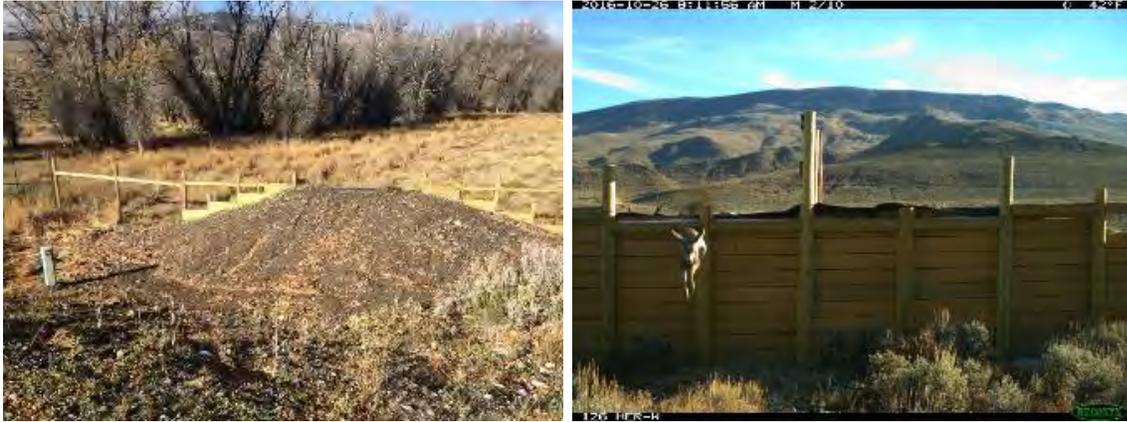
Figure D-36. Colorado SH 9 most successful escape ramp type with a 3:1 slope and no center fence (left) (photo credit: P. Cramer). Mule deer using escape ramp with center fence in Colorado, SR 9 (right) (photo credit: CDOT, CPW, Eco-Resolutions).

Escape ramps are mounds of earth placed in the right-of-way along the exclusion fence to provide an area animals trapped in the right of way can use to jump out of the area. Escape ramps should be placed with wildlife biologist input to maximize use by trapped wildlife. In Utah and Colorado, the standard is four escape ramps per mile of wildlife exclusion fence. Experiments with various ramp designs have found that the most effective designs include the following (Figures D-36 through D-39):

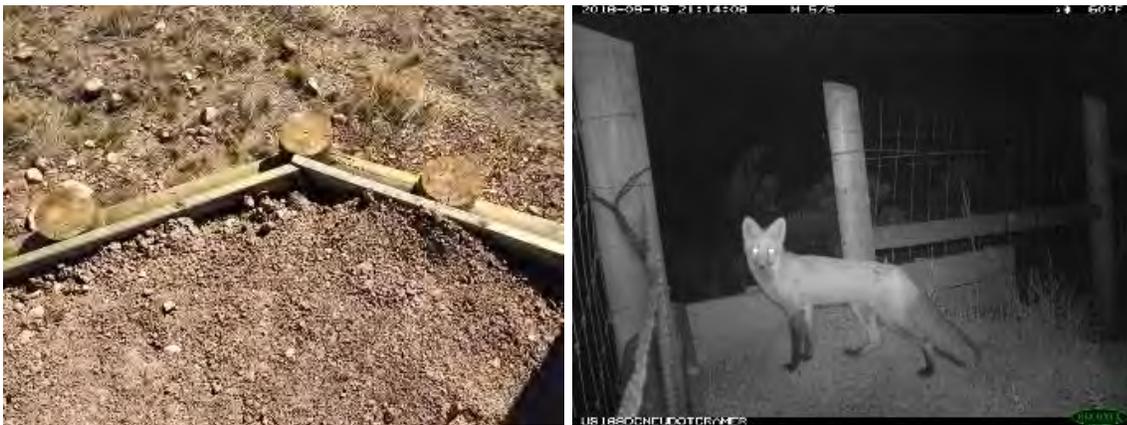
Figure D-37. Angle of escape ramp in fence along Utah's US 189 (left). Red fox on Utah escape ramp on US 189 (right). Ramp is at approximately a 150 degree angle to fence line (photo credit: P. Cramer, UDOT).

- A minimum ramp opening of 10 feet at the top.
- In Utah, Cramer and Hamlin (2019b) found that placement of ramp at a slight angle (approximately 150 degrees), or at an inflection point in the fence to draw the animals inward and over the ramp to the wild side worked best.

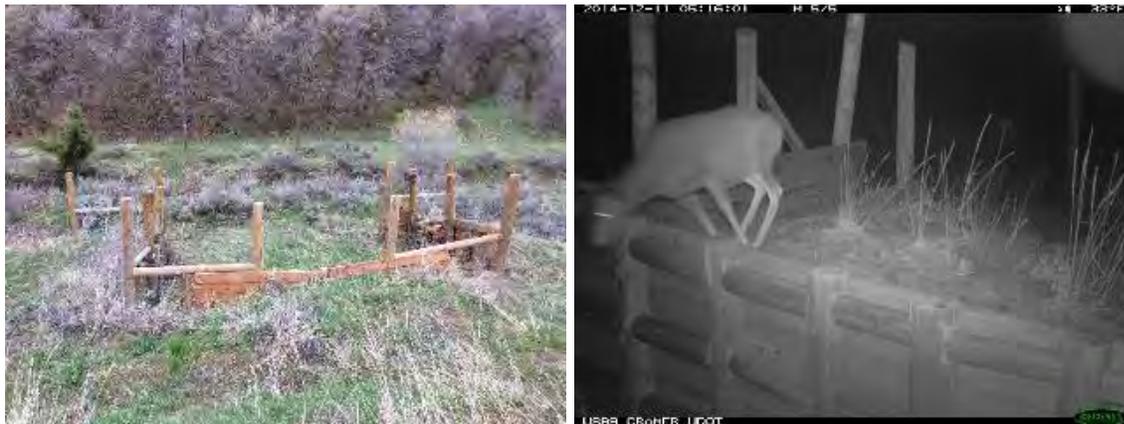
Figure D-38. A Utah high migration escape ramp on US 91 (left). Three sides provide three escape opportunities (photo credit: P. Cramer). Mule deer uses a high migration escape ramp in Utah, US 91 (right) (photo credit: P. Cramer, UDOT).

- There are several different escape ramp designs. There can be one, two, or even three ramps tied together at an opening in the fence location. These multiple ramp entries improve the chances that wildlife will find and use them.

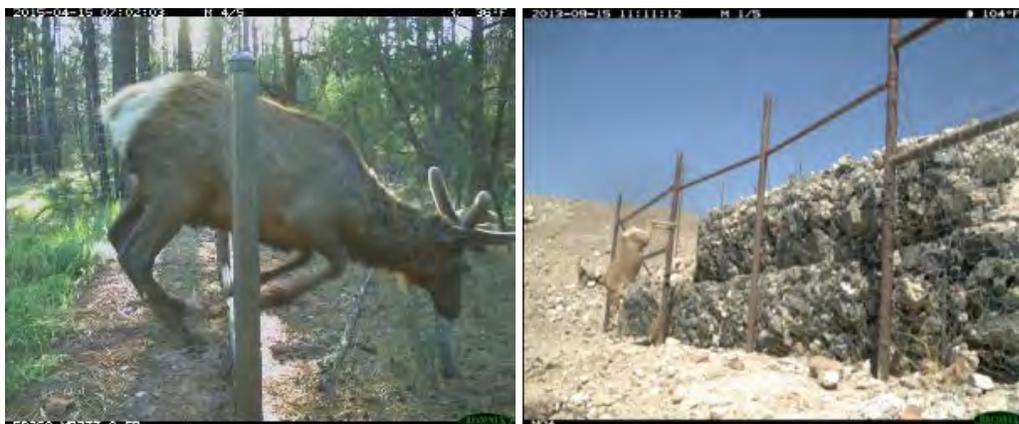
Figure D-39. Elk use escape ramp (left) and desert bighorn sheep use a 6-foot escape ramp (right), both in Arizona. The bar on the desert bighorn ramp was placed higher than 6 feet (photo credit: AZGFD and AZDOT).

- The landing pad on the wild side should be flat and clear of vegetation, rocks, and debris.
- The height of the ramp will depend on species; for example, a ramp height of 6 feet is recommended for elk, but a ramp for deer should be in the 5 to 6 feet range (Kintsch et al., 2021). If there are elk present in the same area as mule deer, ramps should conservatively be placed at 6 feet high due to the safety concerns caused by larger bodied elk (Gagnon et al., 2020c). Bighorn sheep require a crossbar set at 18 to 20 inches above the lip of the ramp to reduce entry into the right-of-way while still allowing them to go over or under the ramp to exit (Gagnon et al., 2017 and 2020c).

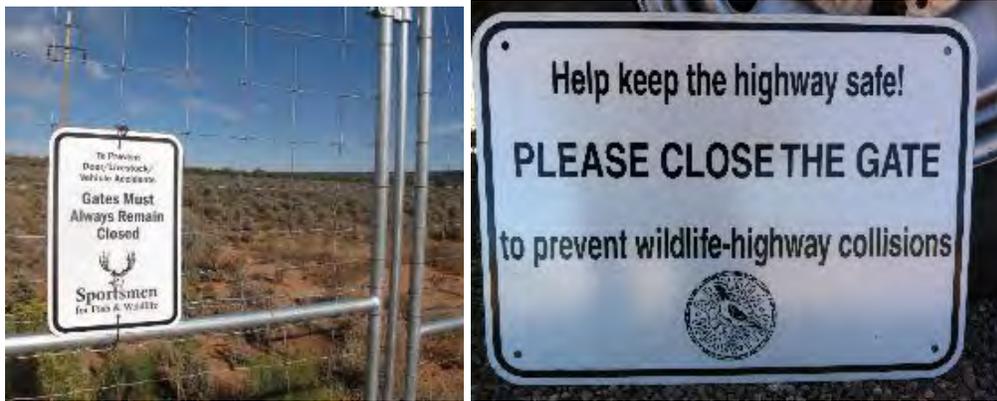
Figure D-40. Educational signs on gates in wildlife fence in Utah (left) and Arizona (right) (photo credits: P. Cramer, J. Gagnon).

internal spring mechanisms should be a consideration in design to minimize the chances of gates being left open. If a project budget allows, other robust measures besides gates should be used.
