Draft Wildlife Corridors Action Plan

December 31, 2021

New Mexico Department
of Transportation and
New Mexico Department
of Game & Fish

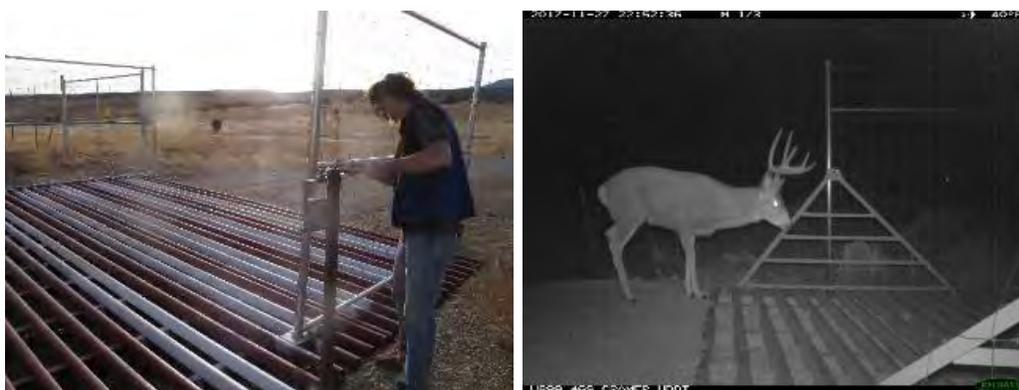
Figure D-41. Utah double cattle guards with appropriate side fences and aprons, no mid-guard support, rounded top bars (left) (photo credit: P. Cramer). Mule deer ponders a Utah guard on US 89 and was deterred (photo credit: P. Cramer, UDOT, UDWR).

In situations where gates are not feasible, guards should be used to allow vehicle access and limit wildlife access. Single cattle guards are the typical guards placed to keep cattle from entering roads. Paired single cattle guards are typically called game guards, or double cattle guards, and are used for deterring wildlife from entering roadways at egress and ingress places along wildlife exclusion fences. These game guards (double cattle guards) should have a more rounded or pointed top surface to help reduce wildlife with hooves from using the bars to walk across and accessing the roadway (Figure D-41).

The game guards (paired cattle guards) should be continuous bars, with no concrete support between the two, as mule deer photographed in studies in Utah, Montana, Colorado, and Arizona have demonstrated an ability to use that middle strip as a launch point. Grate style wildlife guards have been successfully used to limit mule deer and white-tailed deer access to roads in Montana (Allen et al., 2013), Utah (Flower, 2016), and Florida (Peterson et al., 2003). The sides of all guard types typically have concrete supports for the vault below. Those concrete side supports need to be fenced over and not available to mule deer and other wildlife to walk on to enter the road right-of-way. The aprons that attach to the posts and cover the concrete lips also need fence placed under them so animals do not use the area beneath the aprons to access the road. Or, the fence can be placed directly to the guard edge, and the aprons placed on either side. The best in road wildlife deterrents are not 100 percent effective, and some animals move over the guards and onto the road. However, Cramer and Flower (2017) found double cattle guards (game guards) to be 85 to 90 percent successful in deterring mule deer efforts to breach them. At every guard location, there need to be escape ramps within several hundred feet of the guard to allow animals that have breached them who become caught in the right-of-way a nearby escape mechanism. In recent projects in Utah (Cramer and Hamlin, 2019a, 2019b, and 2019c) and Colorado (Kintsch et al., 2021; Cramer and Hamlin, 2021), all roads, driveways, and vehicle entrance and exit ramp entrances have at least one escape ramp placed nearby.

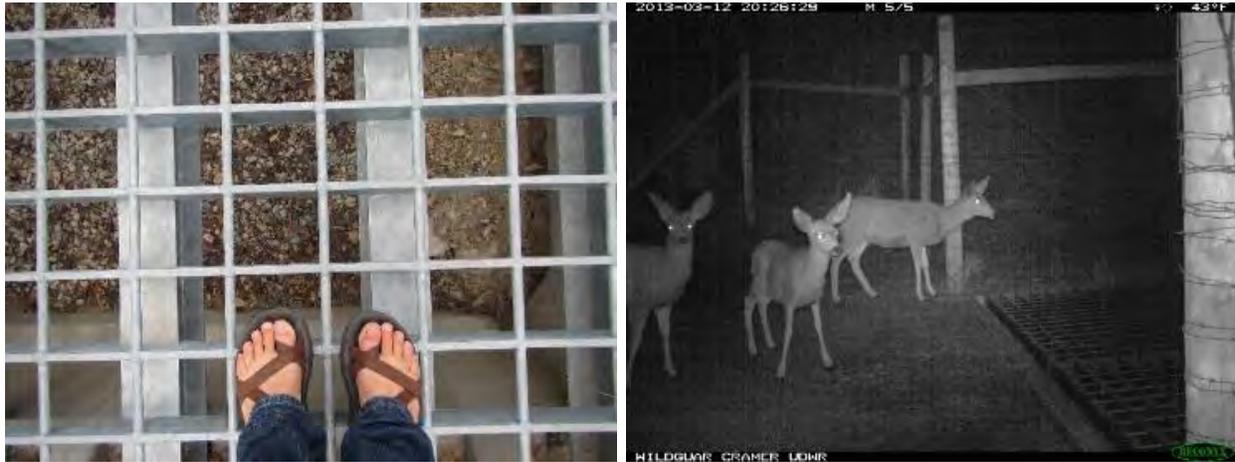
Figure D-43. Wildlife guard in Utah, US 91 (left). Mule deer breached the guard by walking on the outer lip of the vault (right) (photo credits: P. Cramer, UDWR).

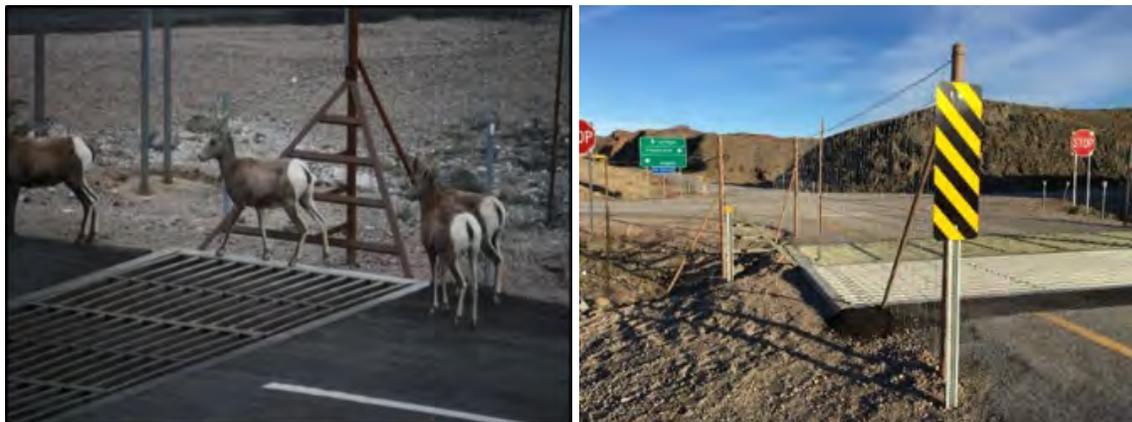
Figure D-44. Desert bighorn sheep breach a single cattle guard by using support lip in Arizona (left). The guard was adapted to a double cattle guard and the vault lip was covered with fence (right). Monitoring Found no bighorn sheep breaches after retrofit (photo credit: AZGFD, AZDOT).

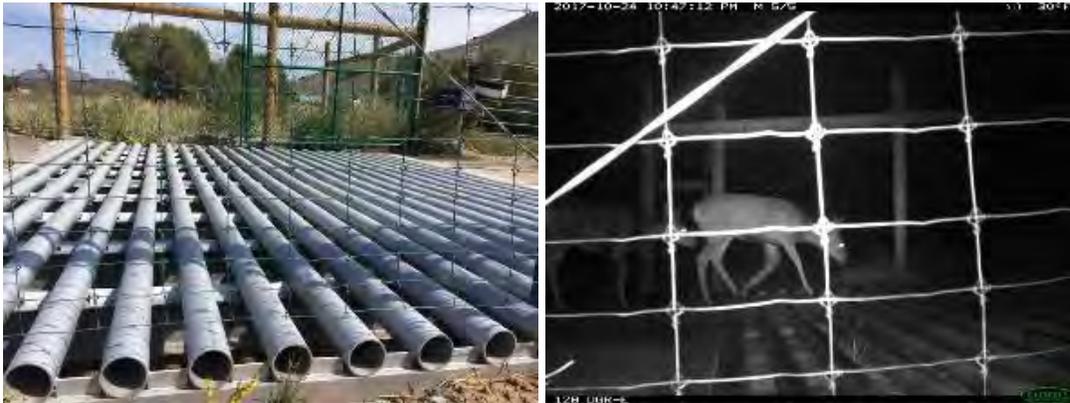
Figure D-45. Colorado SH 9 round bar double cattle guard (left) (photo credit: P. Cramer). How mule deer can use the support beams to breach the guard (right) (photo credit: CDOT, CPW, and ECO-Resolutions).

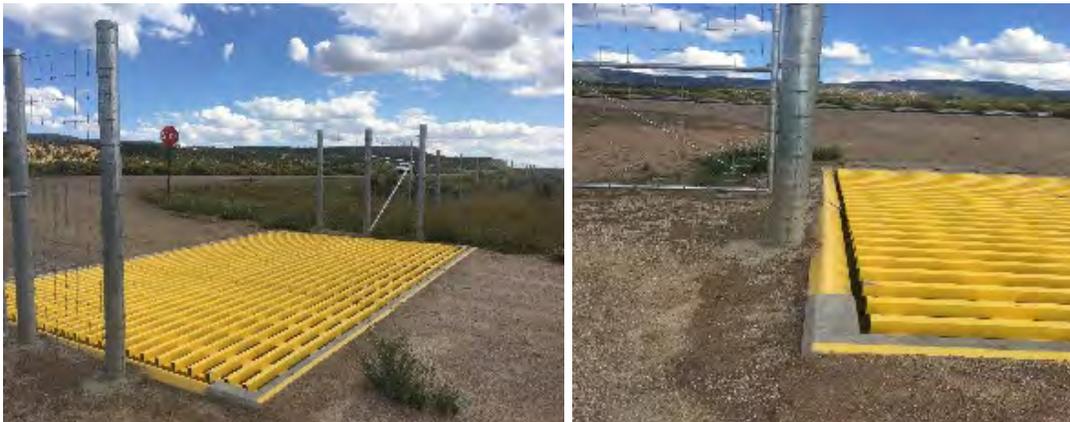
Figure D-46. In New Mexico, US 550 Cuba double-width game (cattle) guard with perpendicular fence and beveled vault edges (photo credit: AZGFD).

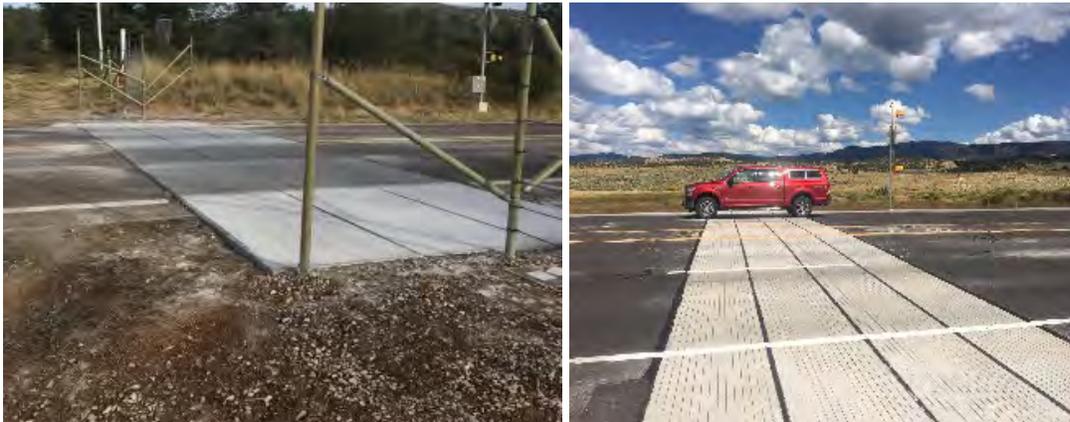
Figure D-47. Electrified barriers installed along SR 260 in Arizona (left) and along US 550 in New Mexico (right) to keep elk and deer out of the right-of-way (photo credit: AZGFD).

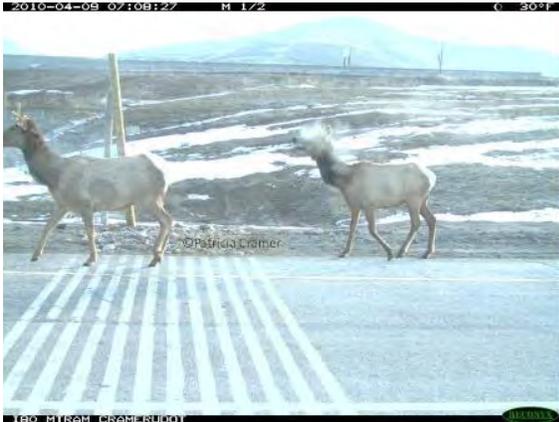
Figure D-48. Elk move over painted lines mimicking cattle guard in Utah along I-80 (photo credit: P. Cramer, UDOT, UDWR).

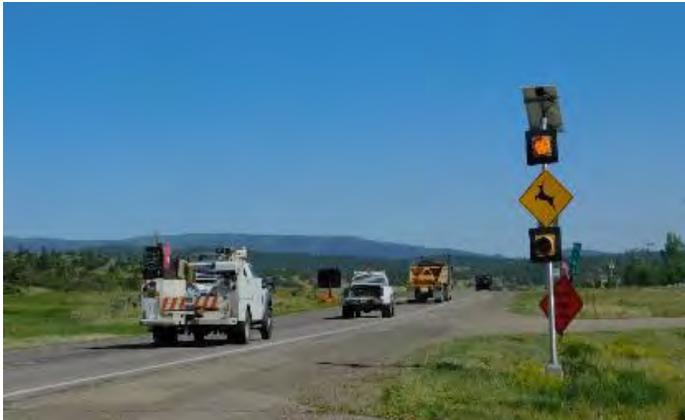
Figure D-49. Warning sign with flashing yellow lights in Chama, New Mexico (photo credit: P. Cramer).

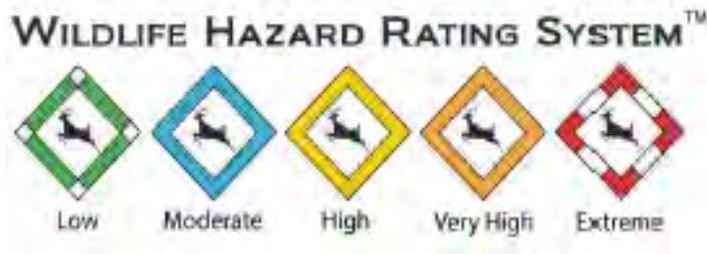
Figure D-50. Variations of deer-vehicle collision warning signs with flashing border intended to alert motorists during peak potential crash periods. color and flash pattern can be changed as needed (from Sielecki, 2017).

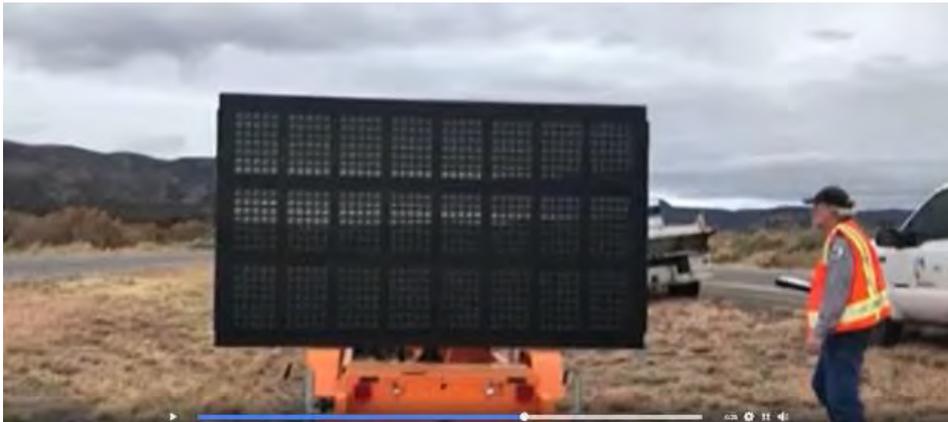
Figure D-51. M. Watson of NMDGF installs driver warning variable message board with NMDOT maintenance personnel (photo credit: NMDGF).

The electronic variable message board or variable message sign (VMS) can be used in specific areas where a problem of wildlife on the road is short in duration and predictable. The wording on the sign can be changed to suit the situation, and can be programmed daily, sometimes from remote locations. NMDGF has purchased two such signs for placement on New Mexico roads. They are moved seasonally to warn drivers of elk on the road near Bent, in the Sacramento Mountains, and near Questa to warn drivers of bighorn sheep on the road. The signs can be general or very specific to detail the problem. However, DOTs and FHWA have specific criteria for the number of lines displayed in a message, display interval and other factors that must be followed. Hardy et al. (2006) found that portable message signs were more effective than permanent signs in eliciting a driver response. Recent research by Donaldson and Kweon (2018) indicated deer carcass removals were significantly lower and motorist speeds were reduced when variable message boards were present. Variable message signs provide a temporary option to potentially reduce collisions. Additional research to corroborate their effectiveness is warranted.

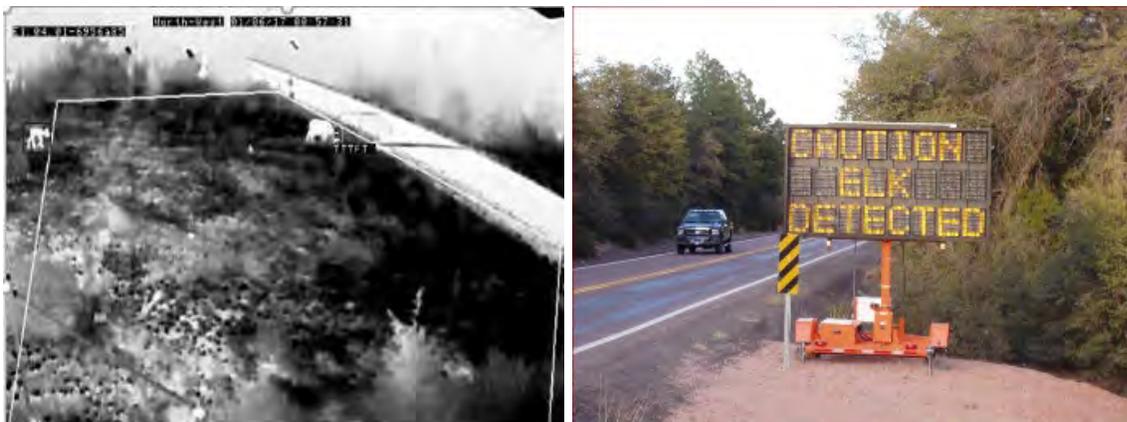
Figure D-56. Screen capture of thermal camera image of elk cow and calf and motorist warning sign on Arizona SR 260 (photo credit: AZGFD and CrossTek, LLC).

Fences are a time-proven method for keeping many wildlife species off roads and when combined with appropriately designed and located wildlife crossing structures provide a successful system for mitigation of roads on wildlife. At some point, fences used to exclude animals and guide them to wildlife crossings needs to end, and can lead to animal end-run events, or concentrated wildlife crossings at the ends of fences. In these instances, animal detection systems can be used to alert motorists of wildlife presence as they cross at these fence termini. A good example of a detection system that addresses an end run situation was implemented in Arizona along SR 260 in 2007. The SR 260 system used thermal imaging technology to detect wildlife approaching the road at the end of the fence. This system combined with the exclusionary fences reduced accidents with elk by 97 percent and continually reduced motorist speeds for nine years. In 2019-2020, this system was upgraded to a more robust and accurate FLIR based thermal system (Gagnon et al., 2019).

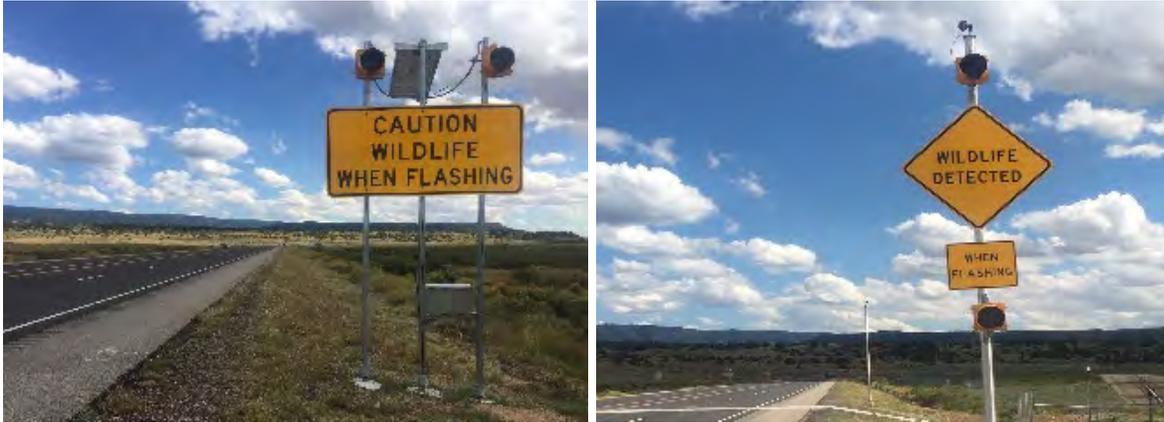
Figure D-57. Wildlife activated driver warning system on US 550, New Mexico (photo credit: AZGFD).

NMDOT collaborated with AZGFD and placed a similar wildlife activated FLIR based thermal sensor system with motorist warning signs along US 550 south of Cuba, New Mexico. These systems were part of a retrofit of existing bridges to guide wildlife under the road. The project was completed in 2019; both driver behavior and wildlife use of the structures and fence ends are being monitored by AZGFD and NMDOT.

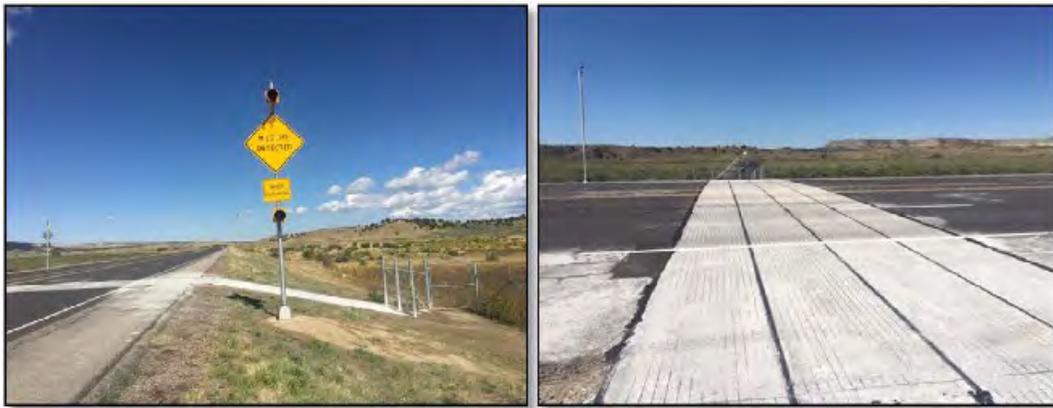
Figure D-58. Driver warning signs and electrified barrier at fence end on US 550, New Mexico (photo credit: AZGFD).

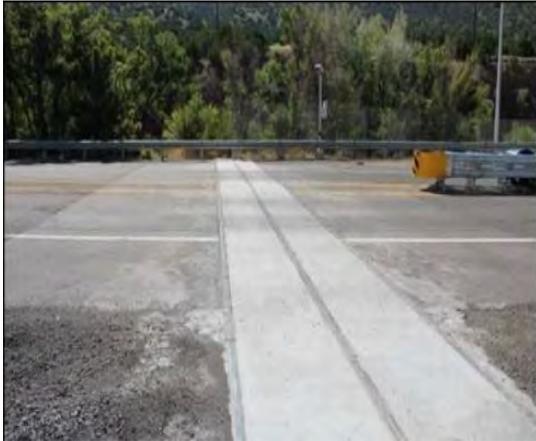
Figure D-59. Tijeras Canyon Safe Passage Project electrified concrete barriers at NM 333 wildlife crosswalk (photo credit: AZGFD).

An animal activated crosswalk could in theory function like an at-grade version of a wildlife crossing in instances where traffic volumes are low enough to allow wildlife to cross the road. An animal activated crosswalk was attempted along Highway 333 in Tijeras Canyon New Mexico in 2007. This crosswalk was put in place to allow wildlife an opportunity to cross Highway 333 and access the bridges to the south that were retrofitted with exclusion fencing to cross under I-40, which parallels Highway 333. Because the detection system failed to operate after a short period of time, the signs were no longer activated by wildlife and stayed on all night. This site essentially became a non-animal activated crosswalk and occasional WVCs still occur.

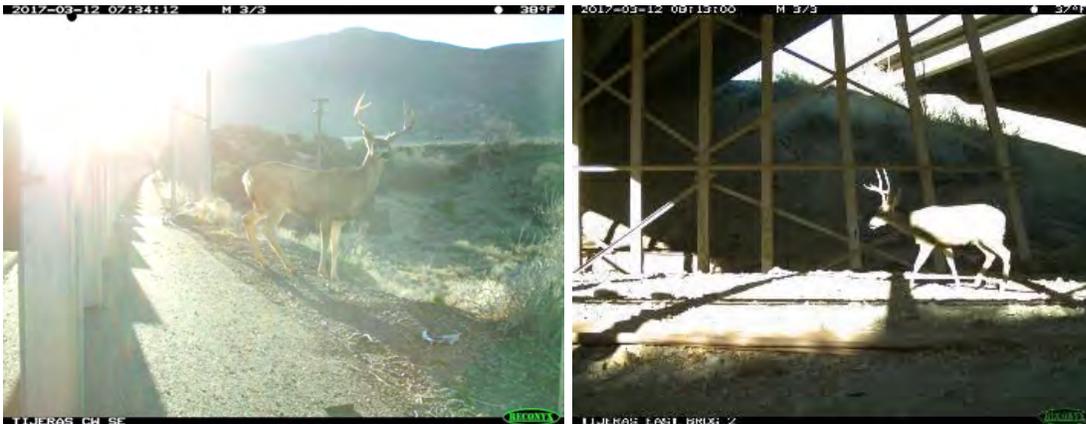
Figure D-60. Two mule deer bucks were recorded entering the NM 333 Crosswalk (left) and exiting the area to the south by using the existing bridges, as recorded by AZGFD monitoring cameras (photo credit: AZGFD and NMDOT).

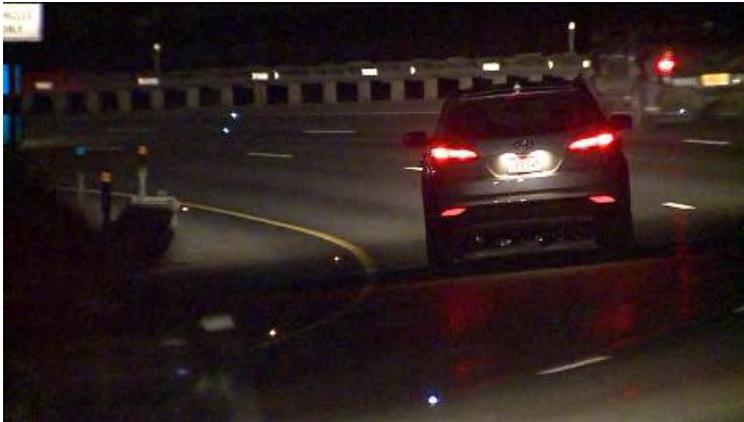
Figure D-61. Solar pucks installed in pavement of I-70 in the mountains outside of Denver (photo credit: Fox Denver, KDVR.com).
