Culvert Asset Management Program

Culvert Identification Handbook (revised 2023)

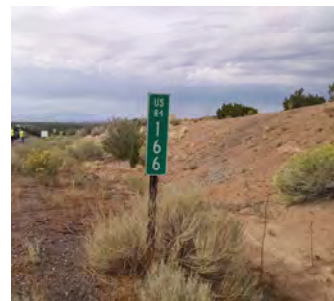
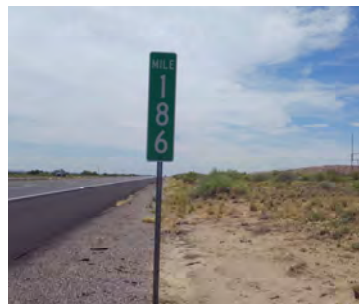
Mile Markers, Mile Posts

Each highway is referenced by mileage from its place of origin. Generally, mile markers run from south to north or west to east. Mile markers numbering begins at zero at a state border and continues in the north or east direction until ending at a state border. There are many exceptions to that, of course. Interstate 25 (I-25) begins at the I-10/ I-25 interchange, Federal Highway 380 (US 380) begins at San Antonio, south of Socorro, State Route 1 (NM 1) begins at Exit 91 on I-25 above Alamosa Canyon and ends in Socorro, and so on.

Mile markers are narrow green signs seen at the right side of a highway. They are also referred to as mile posts. This is a useful tool for locating assets, culverts or problem areas.

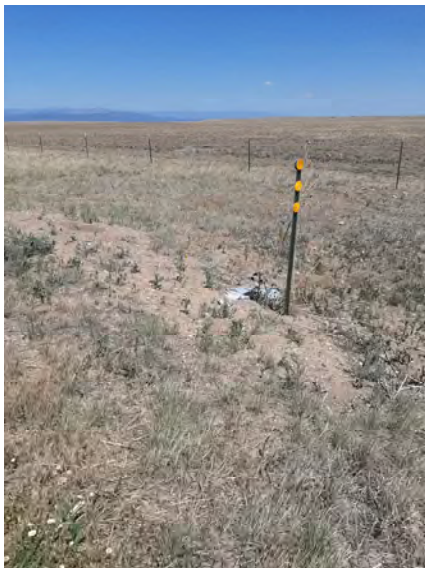
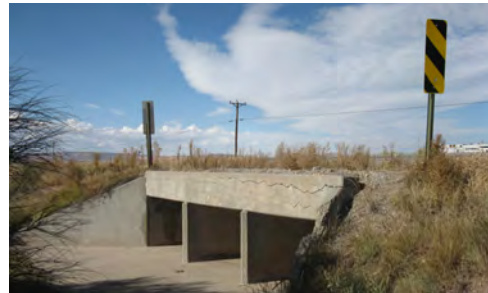
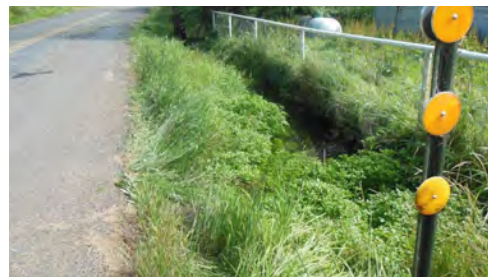
A single t-post with three (3) amber reflectors facing on-coming traffic and a single amber reflector on the opposite side of t-post are placed adjacent to obstructions such as water valves, concrete structures and others that will alert highway workers or the travelling public of a hazard. In our case these will be culverts. Be aware that the same amber reflectors can be put on tight highway curves at the edge of the pavement. Instead of in threes, they are paired or a single reflector. For culverts, bridges and other structures that are at or very near driving lanes, an elongated rectangular sign with diagonal black and yellow stripes will be placed at the corner of structure (see top right photo below). If the culvert is under a deep embankment, the t-post may not be visible from the highway because it will be placed by the culvert. T-posts may not be present in some culverts for various reasons: an on-coming vehicle knocked it down or has not been put in by local patrol. Reading the landscape by identifying valleys and dips will help in locating culverts. Detail sheets for the 3-amber t-post and other road object markers are included with NMDOT Standard Drawings provided for this project.

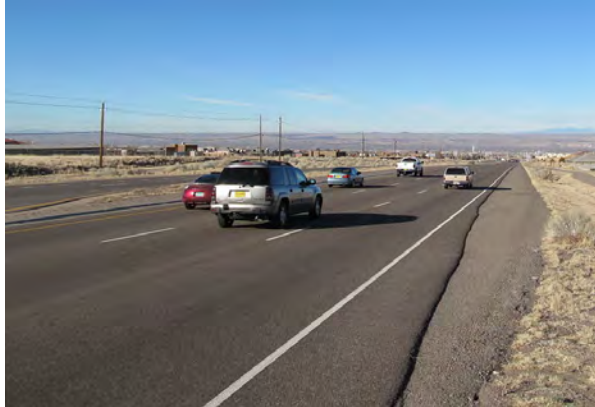
Driving lanes and shoulders

Highways can have two, four or more driving lanes, depending on the anticipated traffic loads. Shoulders are paved sections along side of highway. They are added as safety features and for emergency parking. All interstate highways have shoulders (widths vary from 4 ft along medians to 10 ft on outside). Most US and State highways have shoulders of varying widths (4 ft to 8 ft). Older State highways in the more rural parts of state will have in some cases no shoulders. Shoulders will be your friends, your refuge. Park as far away as practicable from driving lanes on shoulder. On shoulder less roads (usually referred to as 'soft shoulders') 'where' and 'how' to park your vehicle should be given more consideration, especially where there are steep slopes, heavy traffic and muddy soils.

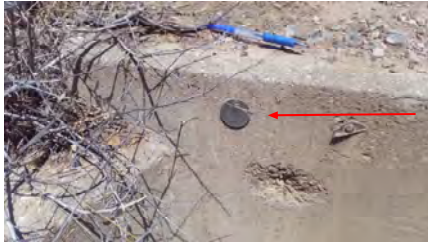
Culvert vs. Bridge: Definition

Bridges, other than the obvious (road deck over another road or waterway with support by abutments and piers) can be large box culverts or multi-barrel circular/arch pipe culverts spanning greater than 20 ft. A brass tag is usually placed on the parapet of a box culvert near the edge (See photo to the left). The

bridge number is embossed in the tag. It is unique to that structure. If the structure is replaced, a new bridge number will be assigned to it.

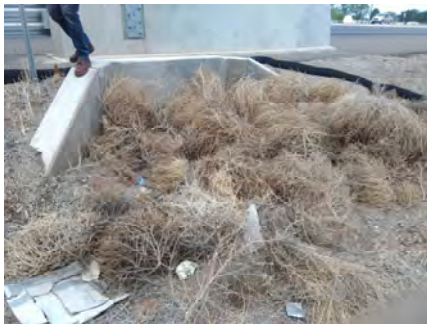
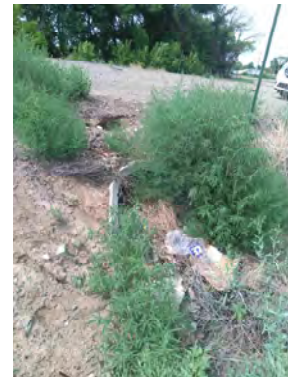
Is Culvert Accessible?

When we say 'inaccessible' it means it **cannot** be accessed. Examples of photos shown here were marked as 'inaccessible' by the 2021 survey. With a little effort, most culvert can be accessed by over coming minor obstacles like climbing a fence or removal of weeds.

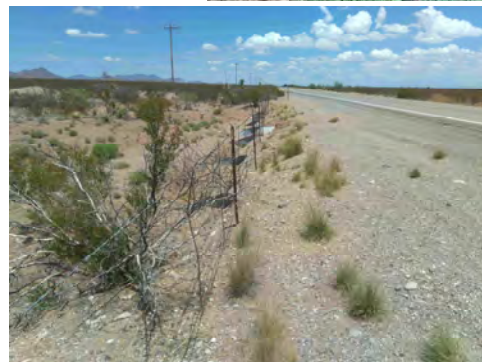
Not all fences are right-of-way. Example to the right was labelled inaccessible because of 'right-of-way' fence. The fence was placed behind a series of metal culverts. Culverts could have been counted from the outside and measured indirectly or directly by climbing the fence.

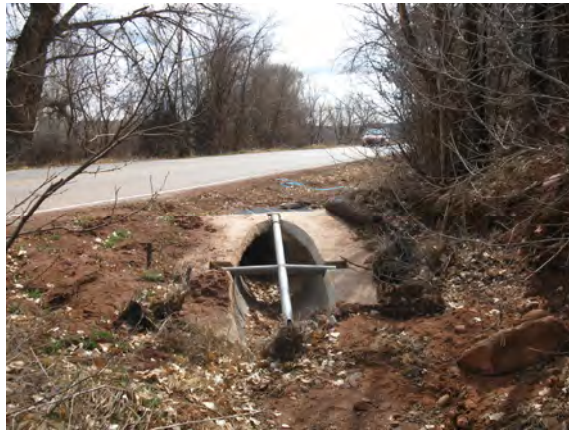
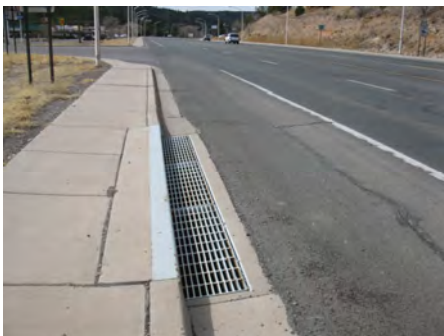
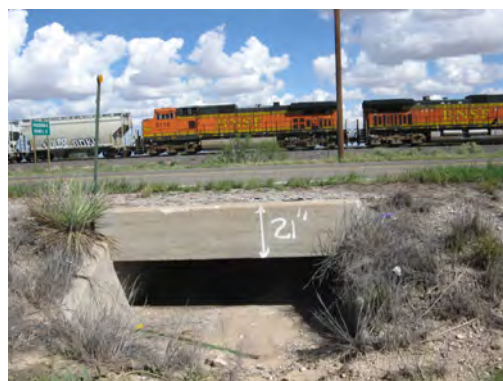
GPS Coordinate Location

This is to identify the structure that is being located by the data collector. List includes inlet, outlet, MDI/SDI, CDI, slotted drain, turnouts (US, State, or County/Municipal roads) and private/commercial driveways.

Skewed culvert to right is on NM 3, south of Ribera, San Miguel County. Triple CDI in the bottom is on US 70, Ruidoso, Lincoln County. Bottom right is on NM 2, south of Hagerman, Chaves County.

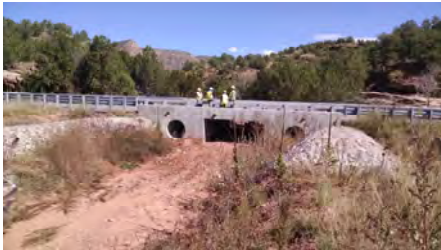
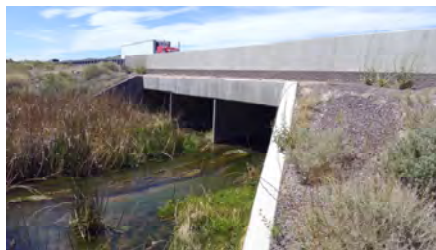
GPS Coordinate Location- Inlet or Outlet

Inlet is where flow enters into culvert, outlet is flow going out.

CBCs (concrete box culverts) shown above are outlets. Reading the landscape like mountains in the background, which way the reeds bend, flow of water or the occurrence of scour can help in determining where a culvert outfalls. Image to left is on NM 3, near La Fragua, Miguel County. Image to right is on EB I-40, Rio San Jose, Valencia County.

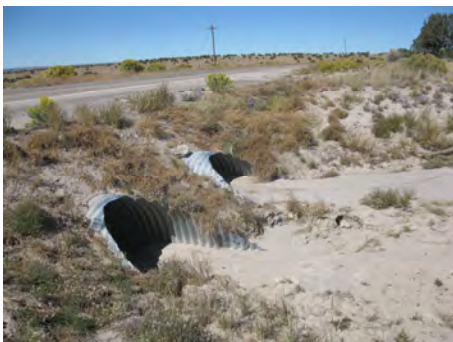
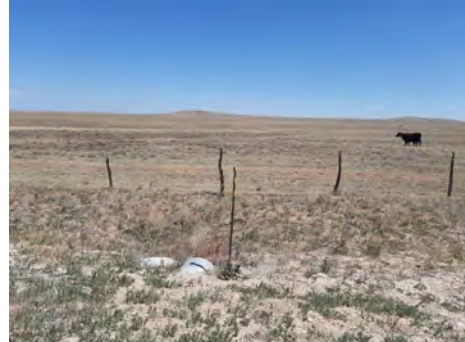
The same applies to inlets. Both examples below are culvert inlets. However, in flat lands (like the bottom right image) it is hard to make the distinction. If in doubt, leave it blank. Locations are unknown.

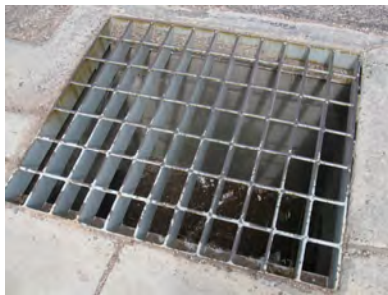
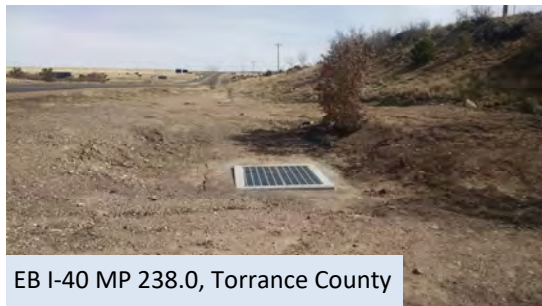
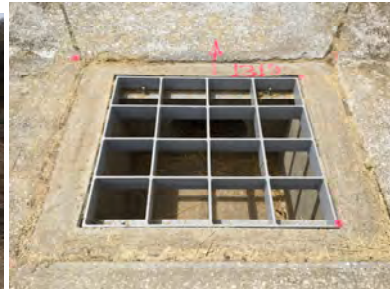
GPS Coordinate Location - Median or Shoulder Drop Inlets

Drop inlets are concrete structures with grates where flow enters into a concrete chamber connecting to a culvert or culverts. Median drop inlets (MDI) are placed in road medians or locations outside of traffic. Shoulder drop inlets (SDI) are essentially the same size as median but are designed to withstand impacts from moving traffic.

When measuring an SDI/MDI, **do not measure** the dimensions of grate. Instead, get the span and rise of the culvert inside. Usually, a grate with a large mesh is easier to measure the pipes inside of box. Note the interior arrangements of pipes as shown in page 19 of this handbook. Measure the larger of the pipe and enter into data collector if multiple pipe are in the inlet. If you cannot get the span and/or rise dimensions, either because it is silted up or cannot see into drop inlet, then mark as 'silted', leave blank ('null') or mark as 'unknown'. If the mesh of grate is

too small to see into box, then leave it blank ('null') or mark as 'unknown'.

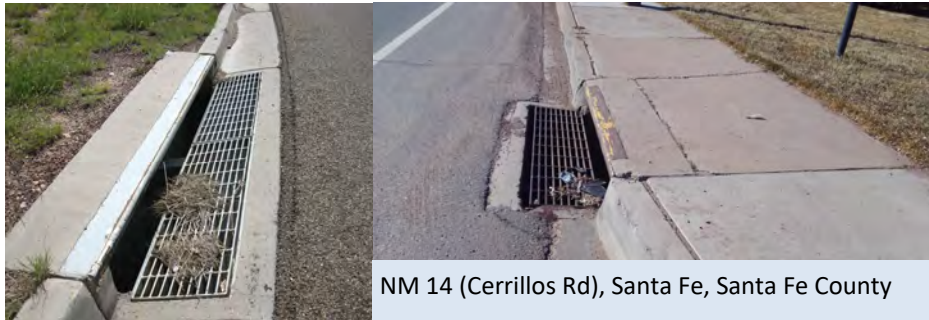
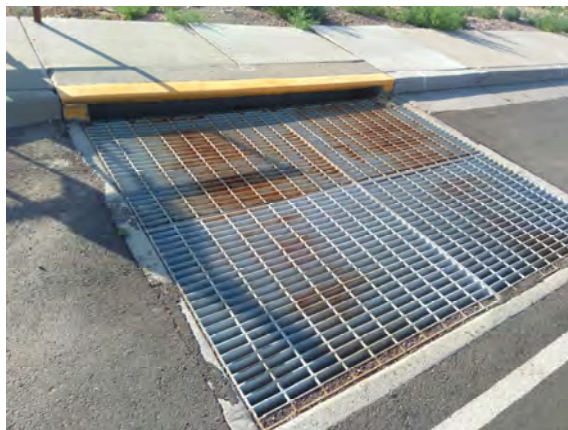
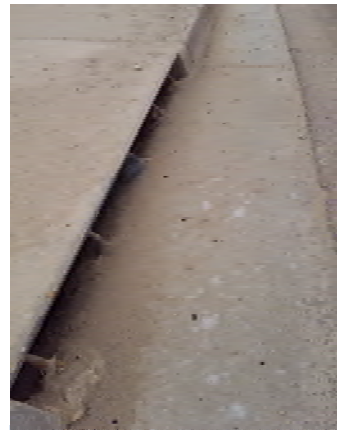
GPS Coordinate Location - Curb Drop Inlets

Curb drop inlets (CDI) are distinguished from other drop inlets in that they have an opening on the side of curb called a sweep. The majority have a grate built along with the side opening. There are some instances where there are only the side openings (bottom right).

As in SDI/MDIs, do not measure the exterior dimensions of CDI. Measure the dimensions of culvert inside if possible. The grates of CDIs invariably have a smaller mesh than SDI/MDIs, hence it is more difficult to see into them. If it is not possible to see inside CDI leave span and rise fields blank or 'null'.

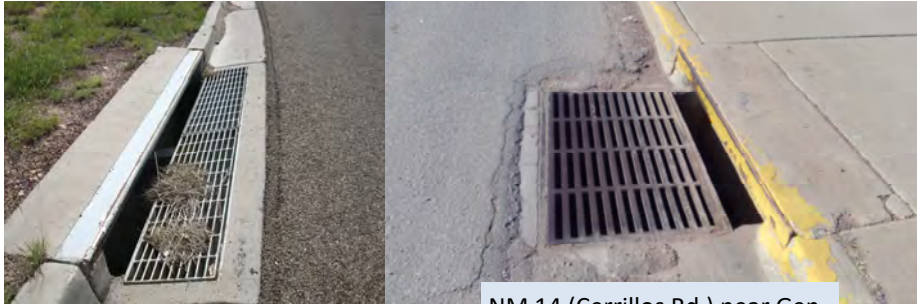
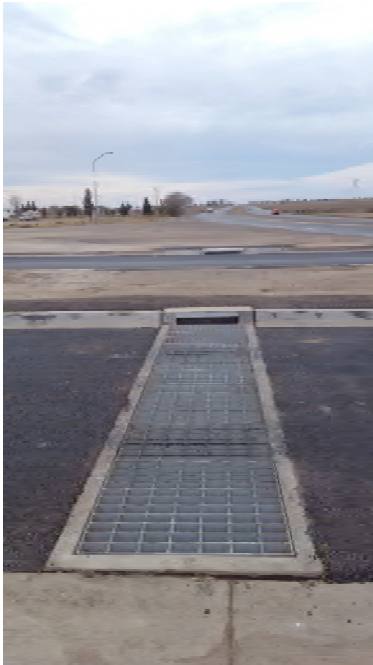
Drop Inlets- Curb Drop Inlets cont.-

More examples of curb drop inlets (CDI)

Typical NMDOT curb drop inlet (CDI). They are 1.5 ft in width and come in 5 ft increments (5,10,15 ft.). CDIs are usually installed on highways with 6 to 8 inch curbing.

Image to left is transverse drop inlet. Width can vary from 4 ft up to the width of a driving lane. Location is on the junction of NM 2 and US 285, south of Roswell, Chaves County.

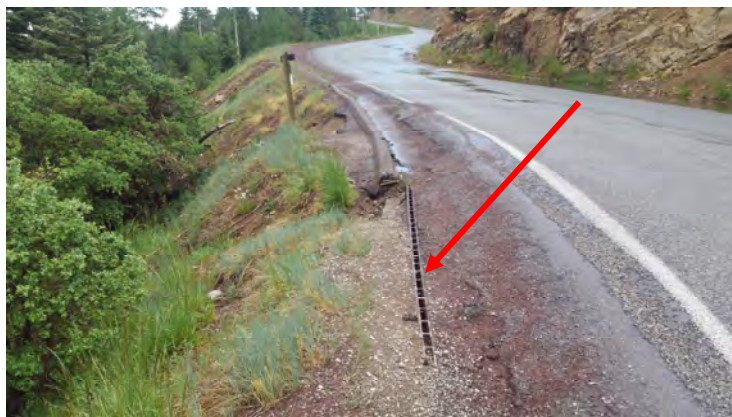
GPS Coordinate Location– Slotted Drains

Slotted drains are metal culverts with a narrow grate placed above. They are usually along highway curbing or a shallow concrete ditch. They may be found as stand-alone or attached to a nearby drop inlet. The pipe associated with slotted drains come in 18 or 24 inch diameters. Place tape measure or a stiff narrow stick into slot and gently push into grate. Read the measurement and put value into 'rise'. There may be some silt in the slotted pipe, hence the need for a stick or prod to be worked to bottom of silt. Measure the length of the slotted drain in feet. Place measurement in 'width of multi-culverts' or as a note in 'comments'. If outlet is not known, leave field as blank ('null') or mark as 'unknown'.

NM 475 MP 13.0, Santa Fe County

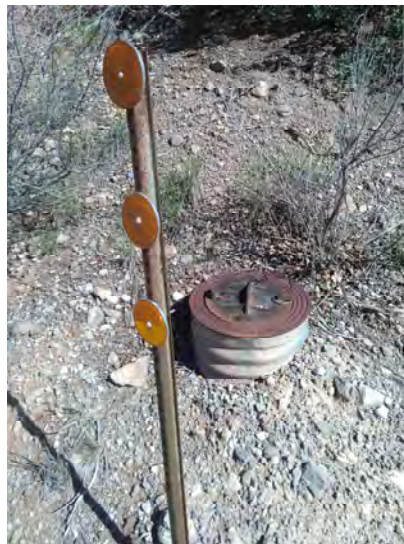
GPS Coordinate Location – Triple Amber Reflector T-post

If there is no evidence of a culvert at a triple amber t-post, check the opposite side of road to see if culvert is visible. Also confirm that it is not marking another roadside 'obstruction' such as a telephone riser, protruding concrete structure, water-meter, etc. Geo-locate and mark GPS Coordinate Location as 'T-post Reflector'. Take a photograph of t-post and include some background information on the condition of surrounding areas. It is likely that the t-post marks the location of a culvert, albeit silted up or hidden in weeds or brush especially in rural areas. If in doubt, geo-locate it.

Photo on the right was geo-located on NM 4 MP 19.96. Collector commented that they were not sure if this was a culvert or not. It turns out that this is a typical structure for a water meter or water line shut-off valve. Once again, if in doubt, geo-locate any t-post with no apparent culverts and add a comment. This will be sorted out later.

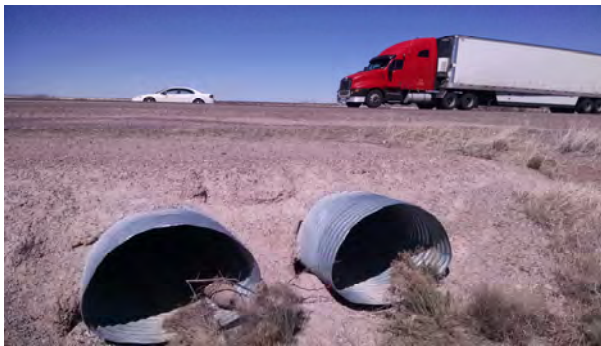
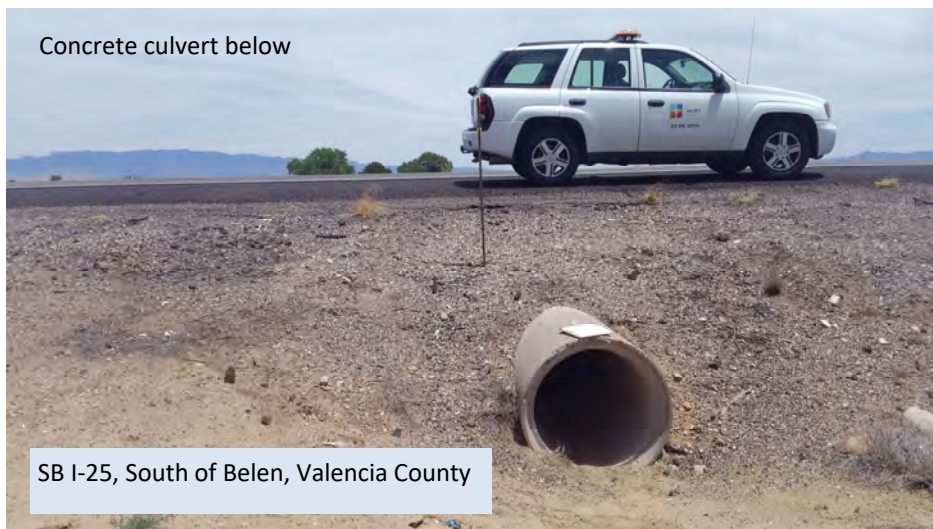
End Sections– None (or ‘Projecting’)

End sections are used to improve flow intake, protect culvert from damage and improve safety to the traveling public. In the examples below no end (or ‘projecting’ as it is referred to in Hydraulics) sections were used. This was common in older roads.

Corrugated metal culvert above. Image to left is located on NM 26 MP 36.5, Doña Ana County. Location of image to right is unknown.

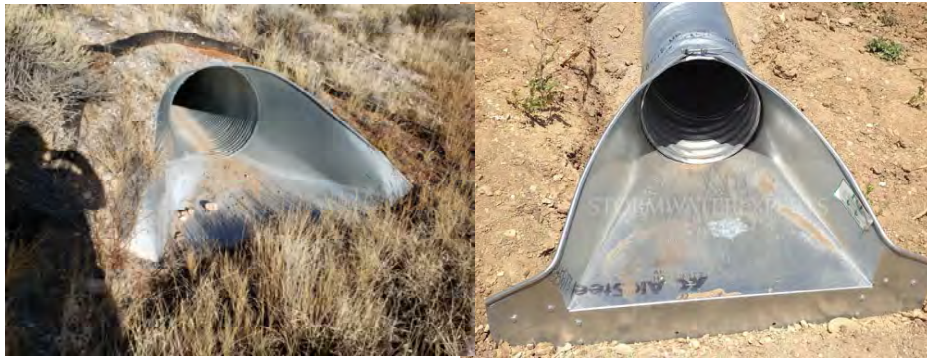
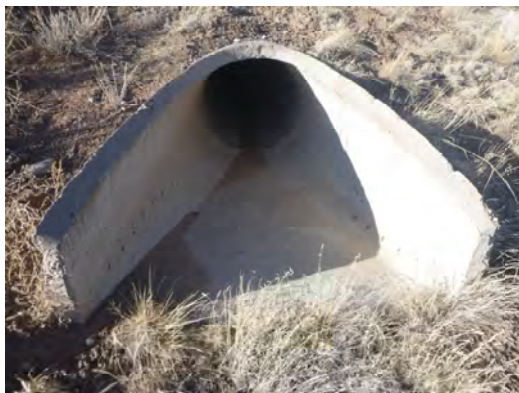
End Sections-Metal and Concrete

Metal and concrete end sections are flared to improve flow of water and also to protect pipe end from damage. End sections are applied to both inlets and outlets of culverts.

Corrugated metal pipe above

Concrete culvert pipe below

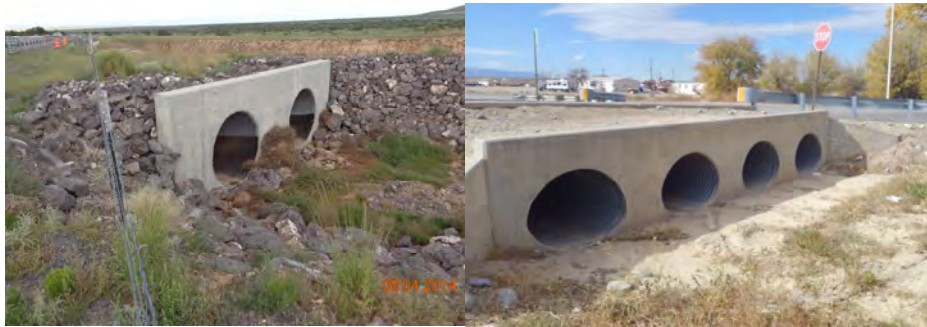
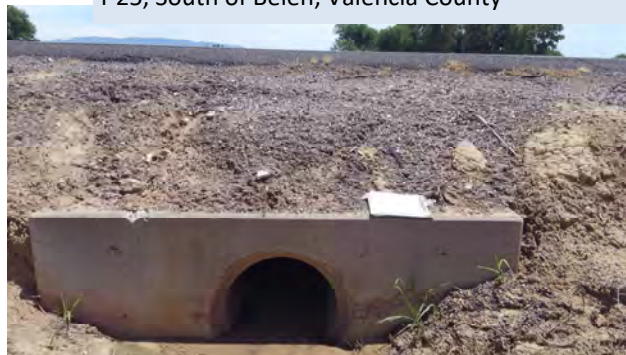
End Sections– Headwall

Headwall is a vertical concrete structure placed at the end of a culvert or series of culverts. Use this for circular, elliptical or arch pipes for all material types. Box culverts will be treated separately in the following pages. Some headwalls may have wingwalls as shown on top right image. Image to left is located on NMRX (Railrunner), south of Santa Fe, Santa Fe County. Image to right is located on private drive into US 64, Shiprock, San Juan County.

Concrete culvert pipe below with concrete headwall

I-25, South of Belen, Valencia County

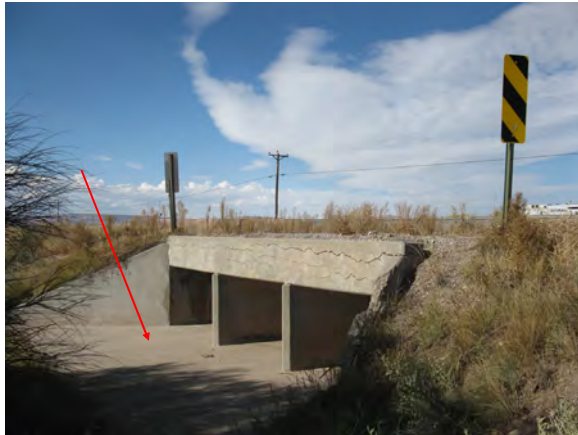
CBC with apron (see arrow on image to the left).

Apron is a concrete floor between wingwalls. Generally it is an extension of CBC floor. A 3 ft. vertical wall (cutoff wall) is placed at the end of apron. This is to prevent erosion undercutting beneath apron.

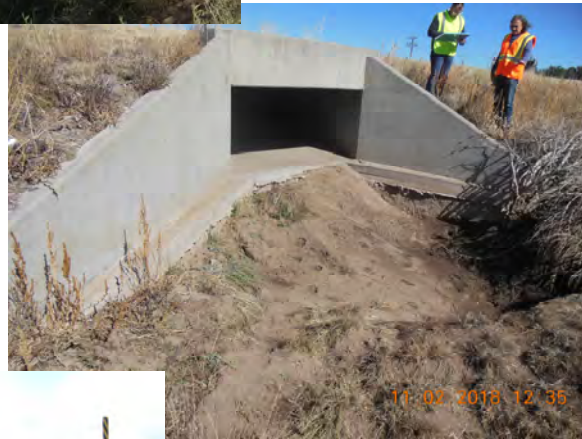
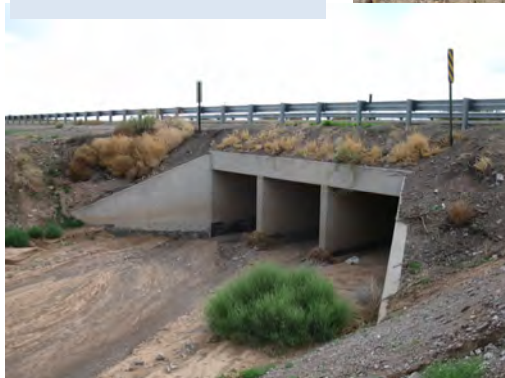
CBC without apron. Common on structures built before 1970

Apron not evident. Likely covered in silt.

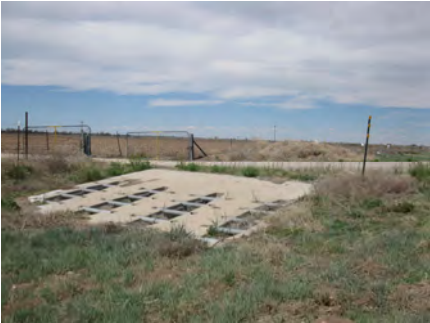
Concrete slope blanket is a slab of concrete that is placed at the inlet/outlet of a culvert or series of culverts. Culverts are usually cut to match the slope of blanket. In some cases, safety grates are placed to prevent an errant vehicle from overturning into slope below.

Metal culverts, with safety grates. Location is on NM 2 south of NM 438, Eddy County.

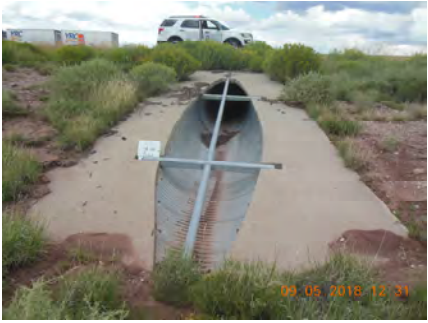
Metal culvert, with safety grate. Location is unknown.

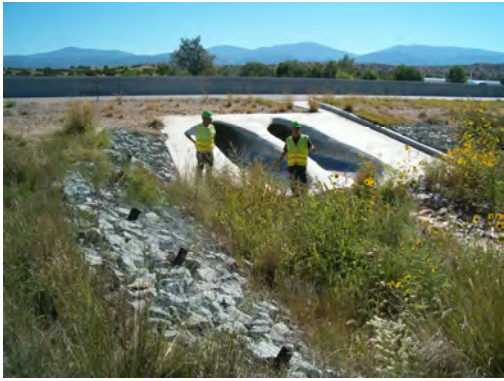
Concrete culvert pipe, no safety grate. Location is on US 84/ 285 south of Cuyamungue, Santa Fe County.

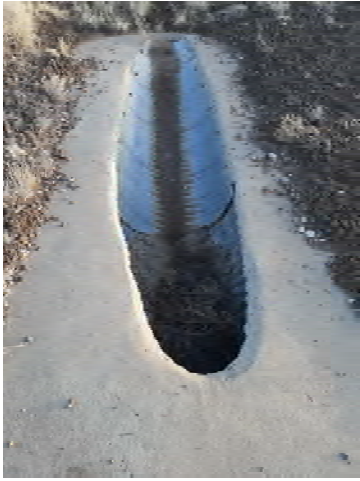
Metal culvert, no safety grate. Location is unknown.

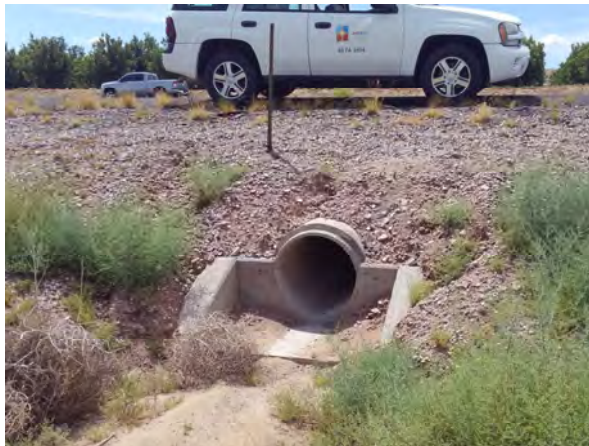
For an end-section that does not fit any of the previous descriptions, select 'other'. For a culvert that is inaccessible, leave the default 'null' value. Note the concrete end section on the image below. This was a common feature placed on culverts during the early decades of the interstate system through New Mexico. Siphons (see image below) are used for irrigation ditches under a road where sight distance of oncoming traffic becomes a chief safety factor.

Concrete end sections common in construction of Interstates in the 1970s. Culvert to left is on I-25, south of Belen, Valencia County.

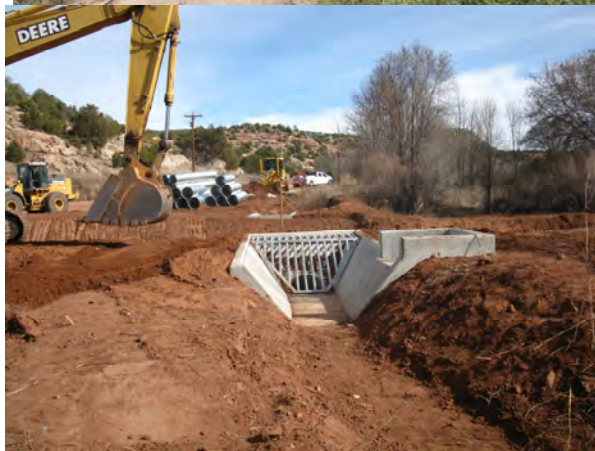
Concrete siphon used for irrigation ditches. Sample to the left has trash rack and built-in side gate. NM 3 near La Fragua, San Miguel County

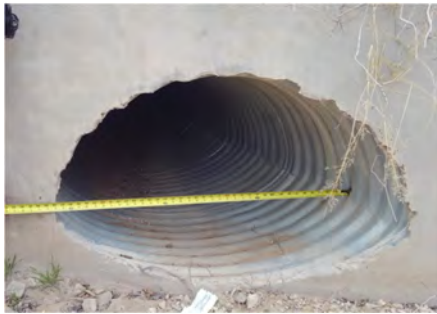
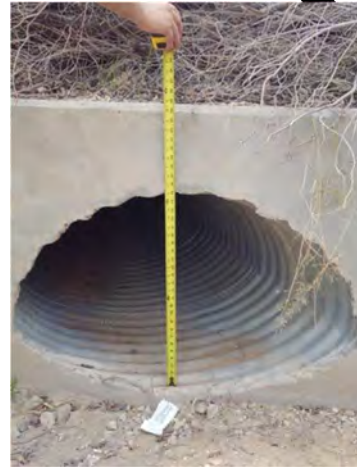
Span, Rise and Width for Circular, Arch and Elliptical Pipe

Diameters of circular culverts come in 6 inch increments (18, 24, 30, 36 etc). For arch pipe and elliptical, the measurements are dependent on the manufacturer. For all cases, measure to the closest inch for span and rise where ever possible. If culvert is partially silted, dig to the bottom of culvert to get value for rise.

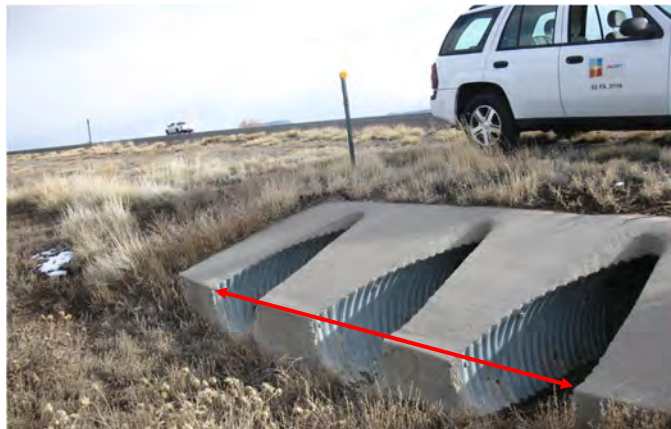
For multi-barrel culverts (with or without concrete slope blankets), measure total width from end to end as shown in this image to the closest 0.1 ft. Count the number of pipe and put value in appropriate field.

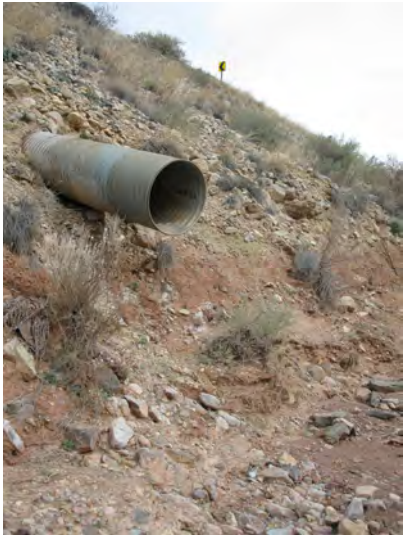
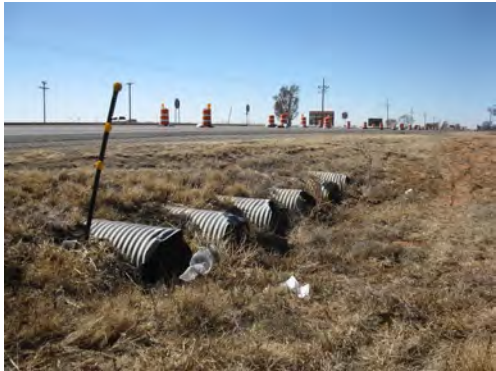
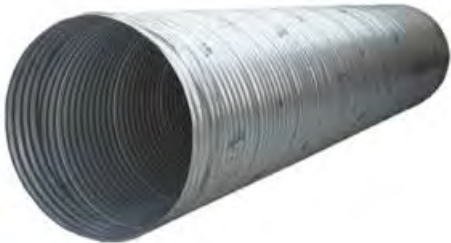
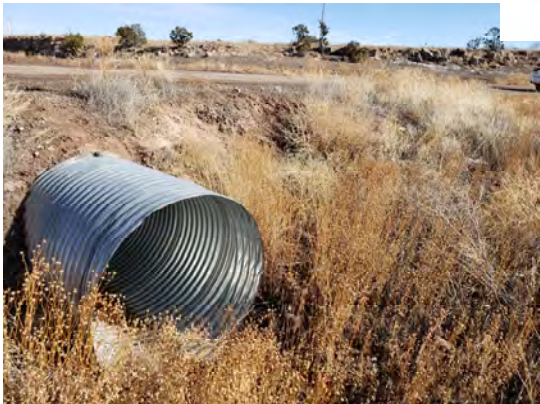
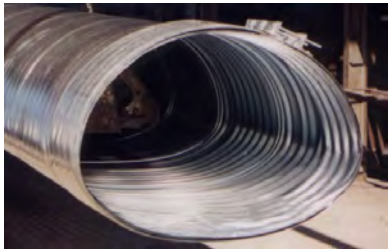
Culvert Materials—Metal

Corrugated Metal Pipe (CMP). Also labelled as Corrugated Metal Culvert (CMC).

Top left is located on NM 165, near Placitas, Sandoval County. Top right is located on US 60 near NM 467, Curry County. Locations for remaining images are unknown.

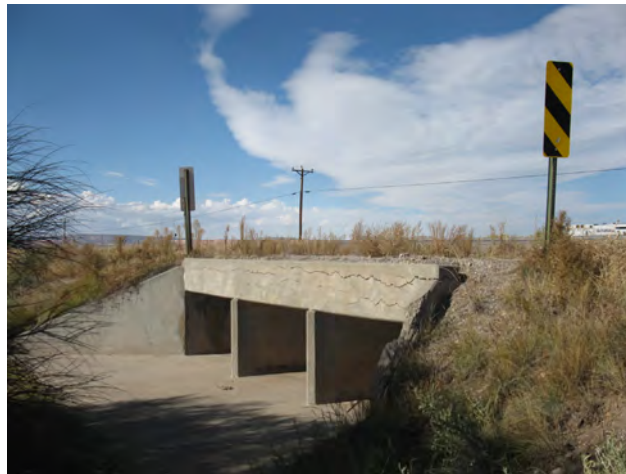
Concrete Box Culvert (CBC), Concrete Pipe Culvert (CPC). The latter can also be labeled Reinforced Concrete Pipe (RCP).

The CBC above is technically a bridge because it's width is greater than 20 ft. Shown here for illustrative purposes only. A single box can span from 2 ft to 14 ft.

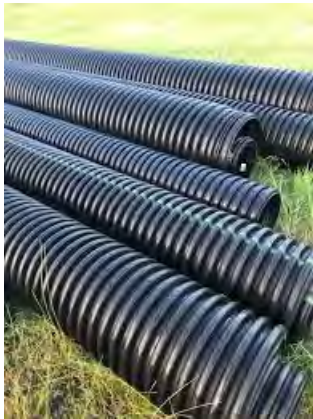
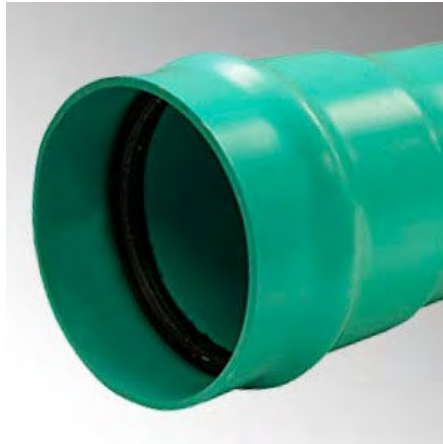
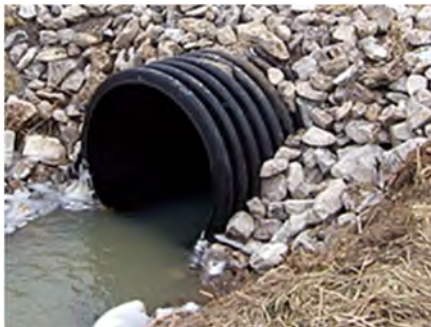
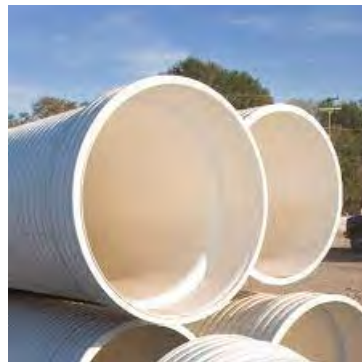
Culvert Materials: Plastic

High Density Polyethylene (HDPE) is used in special cases for drainage where water and/or soils are highly corrosive . Other types are Poly vinyl chloride (PVC) used in sewer and water lines. It is sometimes used for driveway drainage. There are other types of plastic pipe in the market but are not shown here.

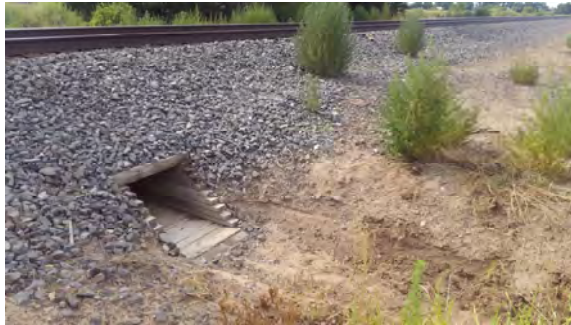
Photos shown below are timber boxes used for drainage and irrigation in railroads. As they age, they are being replaced by newer materials. Railroad culverts are not in the scope of this work.

Location of timber box culvert shown on left is adjacent to NM 116, Jarales, Valencia County

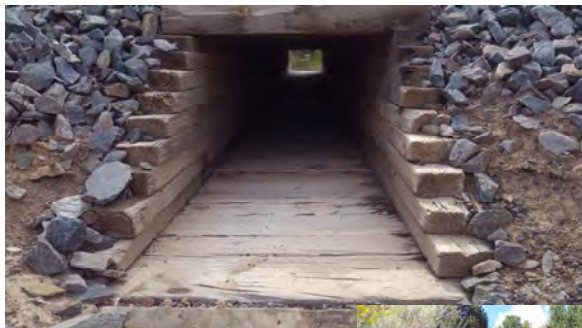
One of the few remaining wooden bridges along New Mexico highways. Image on the right is on NM 344, north of Cedar Grove, Santa Fe County.

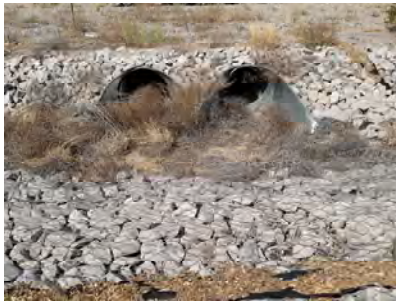
Wire-enclosed riprap

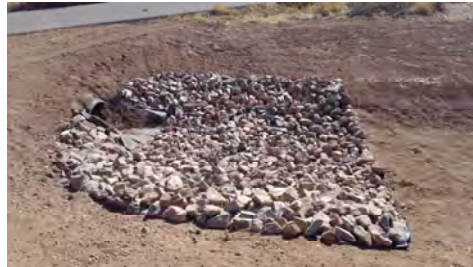
Loose rock riprap

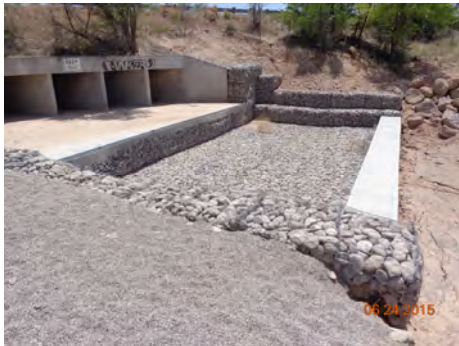
Combination wire-enclosed riprap and gabions below CBC apron.
Location unknown.

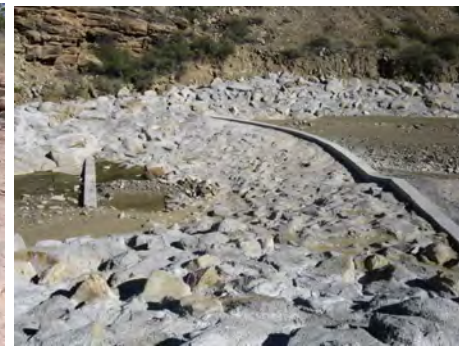
Grouted rip-rap (wire-enclosed or loose rock) - Above example is grouted loose rock. Average size of rock shown here is between 24 to 36 inches. Location is an arroyo paralleling NM 51, upstream of Elephant Butte Reservoir, Sierra County.

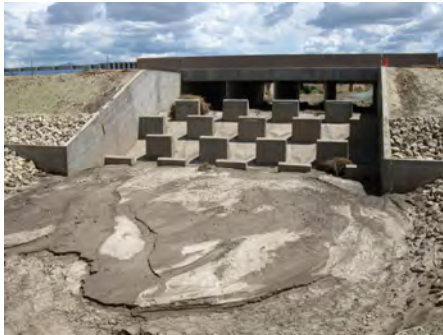
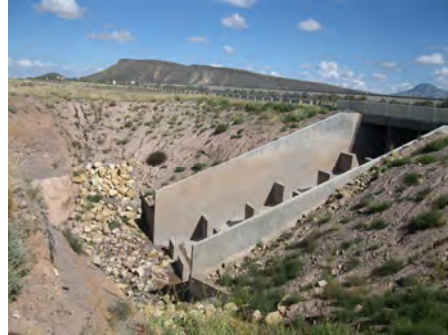
Examples of energy dissipaters used for erosion control. Although structures shown above are considered bridges they illustrate types of 'concrete' structures that have been designed for erosion control. Both ED are located along US 54, south of Tularosa, Otero County.

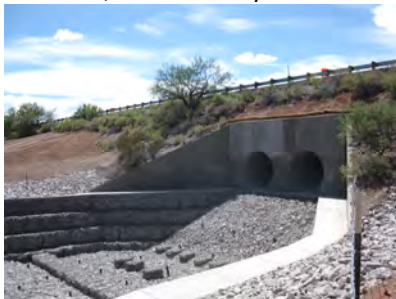
Combination wire-enclosed riprap and gabions. Location is NB I-25 at MP 123.5.

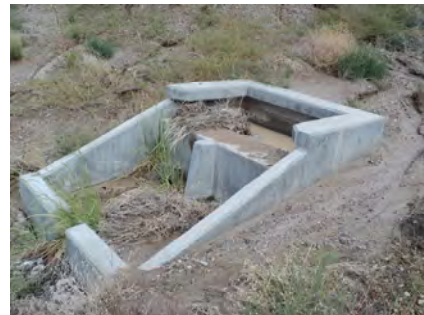
Another example of 'concrete' structure used for erosion control. Location unknown.

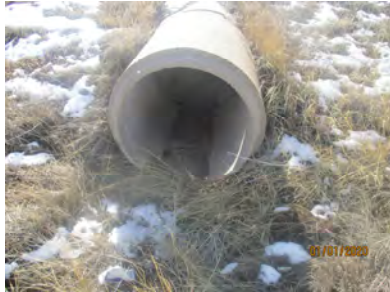
'Clean' or 'Less than 10% silting'

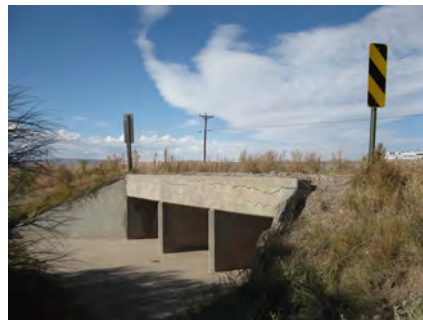
'Clean' or 'Less than 10% silting'

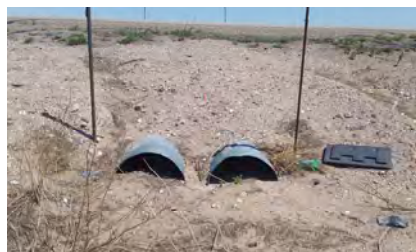
30% to 60% silting

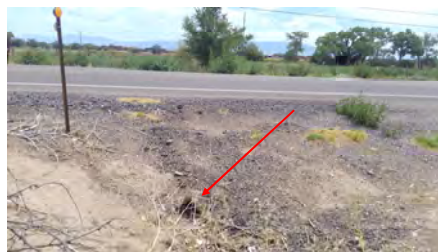
Greater than 90% silting. The culvert shown by red arrow is almost covered. Only the t-post to the left gives away the culvert's location.

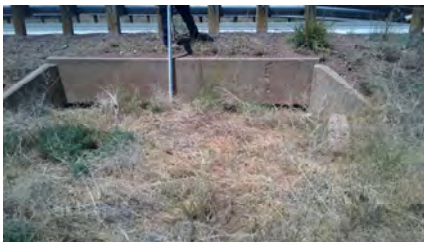
Greater than 90% silting

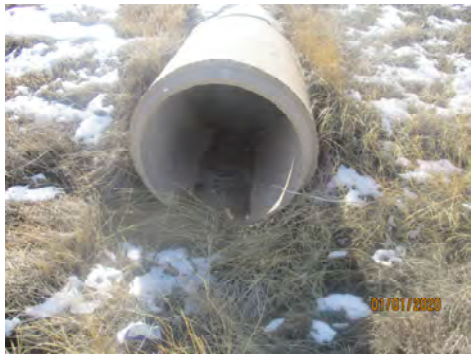
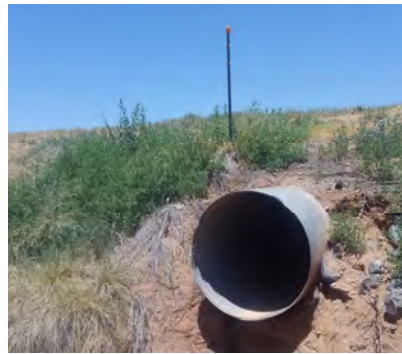
Culverts above show no signs of physical damage. Accept default value of 'null' value or enter 'none'.

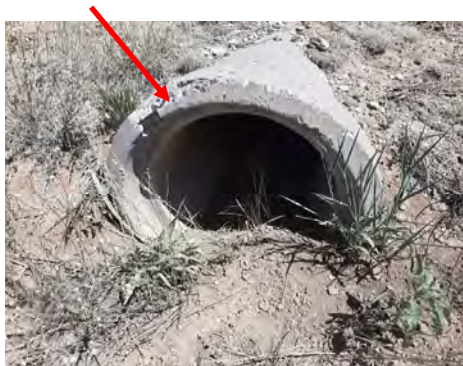
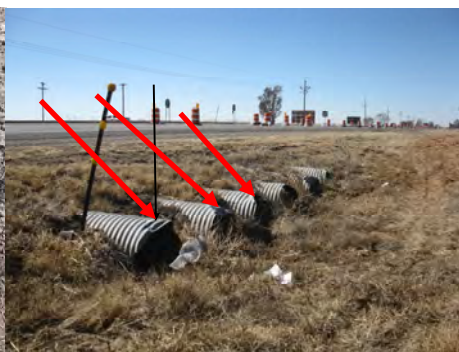
Concrete and metal culverts show minor damage. Rim of concrete culvert is chipped but otherwise in good condition. Battery of metal culverts to right show minor dings at the tops. Damage here is considered minor.

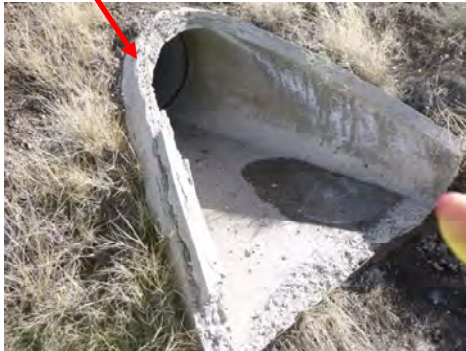
Spalling around edge of concrete end section is very evident. Spalling is when concrete chips or flakes away from structure. There are many causes, but most damage is done by the effects of years of de-icing roads with salt or other chemical interactions between concrete, soil and water.

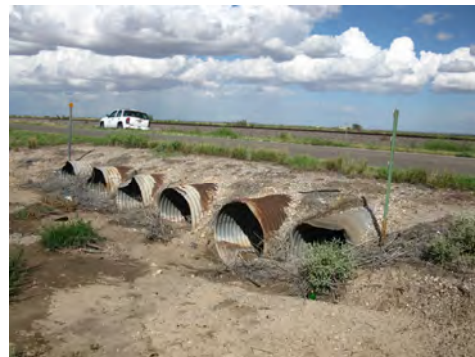
Culverts to the right are collectively considered to have 'moderate' damage due to significant deformation of pipe openings. Corrosion, however is the big concern. That will be taken up on pages 47 and 48. Site is on NM 2 north of Dexter, Chaves County.

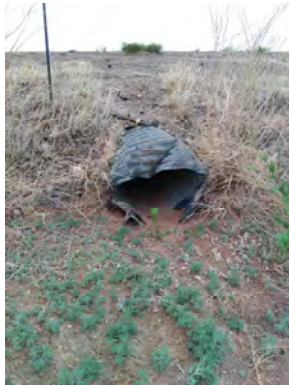
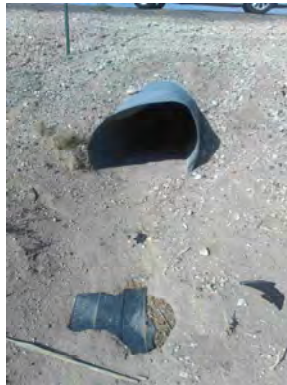
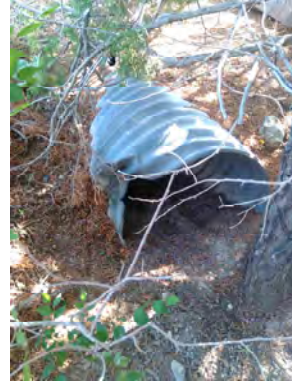
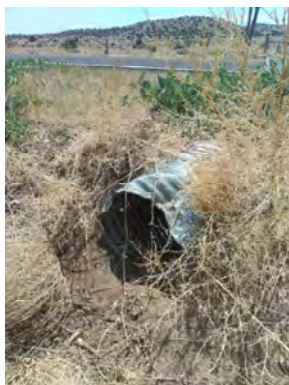
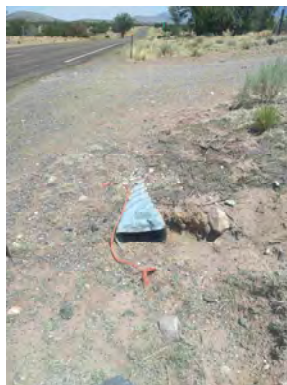
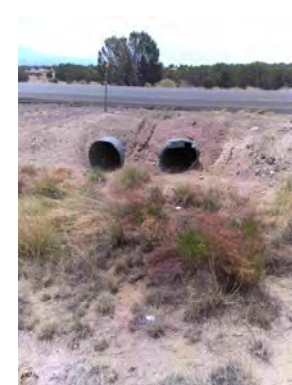
More samples of metal culvert moderate damage. Selected from the CAMP 2021 summer season.

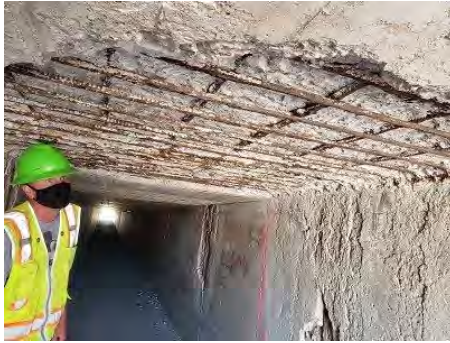
NM 120, MP 6.7, Colfax County

This is where rebar is exposed and considerable spalling has occurred in concrete box culverts. Heavy damage on a metal culvert would be the complete deformation of the pipe at the ends. This could also include signs of culvert bulging or collapsing in the interiors. Note this in the 'comments' field if it appears.

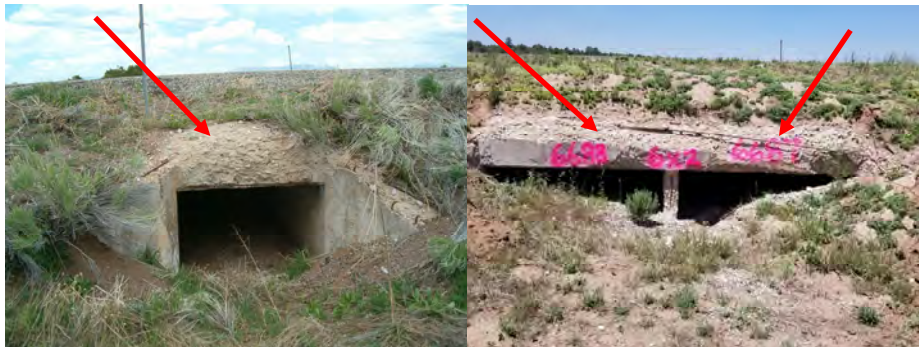
CBC to the left has spalling on the parapet but no exposed rebar evident in the picture. CBC to the right shows severe spalling and exposed rebar. Location is along US 285 north of Tres Piedras, Taos County.

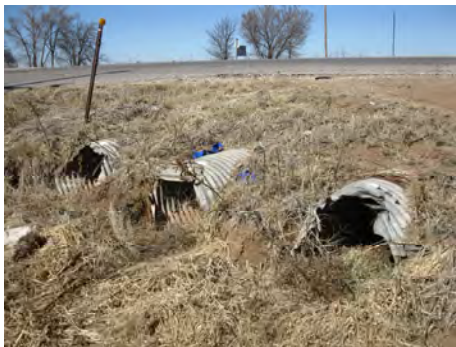
Two outer metal culverts to the left show 'heavy damage'. Center culvert would be considered having 'moderate damage'. Location is along US 60 between Cannon AFB and Clovis, Curry County. Photo was taken before road construction in 2019. This has been repaired since.

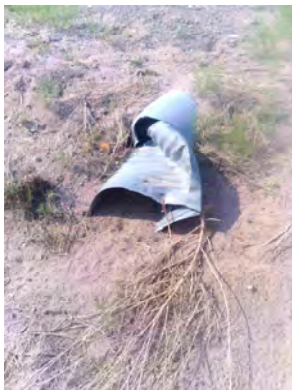
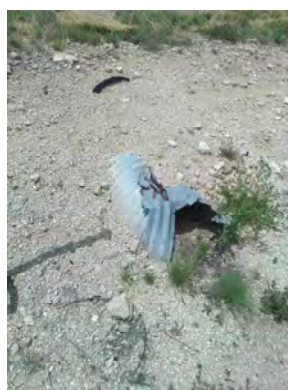
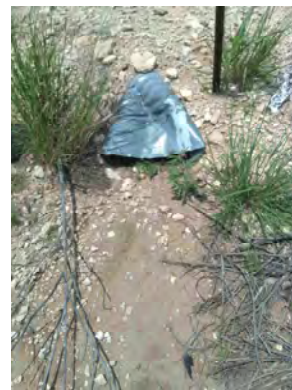
More samples of heavy damage. Images at the bottom are from the 2021 CAMP summer season.

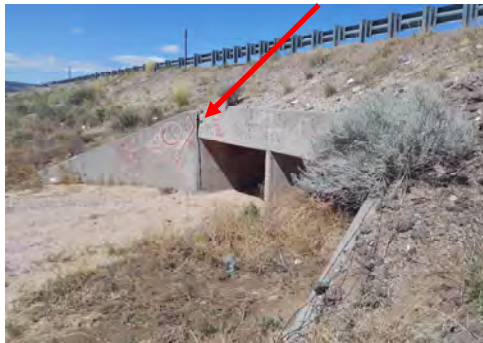
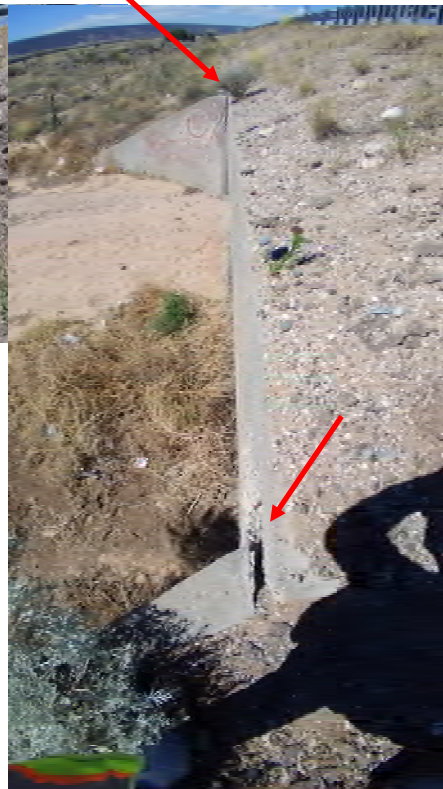
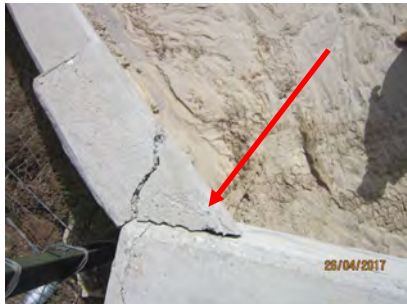
Wingwall is separating from the body of CBC due to differential settling of soils or scour beneath wingwall. Enter as 'severe cracks on concrete' for cracks wider than 1/4 inch. Location is along NM 68 east of Ohkay Owingeh, Tierra Amarilla County.

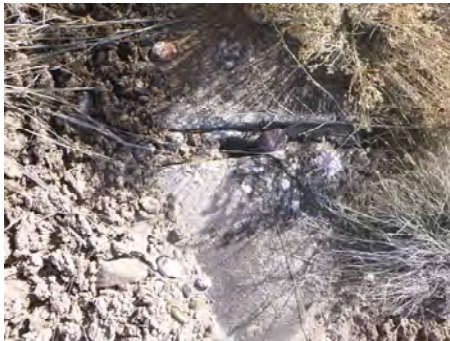
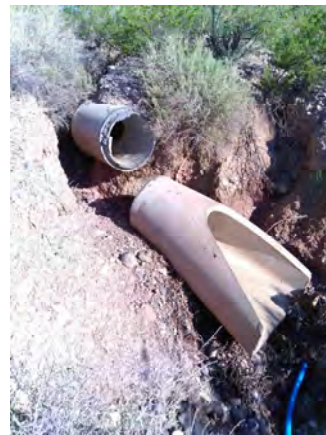
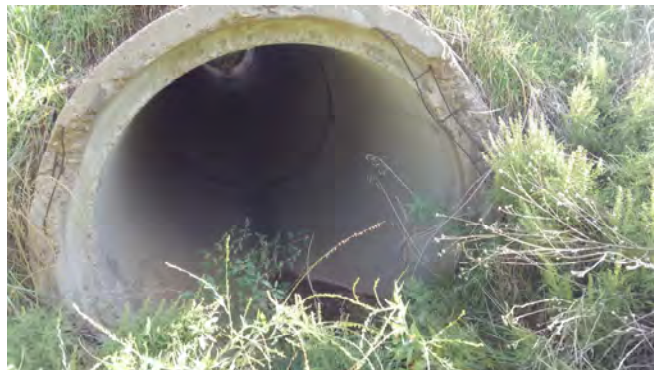
Damage on Circular/Elliptical or Arch concrete pipes. Images below are examples of exposed wire mesh and pipe separation for concrete pipe.

Image to right is located I-25 MP 86.27 (2021 CAMP inventory). Location of image below is unknown.

Note separation of concrete culvert sections on top left. Image on top right shows complete separation of end section to main culvert. Same image also shows major to severe scour. The concrete culvert below has chipped edges exposing the wire mesh reinforcement.

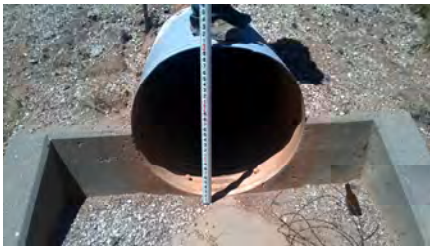
Minor corrosion on inside

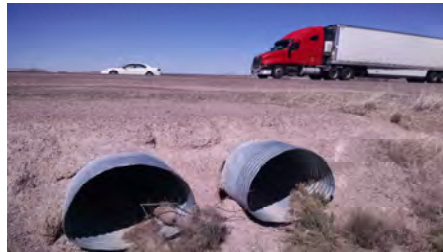
None evident

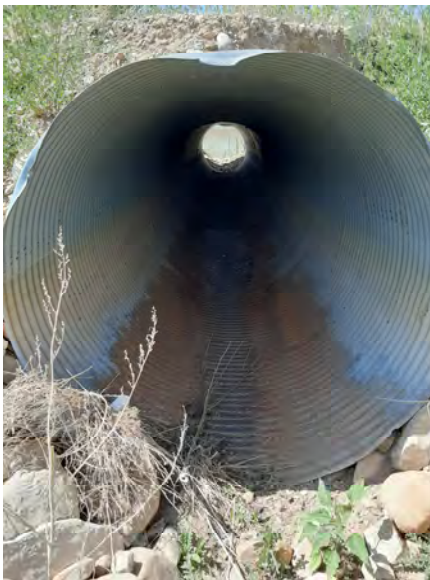
Minor corrosion on inside

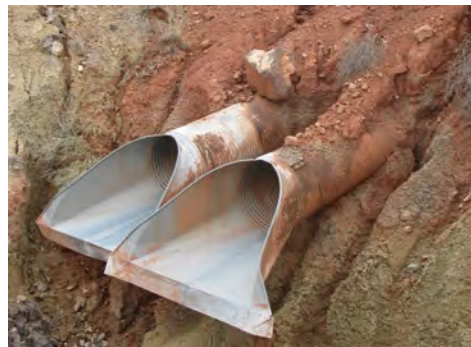
Minor corrosion on outside

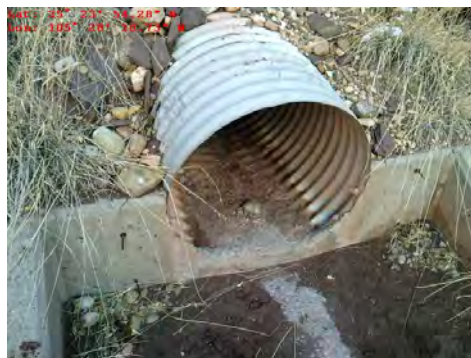
Moderate corrosion on inside. Although not evident on outside, significant corrosion has occurred at the base of culvert. This is caused by abrasion from the movement of gravels and cobbles.

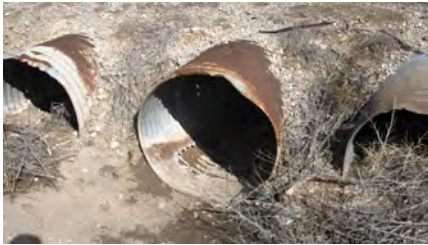
Major corrosion

Major, corrosion on inside and outside. Location is on NM 2, north of Dexter, Chaves County.

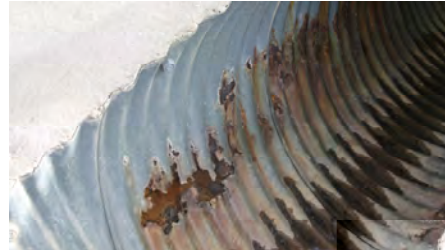
Major, metal has been corroded through culvert, exposing the fill dirt surrounding culvert. Location is WB I-25 MP 120.9.

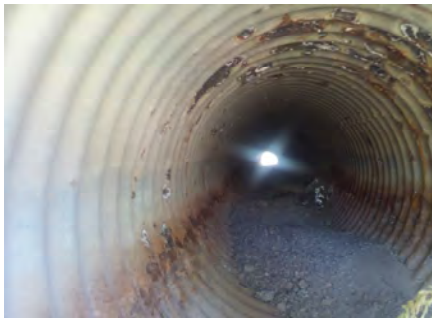
Major corrosion - metal is corroded through culvert on the top of culvert exposing the fill dirt surrounding culvert. Location is on US 60, Mountainair, Torrance County.
