Culvert Asset Management Program

Culvert Identification Handbook (revised 2023)

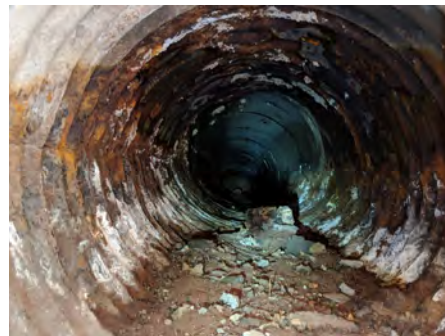
Major corrosion - metal is almost completely disintegrated. Location unknown.

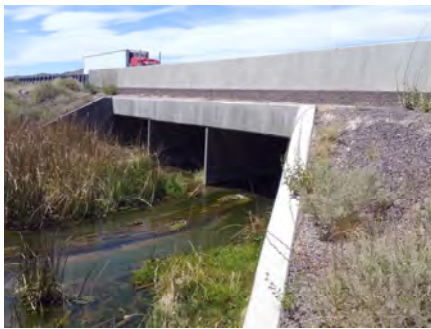
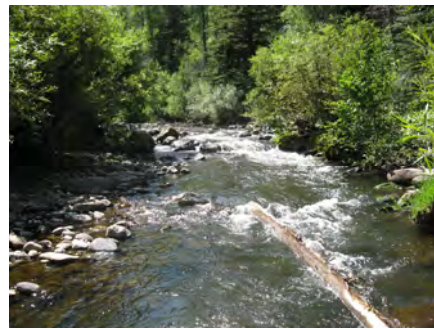
Perennial Channel: Creek or stream that runs throughout the year. Location on left is EB I-40, Rio San Jose. Image on right is somewhere in Conejos County, Colorado.

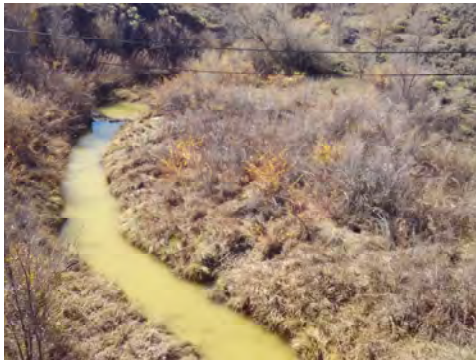
Perennial or Intermittent? Possibly the later. The river runs only during monsoon season or snow-melt. Water is backed up due to an erosion control dam, hence the yellow color. Location is Rio Puerco as seen from US 550 bridge, Sandoval County.

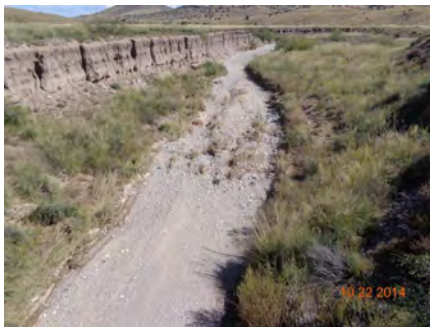
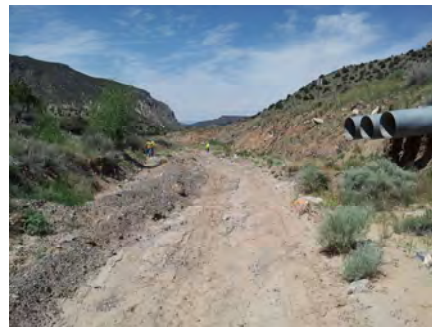
Ephemeral channel: arroyo or wash by any other name. It has a visible sand, gravel or cobble bed with vegetation in flood plain . Runs only during heavy rains. Locations unknown.

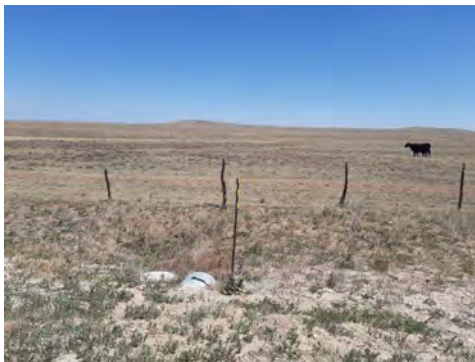
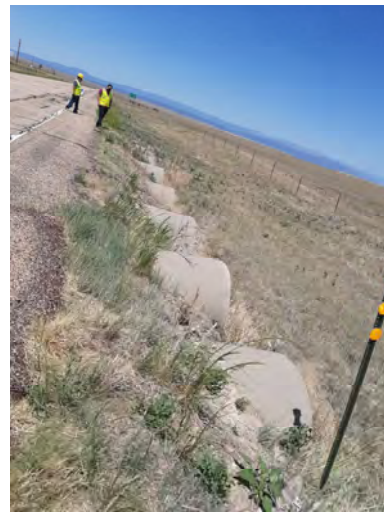
No channel evident– There is no visible characteristics associated with a dry arroyo. Vegetation is uniform throughout. Flow comes only during heavy or long duration rains as sheet flow. Location on left is unknown. Location on right is on NM 104, between Las Vegas and Trujillo, San Miguel County.

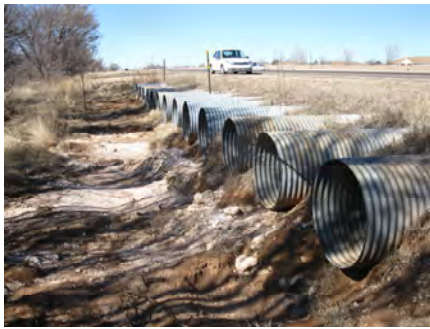
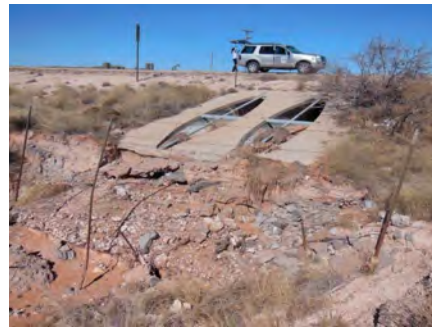
Culvert outlets above show minor scour (1 to 3 ft. depth). Location on left is on US 60 near Cannon AFB, Curry County. Location on right is on US 82, MP 136.0, Eddy County.

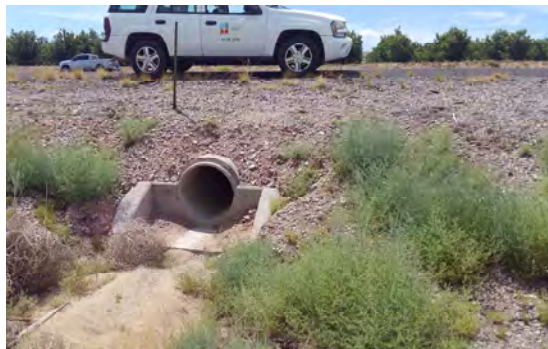
Culvert outlet shows little to no scour (less than 1 ft. depth). If outlet is covered partly in sediment, leave it as blank in data collector and move on. Location above is on NB I-25, south of Belen, Valencia County.

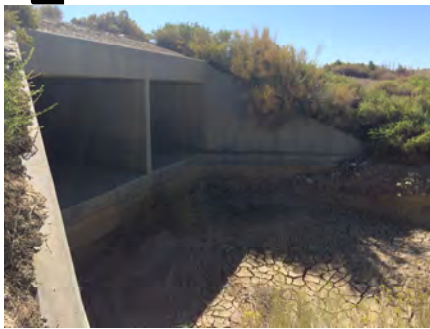
Major scour (from 3 ft. to 8 ft.) at the outlet of 2 barrel CBC. Note the absence of concrete apron, characteristic of older CBCs. Location Unknown.

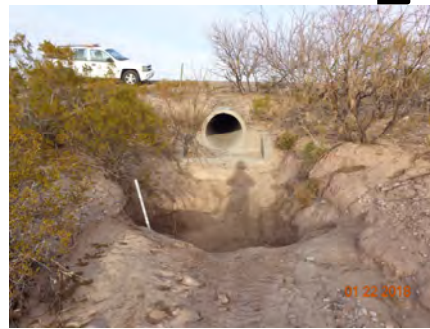
Major scour at the outlet of concrete culvert. Although a scour hole formed at the base of culvert, the surrounding soils are cohesive enough to resist further erosion of flowing water after losing its energy in the scour hole. Location above is on SB I-25 near Hatch, Doña Ana County

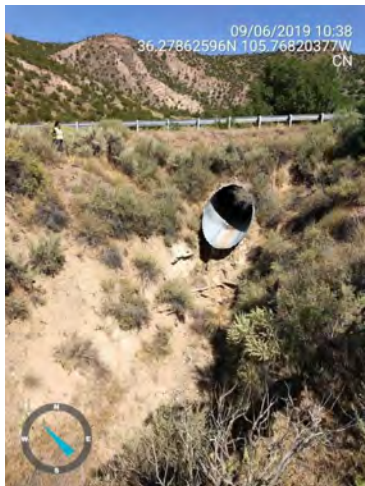
Photo to the left is some serious scour of the dangerous kind. Mark as 'severe' (greater than 8 ft.) Note the observer in yellow vest on top of bank to the left. Location is on NM 68, north of Pilar, Taos County.

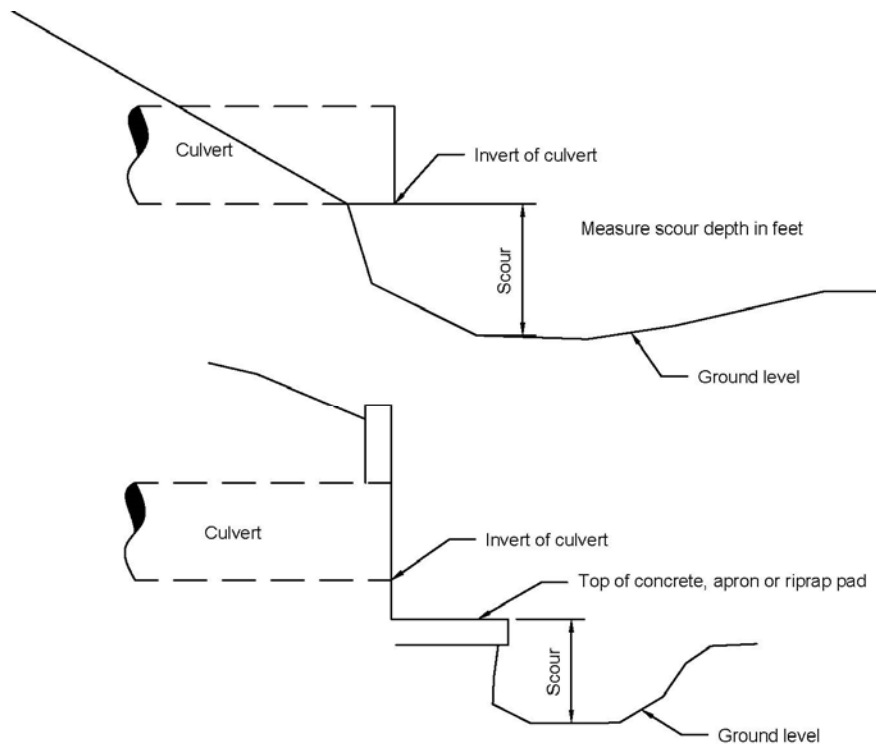
Channel Scour- Method of Measurement

Measure the depth of scour from the invert or flowline of the culvert to the bottom of scour hole if there is no rip-rap pad, apron or concrete pad. Measure scour depth of a culvert from the top of its apron, concrete pad or rip-rap blanket to the bottom of scour hole. These are illustrated below. Scour depths are entered by 'little or no scour (< 1 ft.)', 'minor scour (1 ft to 3 ft.)', 'major scour (3 ft. to 8 ft.)', and 'severe scour (> 8 ft.)'. Once scour depths are near or at the severe end, measurement can become dangerous. Exercise caution!

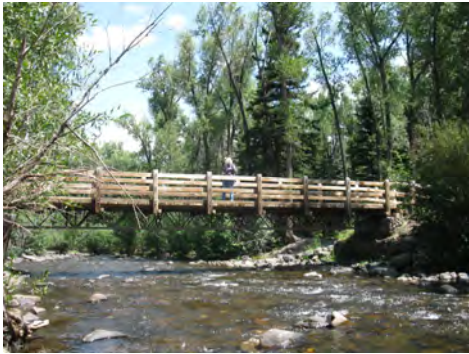
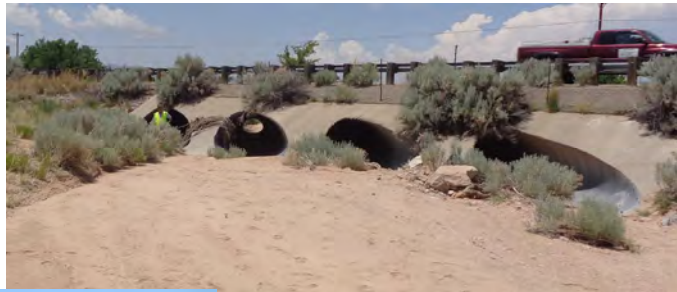
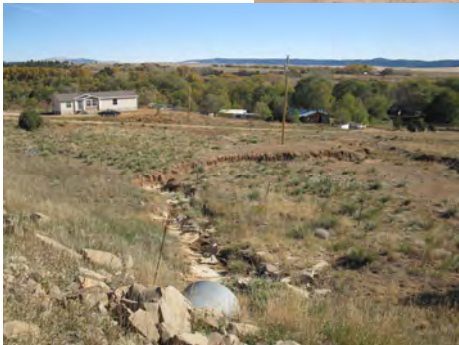
Images to the left and below can be described as 'good' when entering the descriptor for Channel Condition. Both types are functioning as they should be without external disruptions. Many factors come into play when considering the health of the channel. It is better to leave this blank if not sure.

Upper image of river is somewhere in Conejos County, Colorado. Middle image location is on NM 502, east of Pojoaque. Image to the left is on NM 518 near La Cueva, Mora County.

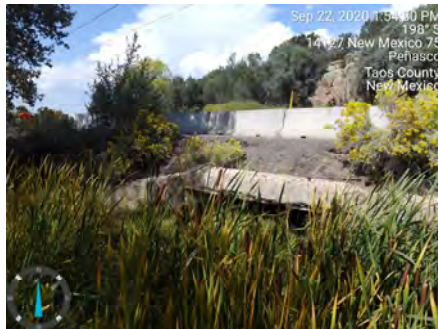
Channel above is swampy and heavily vegetated. Note the cattails growing in the foreground. Location is given on photo.

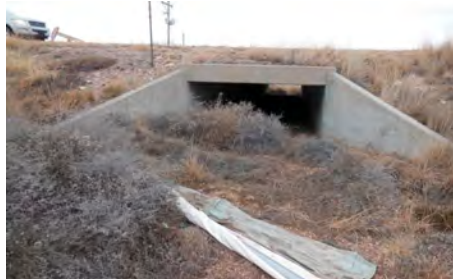
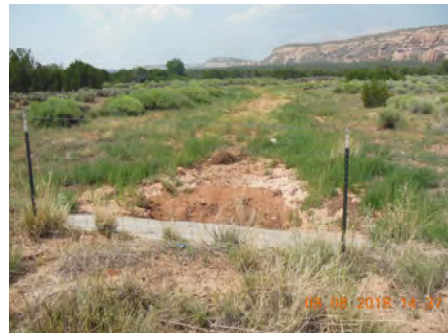
CBC below could be described as 'dry/ heavily vegetated' or 'weed/ debris'. Once again, if in doubt, leave data entry blank. Location is on US 82, west of NM 360 junction, Eddy County.

Channel above could be described as 'weeds/ debris'. Heavy weed growth on channel is due to a wet summer monsoon season. The same culvert is shown below looking at inlet. Location is on NM 53, east of Zuni, McKinley County.

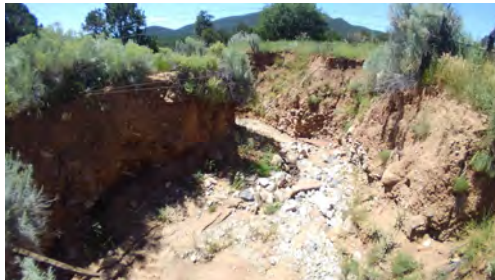
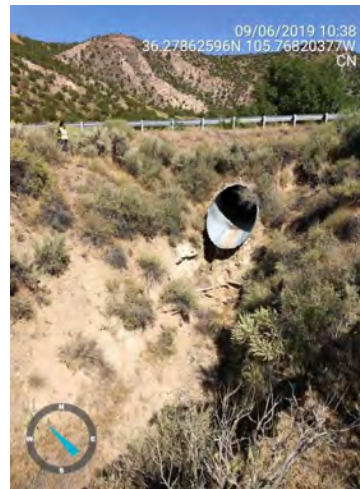
Images above and to the left would be marked as 'channel degrading' where there is scour at channel bottom. There can also be degradation of side banks of channel. Top image is on NM 344, MP 14.6, Santa Fe County.

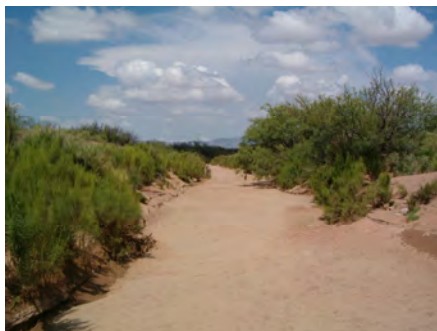
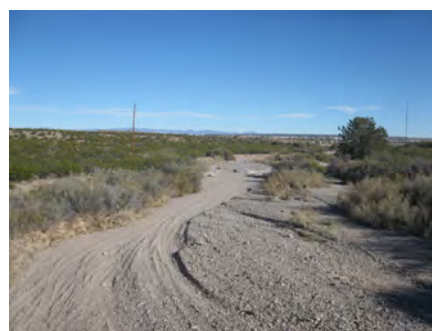
Channels shown on images below can be considered as 'good'. They have well defined low flow channels with vegetation along their flood plains. Bottom left is the Aleman Draw in Sierra County near the Spaceport . Bottom right image is the Yappa Arroyo, NM 181 MP 3.8 in Sierra County.

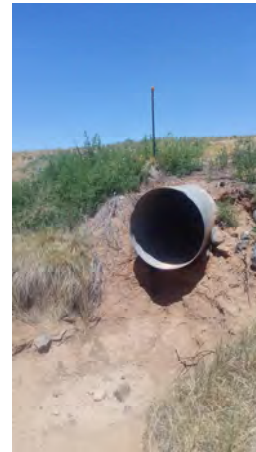
Culvert Material– corrugated metal

Skew– Left Forward

Degree of skew– Normal *[It's really about 10 degrees but since it is out of range of the 22.5 degrees, it can be marked as 'normal'.]*

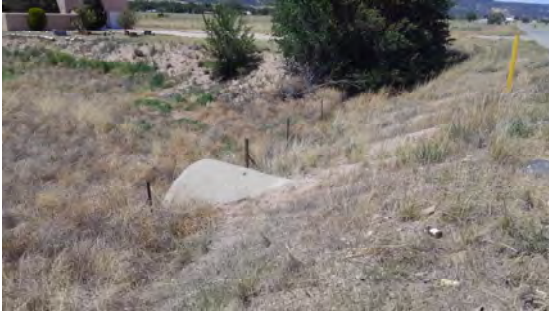
Outlet -78" RCP

The following 3 pages illustrate a more complex data entry sample. First two pages show photos of inlet, outlet and channel conditions. The last page show Trimble TDC600 data entry for this culvert. The outlet is selected for this sample. Note that the inlet is 54" corrugated metal culvert (CMP) rather than the 78" Reinforced Concrete Pipe (RCP) at outlet.

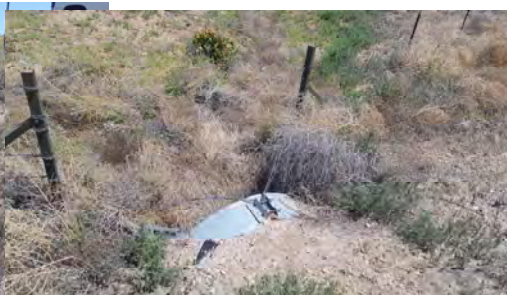
Inlet -54" CMP (!)

Median drop inlet entering into culvert.
