# Countermeasures to Improve Pedestrian Safety on Arterials:

## Design Recommendations for Urban NMDOT Roadways

### Final Report

**Report R922070**

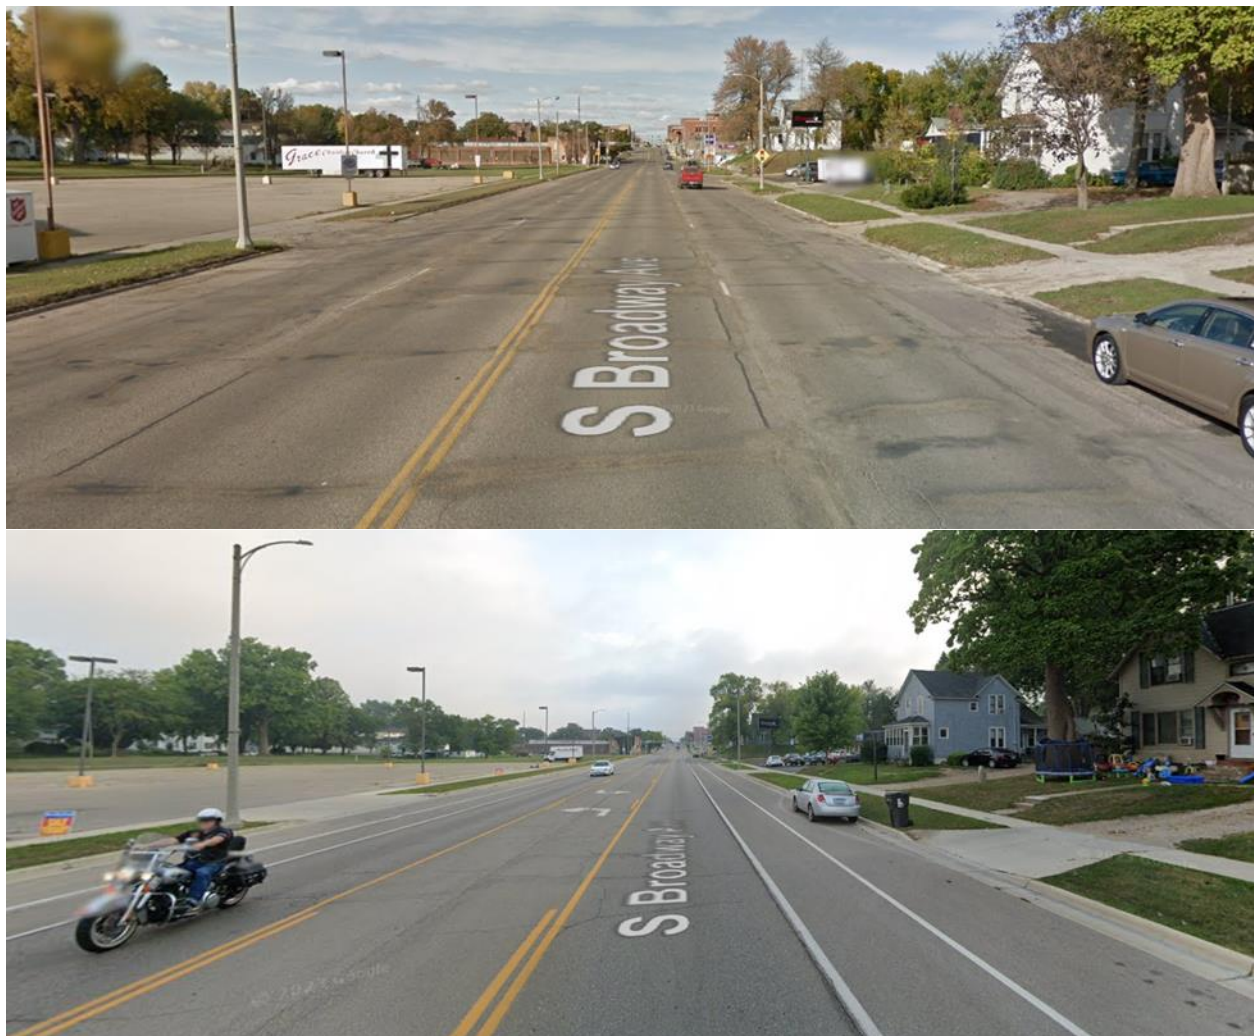
**FIGURE 25. Photo of Highway 65 / South Broadway in Albert Lea, MN before (top) and after (bottom) road redesign**

The road redesign was a traditional road diet that had a four-lane configuration (two travel lanes in each direction) converted to a three-lane configuration with bike lanes on each side of the street (Table 6 and Figures 25 & 26). The road carried between 5,000 and 7,000 vpd both before and after the realignment and the total road width (from outside of sidewalk to outside of sidewalk) was 98 feet, which are both similar to the NMDOT roadways profiled above (14). In addition to lane reconfiguration, the project also saw replacement of sidewalks and traffic signals, new decorative lighting, trees, and curb bump-outs for pedestrians at key intersections.
